# HomeTeam<sup>®</sup>

### HOME INSPECTION REPORT

The HomeTeam Inspection Service made a visual inspection of 123 Main Street, Anytown, USA 55555. Enclosed please find a written, narrative report of our findings in accordance with the terms of our Inspection Agreement.

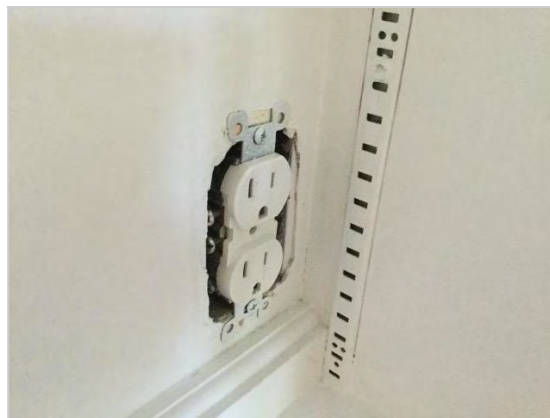
Photo 10

**Missing switch or outlet covers were observed in the living area.** All switch and outlet boxes should be properly covered to avoid a shock hazard. Electrical repairs should be performed by a qualified electrician.
