HOME INSPECTION REPORT

The HomeTeam Inspection Service made a visual inspection of 123 Main Street, Anytown, USA 55555. Enclosed please find a written, narrative report of our findings in accordance with the terms of our Inspection Agreement.

File Number: **1132 - 083016**

Address of Inspection: **123 Main Street**

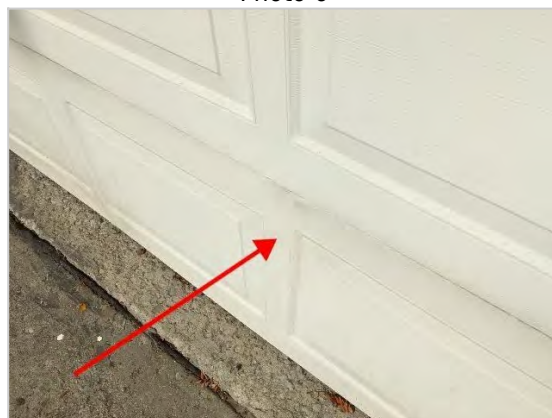
Photo 6

The widest of the three garage door is dented from what appears to be impact. The door was operating correctly at the time of the inspection. Care should be exercised to ensure that the door is not subjected to further impact, as the door may crack or fail.

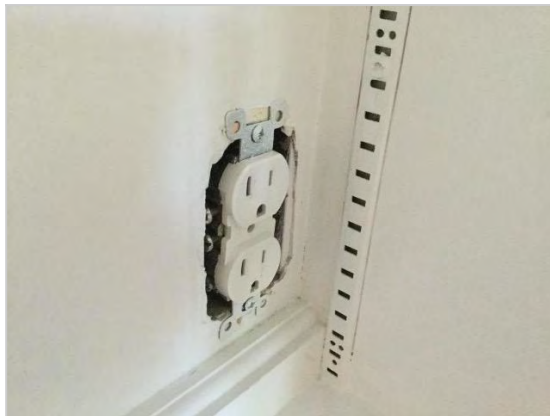
Photo 10

Missing switch or outlet covers were observed in the living area. All switch and outlet boxes should be properly covered to avoid a shock hazard. Electrical repairs should be performed by a qualified electrician.

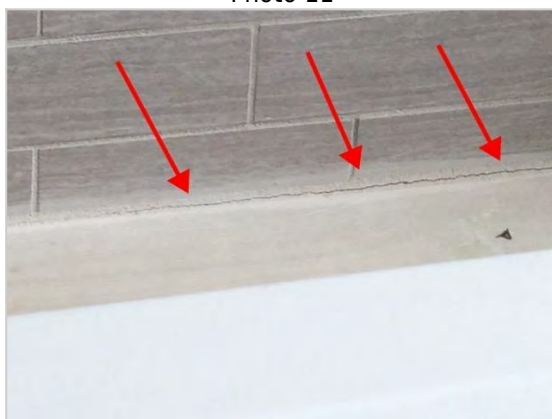
Photo 11

Some of the caulk was missing from around the tub in the master bathroom. These areas should be sealed to prevent moisture penetration. Failure to keep walls sealed can cause deterioration and extensive moisture damage including mold growth to the interior walls, which is not always visible at the time of the inspection.

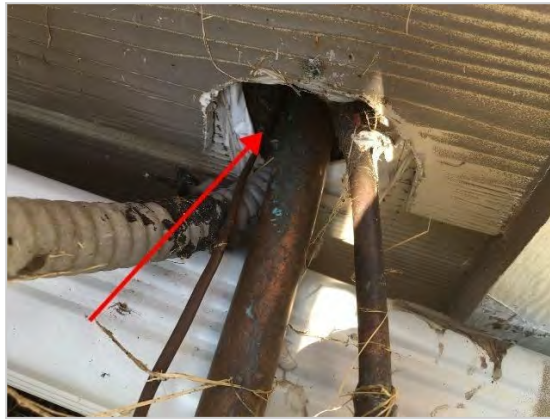
Photo 23

The insulation on the exterior air conditioning line set is missing. This could affect the efficiency of the system and should be replaced.
