HOME INSPECTION REPORT

SAMPLE REPORT

Address of Inspection: **1234 Fifth Street**

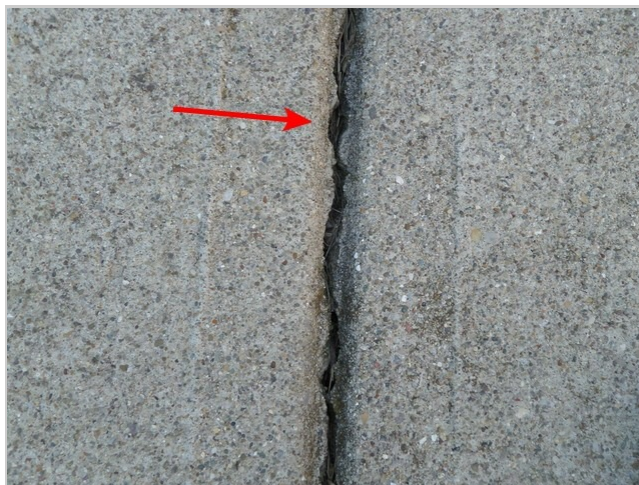
Control joints in walkway need to be sealed.

- **Control joints in walkway need to be sealed.**
- **The patio needs to be sealed where it meets the foundation.**

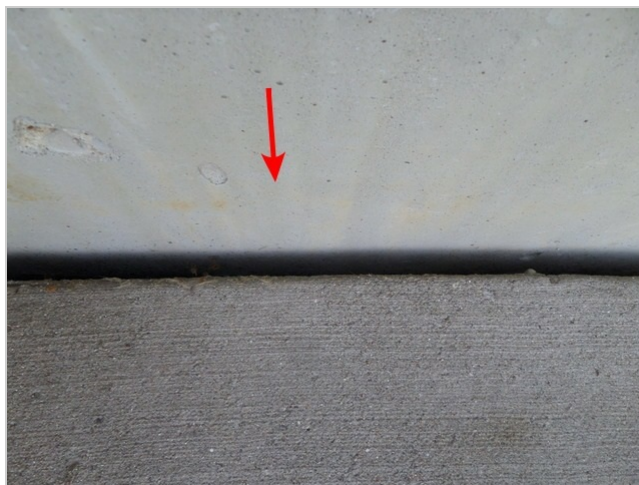
The patio needs to be sealed where it meets the foundation.

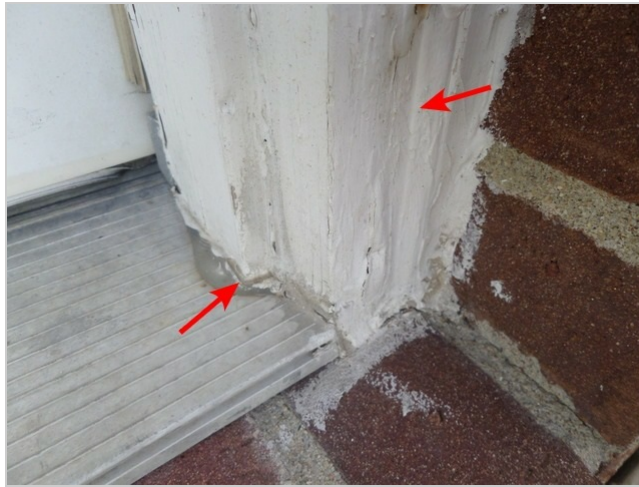
The door to the patio has wood rot on the framing around the bottom that needs to be repaired.

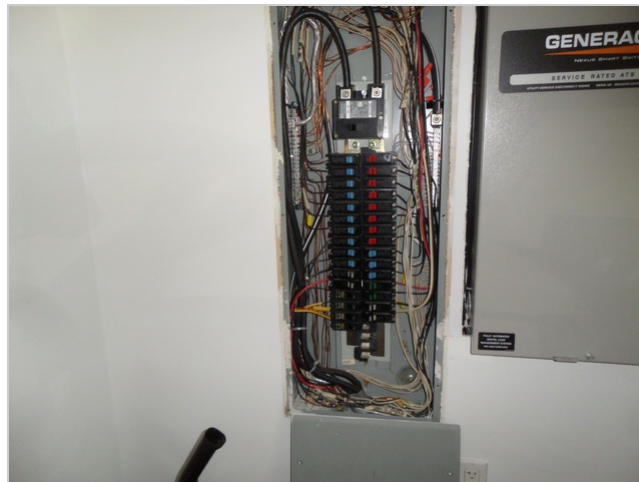
The service wire entered a Cutler Hammer service panel, located on the garage wall with a 200 amp and 120/240 volt rated capacity. The branch circuits within the panel were copper. These branch circuits and the circuit breakers to which they were attached appeared to be appropriately matched.

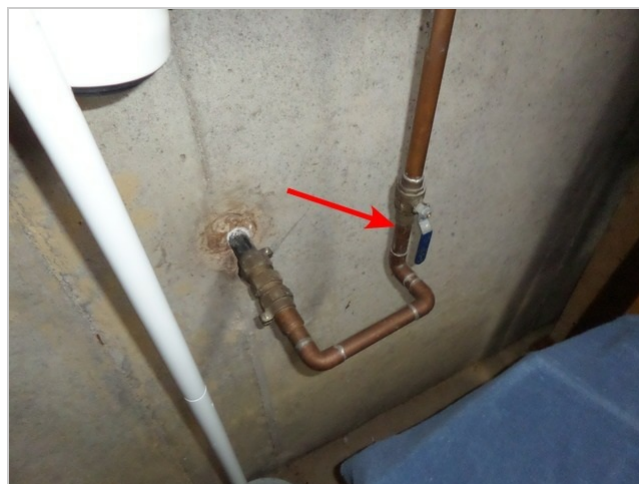
main water shut off

The water meter was located in the front yard. The main water shutoff valve for the home was located adjacent to the water service entry point in the basement.
