HOME INSPECTION REPORT

Address of Inspection: **9650 Eden Manor**

**9650 Eden Manor
Parkland, FL 33076
Inspection # 15664**

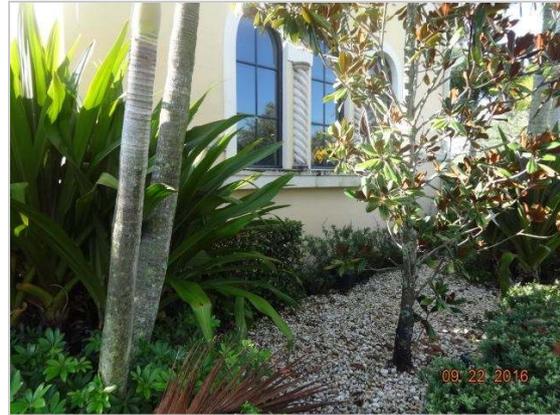
There were areas of foliage and/or tree growth near the home, which prevented a detailed visual inspection of the foundation and walls.

Any foliage or trees in contact with the home should be monitored to prevent damage to the exterior walls or roofing system.

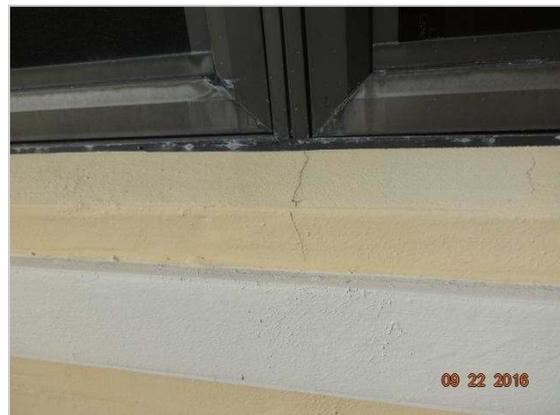
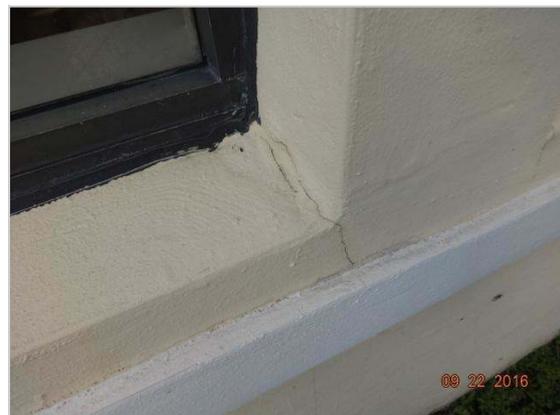
Stucco/sealant repairs were required to hairline surface cracks.

Exterior repairs, \$400 to \$700

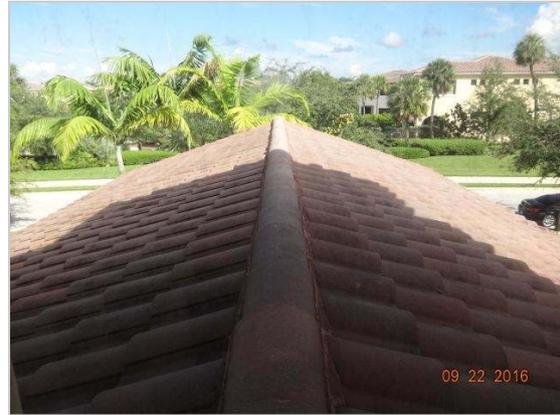
There were material defects detected on the exterior of the roof. For additional information, please refer to the attached Roof Report.

Roof repairs, \$1,100

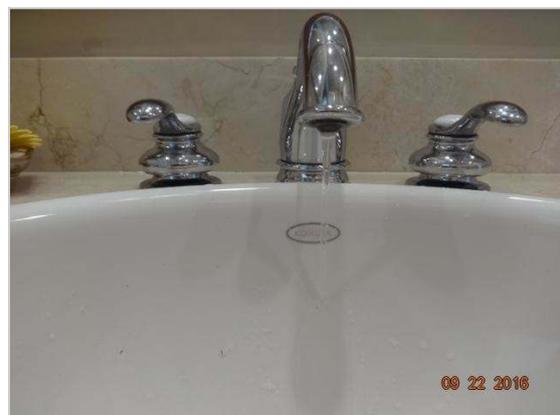
The water pressure was reduced/limited at the sink in the hall bathroom.

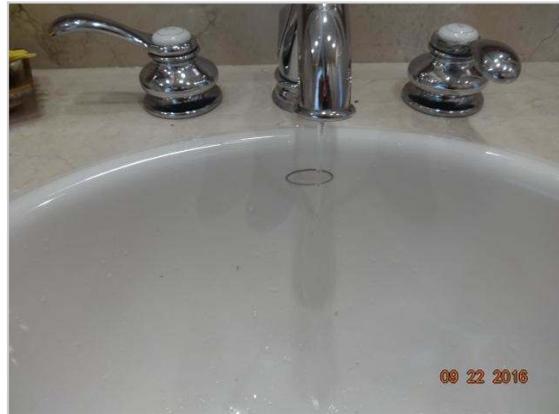
The supply lines did not appear to be secure inside the wall.

Recommend further review and correction by a qualified licensed Plumbing contractor.

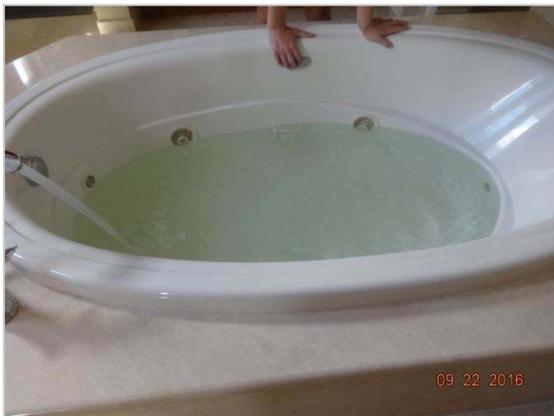
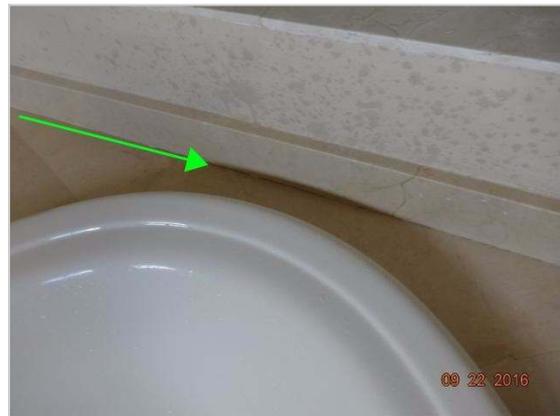
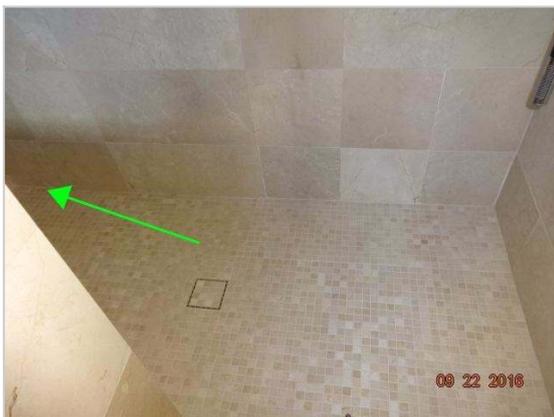
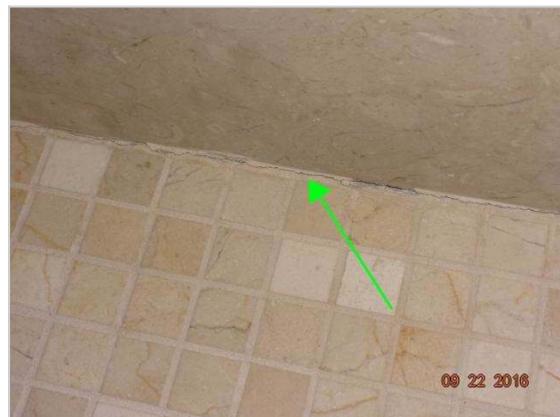
Additional caulk/sealant repairs were required to the whirlpool tub, shower, wall, and floor joins in the bathrooms to provide adequate seals.

A qualified Plumbing Contractor should conduct repairs.

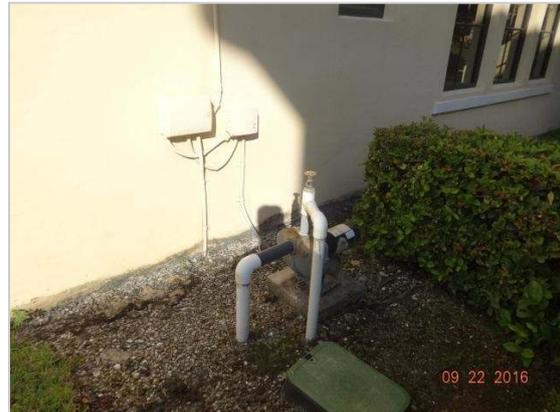
Some sprinkler heads required cleaning and adjustment to restore full function.

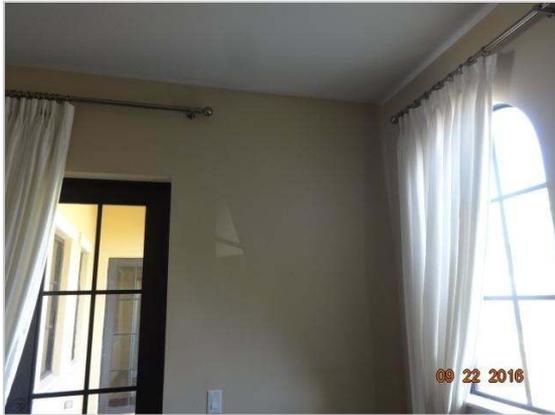
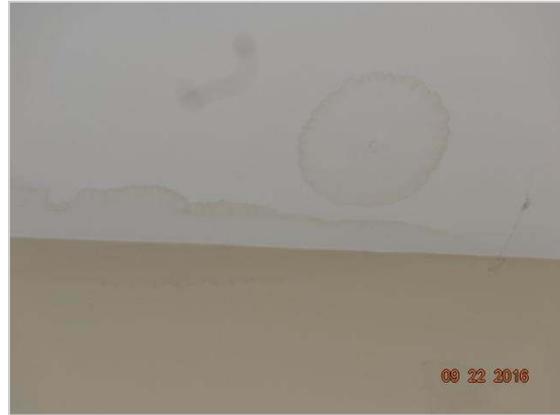
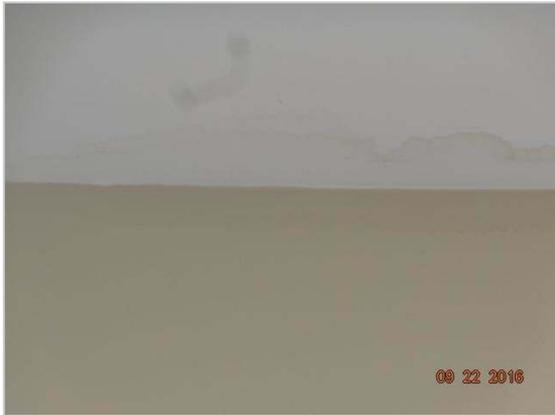
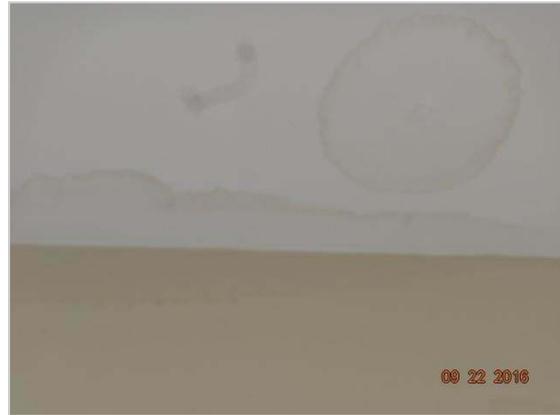
There were moisture stains on the ceiling in the second floor bedroom. The areas were found to be dry at the time of the inspection. Due to the extent of damage observed, the potential exists for damage to have occurred within the ceiling cavities, the extent of which was not visible.

It is recommended that a Mold Assessment be conducted to determine if, and what types, of mold spores are present in the building.

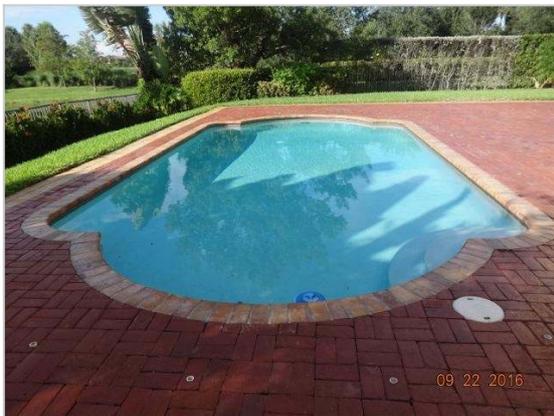
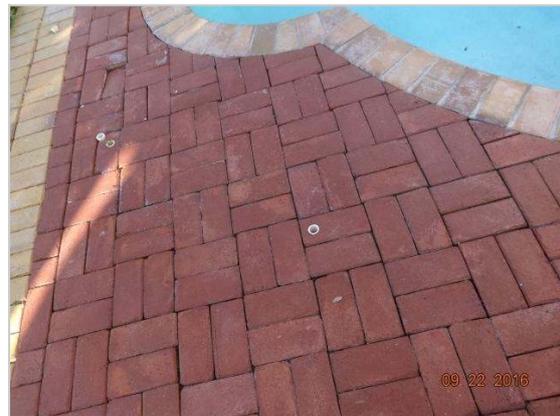
There were no handrails at the pool steps.

There were support holes in the deck for a child safety fence, and it appeared that the fence was stored in the garage. *The safety fencing should be installed and checked for function.*
