**HomeTeam**  
INSPECTION SERVICE

April 9, 2010

**RE: Sample Report  
Jonesboro, AR 72401  
Inspection #: 406-042010-0056**

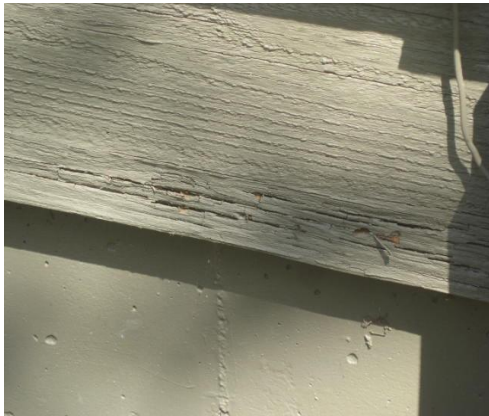
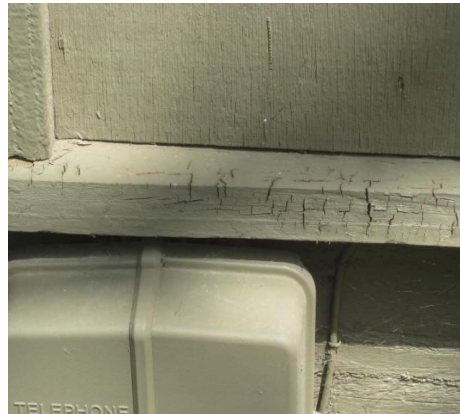
- There was some water damage along the bottom of the wood siding and trim on the back of the home. Wood, metal, and composition surfaces should be kept in good repair, sealed, and painted to extend the life of wood and/or wood products.

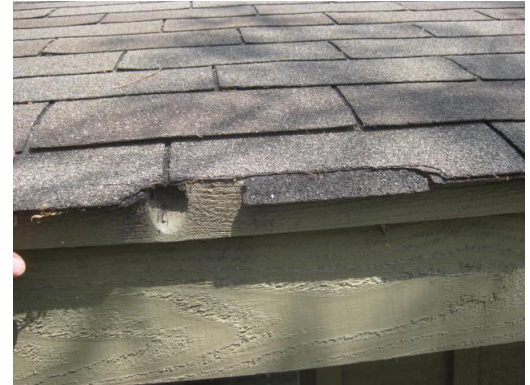
- There was damage to the shingles on the back edge of the roof over the deck. Repair is recommended to keep moisture away from the structural members and decking.

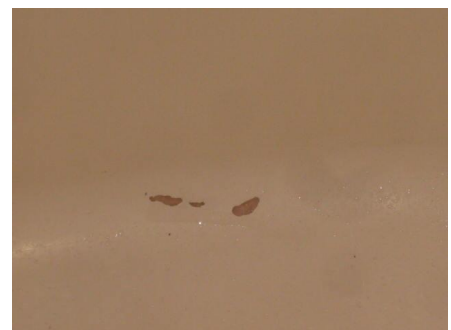
- The faucet on the back of the home drips continuously.
- There were chips in the fiberglass shower floor in the master bathroom. Chips, cracks, and holes in fiberglass should be repaired to prevent moisture from penetrating the surface.

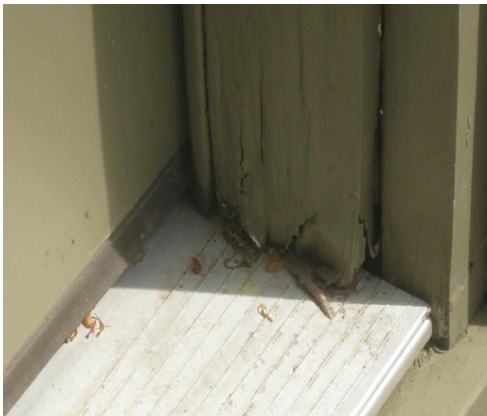
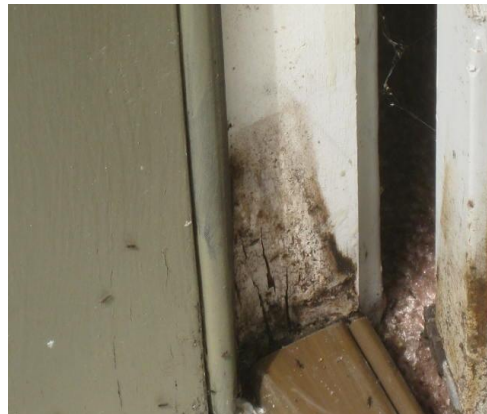
- There was water damage on the bottom inside corners of the back exterior door and the back door frame. This is commonly seen on unprotected exterior doors. Adding protection, such as a storm door or awning, will prevent water from settling in tight corners and causing damage to door frames and doors.

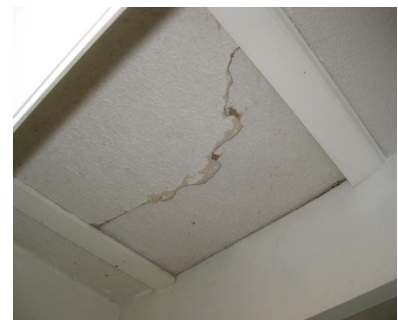
- The cover for the scuttle hole to the attic was broken into two pieces.
- The top catch for one of the folding closet doors in the back bedroom was missing.
- The back door knob and latch do not work properly. Replacement is recommended.
- The door knob on the utility room is loose and should be tightened.

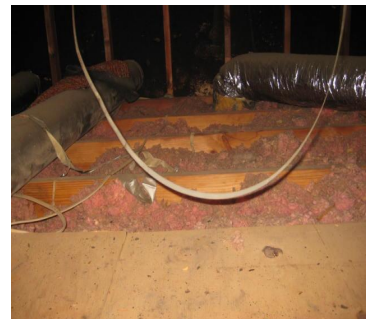
- The amount of insulation present in the attic is insufficient for our climate and will be lacking in energy efficiency. It is recommended that more insulation be added.
