HOME INSPECTION REPORT

**123 Sample Drive
Anytown, TX 55555**

PROPERTY INSPECTION REPORT

Prepared For:	Bill Sample	
	(Name of Client)	
Concerning:	123 Sample Drive, Anytown, TX, 55555	
	(Address or Other Identification of Inspected Property)	
By:	Inspector 1 Inspector 2	9-29-2017
	(Name and License Number of Inspector)	(Date)
	(Name, License Number of Sponsoring Inspector)

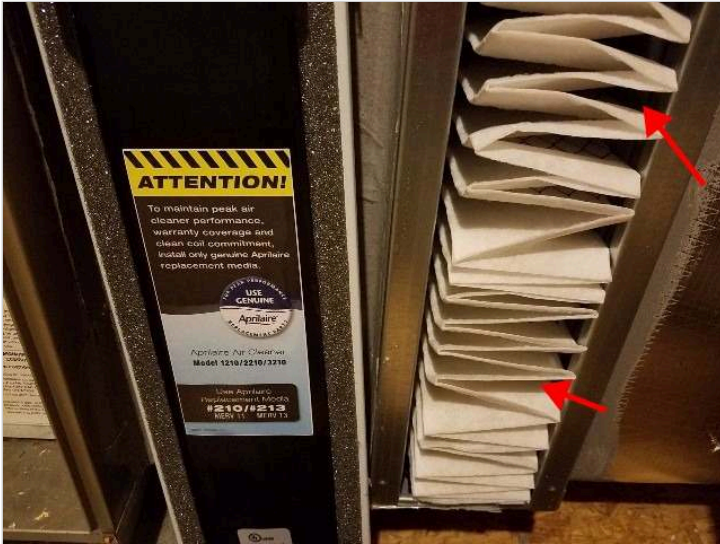
The media filter for the upper HVAC unit was installed backwards (not directed with the airflow in the system).

media filter installed backwards -- metal screen not facing suction side (upper HVAC unit).
