HOME INSPECTION REPORT

**123 Sample Drive
Anytown, TX 55555**

PROPERTY INSPECTION REPORT

Prepared For:	Bill Sample	
	(Name of Client)	
Concerning:	123 Sample Drive, Anytown, TX, 55555	
	(Address or Other Identification of Inspected Property)	
By:	Inspector 1 Inspector 2	9-29-2017
	(Name and License Number of Inspector)	(Date)
	(Name, License Number of Sponsoring Inspector)

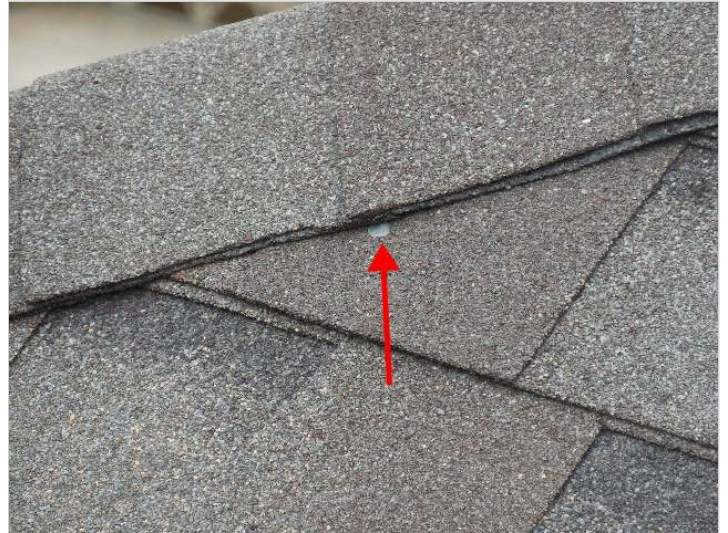
The following minor deficiencies were observed on the roof: exposed and/or rusted fasteners (nails). Recommend seal/caulking and repair to help prevent future damage.

Exposed nail head on roof.

- The following minor deficiencies were observed on the roof: exposed and/or rusted fasteners (nails). Recommend seal/caulking and repair to help prevent future damage.

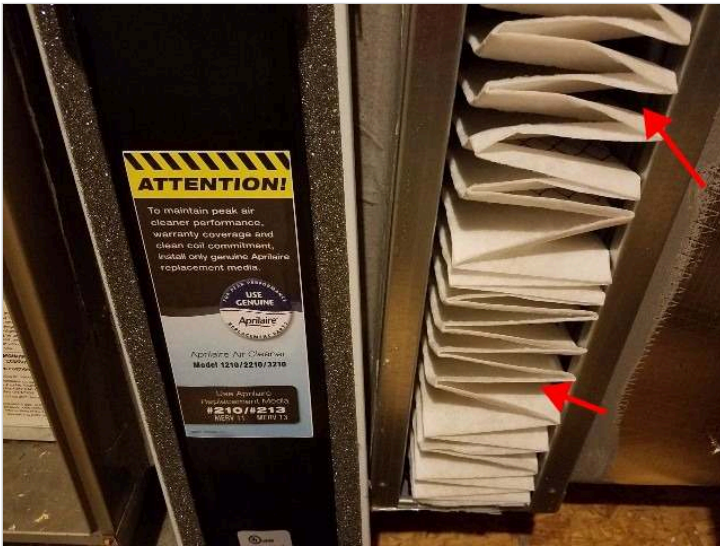
The media filter for the upper HVAC unit was installed backwards (not directed with the airflow in the system).

media filter installed backwards -- metal screen not facing suction side (upper HVAC unit).

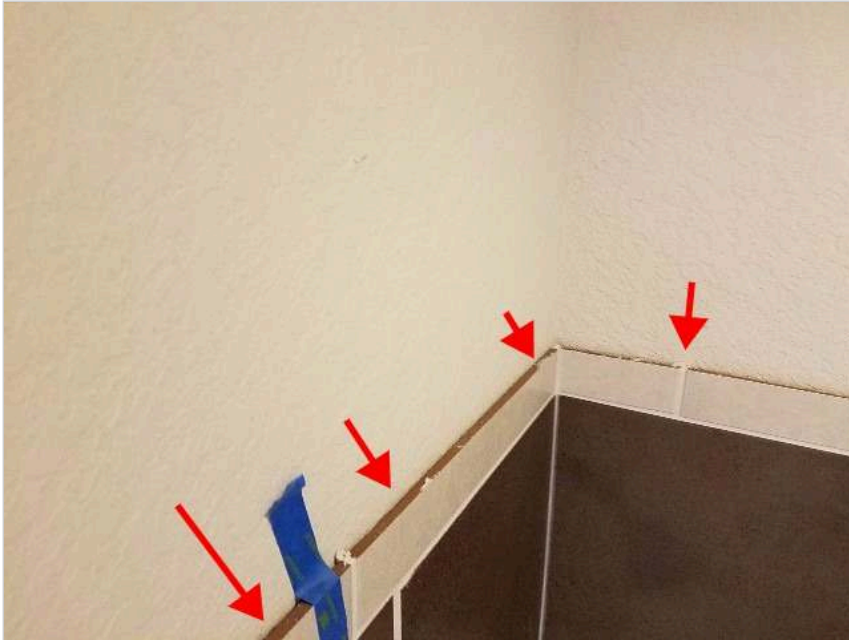
The top of the ALL bath shower enclosures were gapped at the intersection with the wall. Recommend proper caulking/sealing to help prevent damage and water penetration.

example of unsealed/caulked gaps at top of shower enclosures.

- The top of the ALL bath shower enclosures were gapped at the intersection with the wall. Recommend proper caulking/sealing to help prevent damage and water penetration.

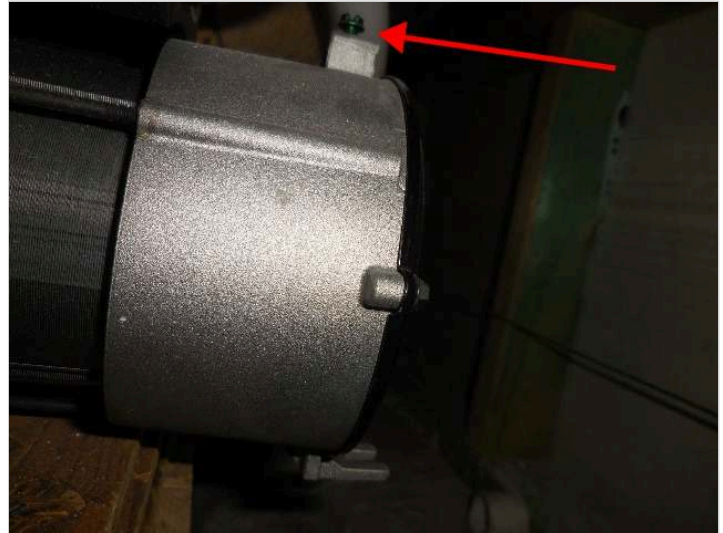
The spa tub pump was not properly bonded/grounded (or unable to determine).

Spa tub motor not bonded.

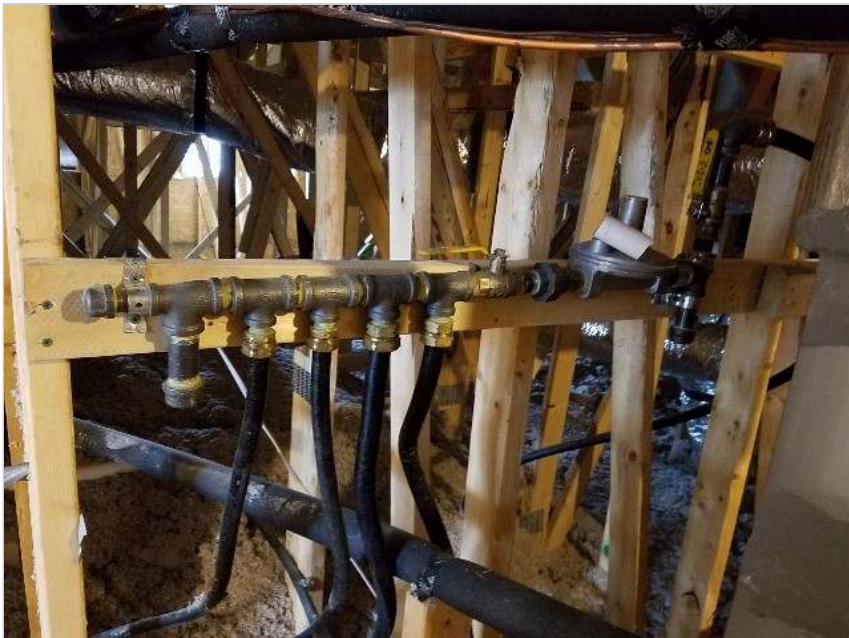
Corrugated Stainless Steel Tubing (CSST) was used in the gas supply system and we were unable to verify proper adherence to the manufacturer's bonding instructions. Bonding to the gas supply system was observed at the gas supply line next to the gas meter. (New Homes with CSST) It is recommended that you consult with your builder and have them certify proper CSST bonding according to the specific manufacturers instructions. CSST Advisory Notes: The lack of suitable electrical bonding may increase the potential for lightning strikes to cause arcing at the CSST gas piping and may result in perforation of the piping, gas leaks, and fires. Proper adherence to the manufacturer's bonding instructions should lower the risk of electrical arcing and related damage. It is recommended that you retain a licensed electrician (or certified CSST specialist) for further evaluation of the installation and that corrective action be taken as needed.

CSST manifold in attic space.

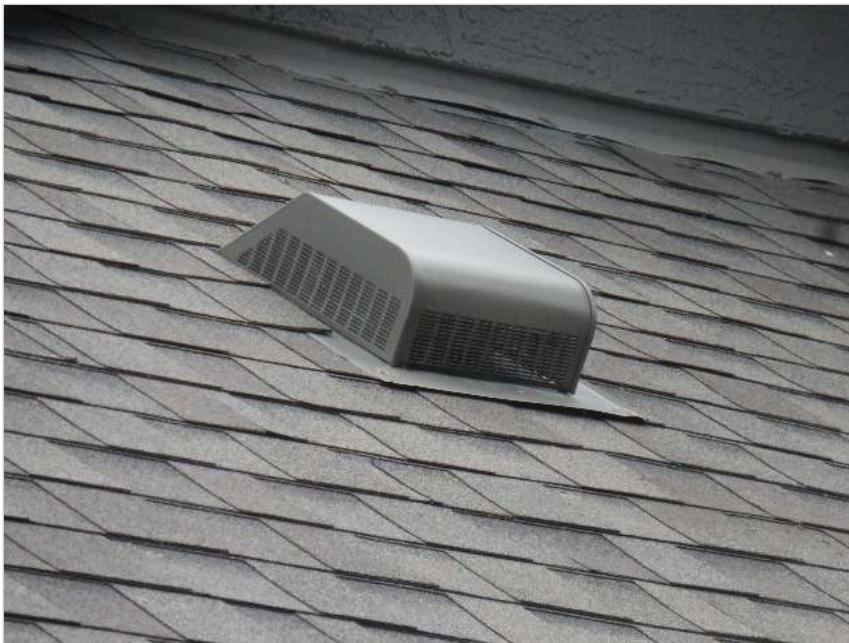
The dryer vent has a screened or grated termination cover which collects lint and is a potential fire hazard. Recommend removing and replacing with an appropriate dryer cover with back-draft damper

Screened dryer vent cover.

- The dryer vent has a screened or grated termination cover which collects lint and is a potential fire hazard. Recommend removing and replacing with an appropriate dryer cover with back-draft damper
