File Number: **5686**  
Address of Inspection: **[REDACTED]**

## INSPECTION SERVICE

**Inspection #: 5686**

## INSPECTION REPORT

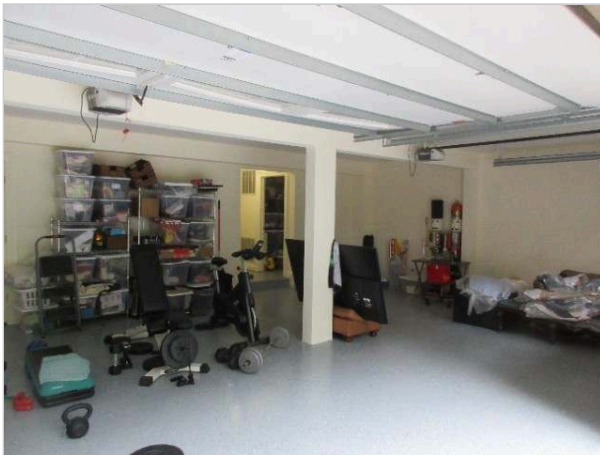
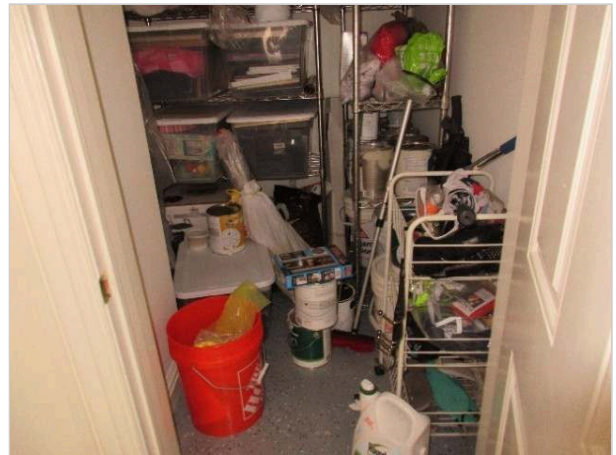
2. There was a fire rated door in place leading to the home. The door did not return automatically to the closed position. A spring should be installed to aid the door in returning to the closed position.

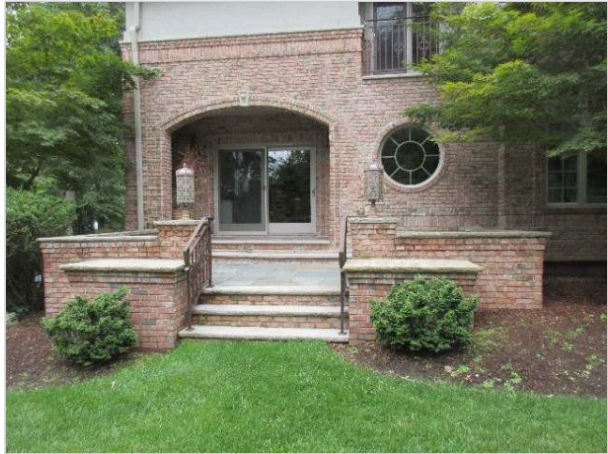
- 1. The patio floor has settled in the past and repairs have been made.

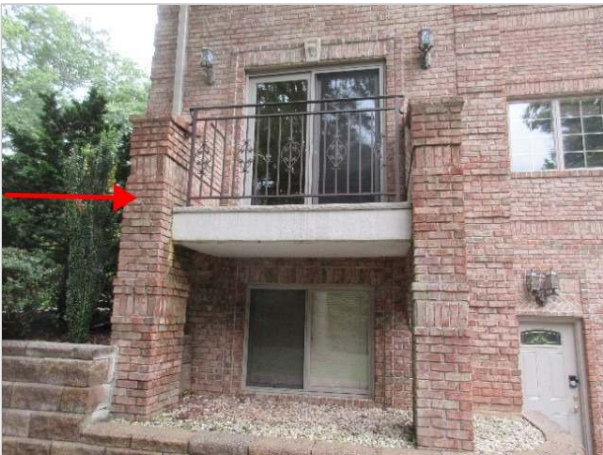
- 1. There were water stains below the right side dining room balcony and this needs to be addressed to prevent further water penetration into the balcony structure. All balcony floor penetrations and floor joints must be properly sealed.

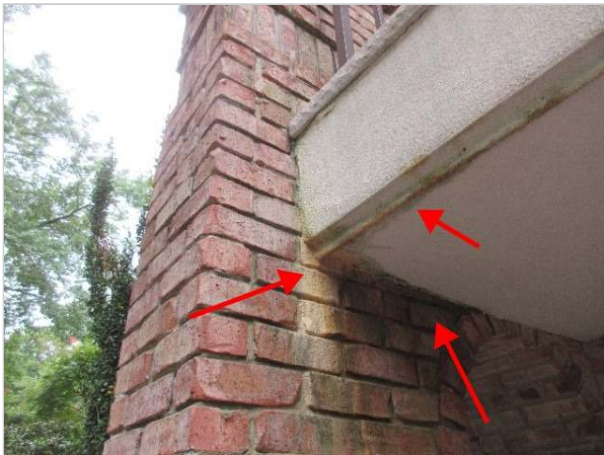
water penetration

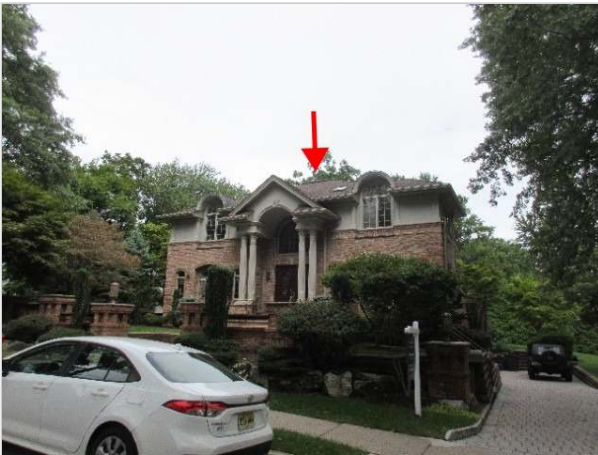
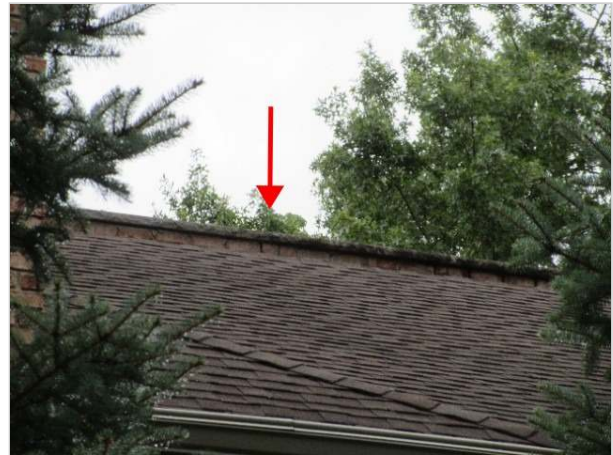
1. There was a flat roof section, with a large skylight, at the center of the main hip roof. This roof section and skylight were not visible from the ground. The seller must disclose any maintenance performed on this roof/skylight over the past 15 years. In lieu of any information it is recommended that this roof section/skylight be further evaluated by a qualified roofing contractor prior to closing.

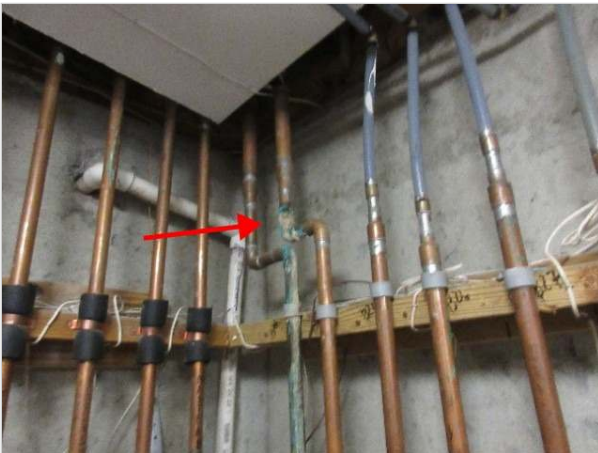
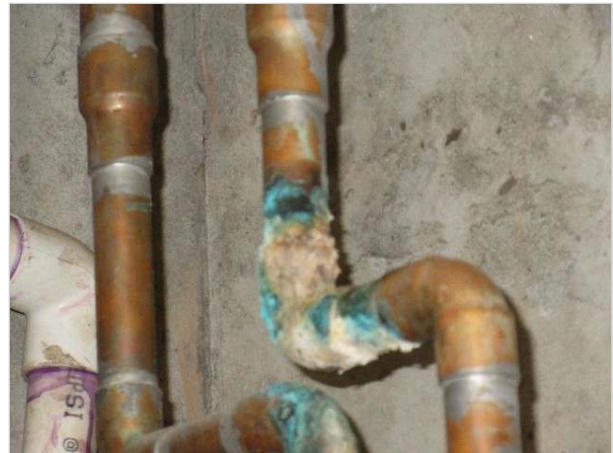
close up

1. There was corrosion on the pipes above the Dunkirk boiler in the garage utility room and this must be addressed by a qualified plumber to help avoid future leaks.

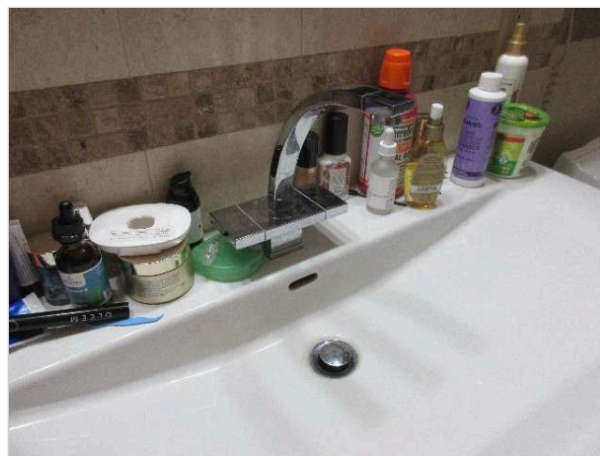
2. The basement bathroom sink faucet was loose and this must be addressed by the above plumber.

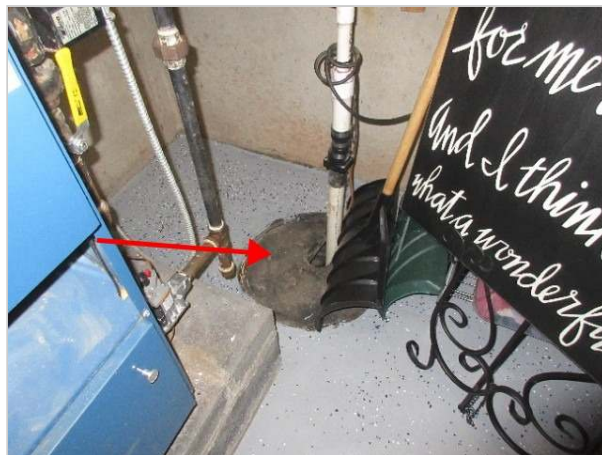
There was one sump pump located in the garage utility room. The sump pump was functional. There was water in the pit at the time of the inspection.

1. You need to install a backup power supply for the pump in case of an electrical failure.

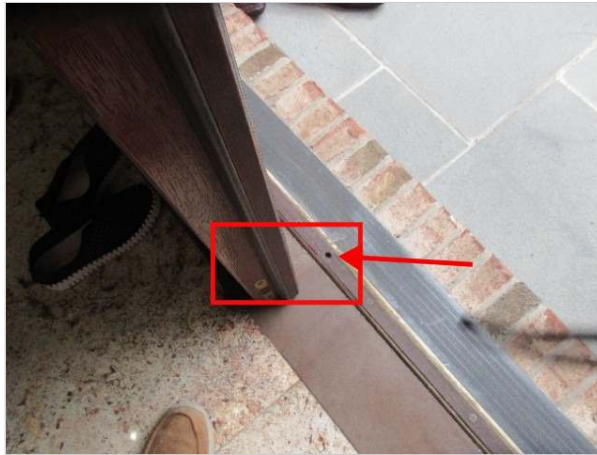
1. The front door, while operational, was not adequately secured. The flush bolts at the top and bottom of the right side door need to be properly anchored to secure this front entry door. This needs to be addressed by a qualified window/door contractor.

not adequate

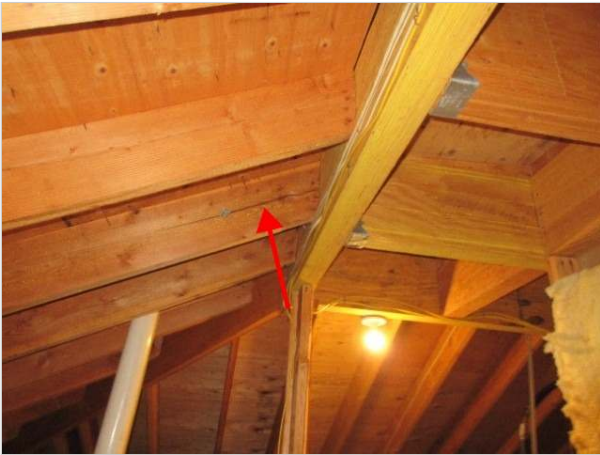
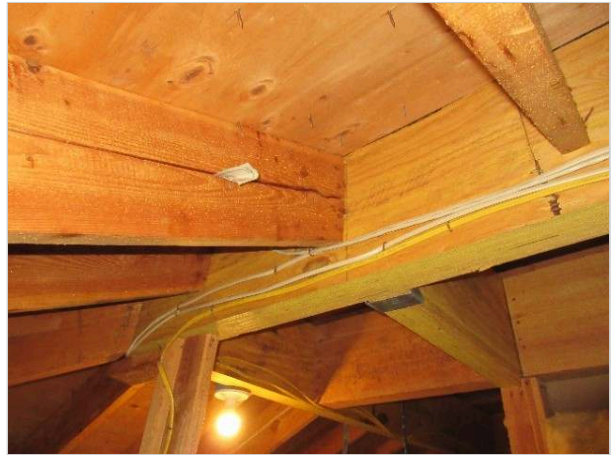
close up

1. One of the rafters at the right side of the skylight and towards the front was cracked and it needs to be properly repaired/sistered.

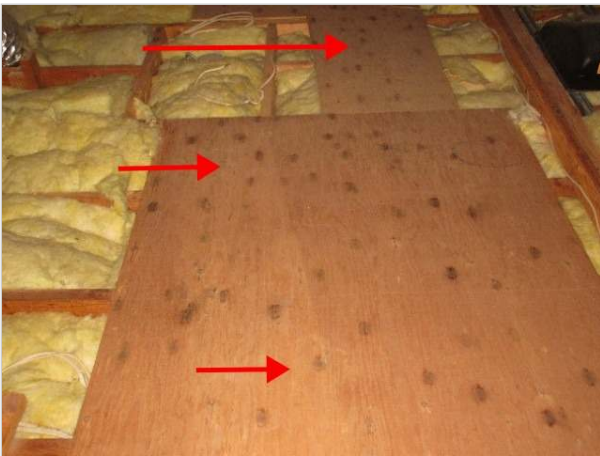
2. There were water droplet stains on the plywood flooring as a result of sweating nail tips. This is an indication of the attic overheating, elevated humidity levels, and/or frosted nail tips. This condition can lead to rot of the wood sheathing and potential mold growth. Additional ventilation for the attic may be necessary. Any additional ventilation must be addressed by a qualified roofing contractor. The installation of the thermostatically controlled fan may have corrected this condition. The seller must disclose if in fact they installed the fan after the home was constructed to address this condition.

spots on floor

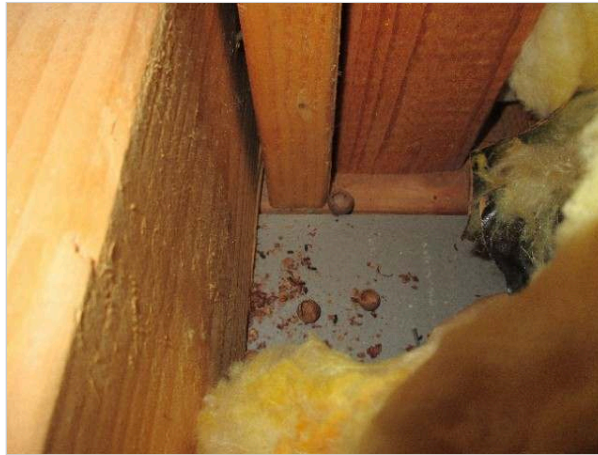
3. There was evidences of rodents having been in the space. You may want to consult with a qualified rodent control contractor.

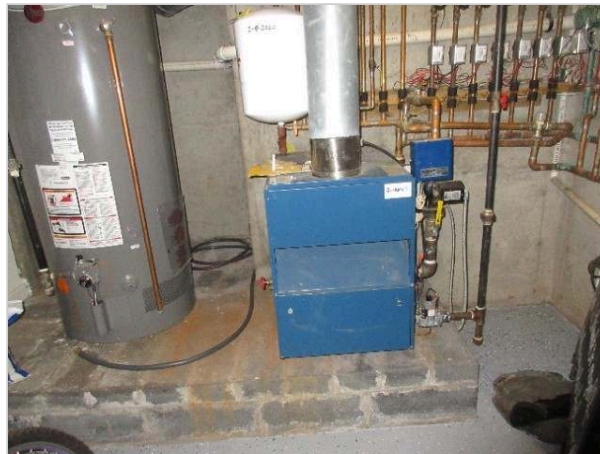
1. The boiler has met the manufacturer's life expectancy; you should budget for future repairs, if not replacement.
2. It should be noted that proper maintenance will help extend the life span of any mechanical system beyond the manufacturer's time frame. The heating system should be inspected and serviced on an annual basis. You should obtain from the seller well before close of escrow any documents concerning regular maintenance.
3. The seller must demonstrate that the radiant floor heat is operational prior to closing.

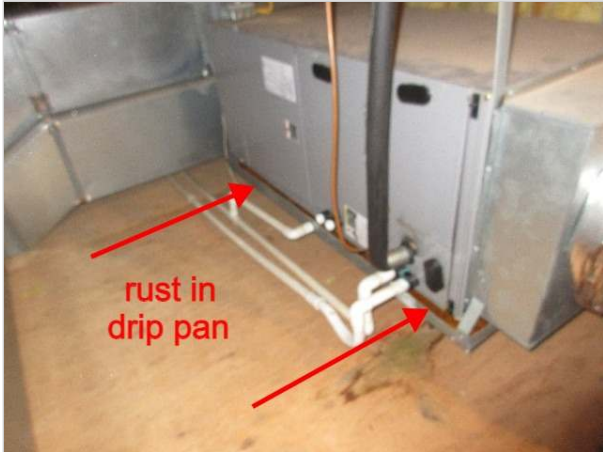
- 4. There was rust/corrosion in the drip pan under the front air handler in the attic. This must be noted by the above AC contractor.
