### HOME INSPECTION REPORT

The HomeTeam Inspection Service made a visual inspection of 123 Main Street, Anytown, USA 55555. Enclosed please find a written, narrative report of our findings in accordance with the terms of our Inspection Agreement.

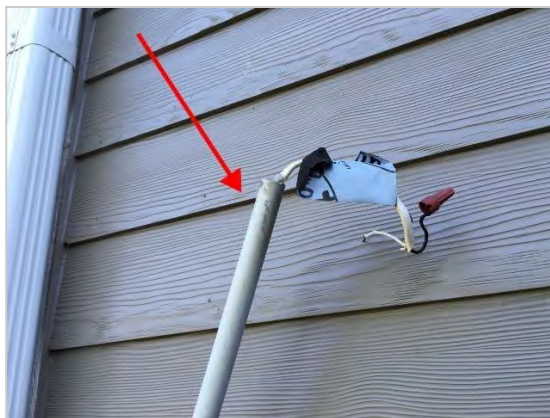
Photo 2

**Exposed or un-terminated live wires were observed on the exterior.** The wires should either be disconnected at the source or properly terminated in an approved, covered electrical box. Consult with a qualified electrician for repair and further assessment.

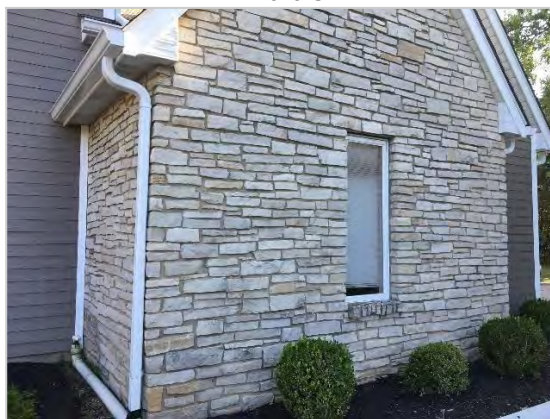
Photo 3

NOTE: The structure has a manufactured stone veneer (MSV) cladding. Structures with MSV can develop moisture intrusion problems even when properly constructed according to industry standards. The problem can develop because of moisture buildup behind the veneer that is unable to drain, and this moisture can cause significant structural damage that is not visible during a non-destructive test. Specific areas of concern include areas around the windows that may have been subjected to prolonged water exposure. Other areas of likely penetration are around chimneys, decks, and any other penetration points. Water intrusion is more likely at these points. In all cases, HomeTeam recommends having MSV-clad structures professionally inspected by an MSV-qualified technician prior to purchase and again each year. Typically, this type of test involves drilling several holes and inserting moisture meters to determine if any moisture is present behind the veneer.
