HOME INSPECTION REPORT

The inspected property consisted of a ranch wood-framed structure with plywood siding / cladding that was occupied at the time of the inspection. Minor, exterior type caulking and maintenance, painting are common on most homes and may be present but may or may not be specifically identified in this report. The approximate temperature at the time of the inspection was 70-75 degrees Fahrenheit, and the weather was sunny and clear. The utilities were on at the time of the inspection. The buyer was present during the inspection. The home was situated on a lightly sloped lot. The general grade around the home appeared to be mostly adequate to direct rain water away from the foundation. The age of the home, as reported by the building permits was said to be 37 years old.

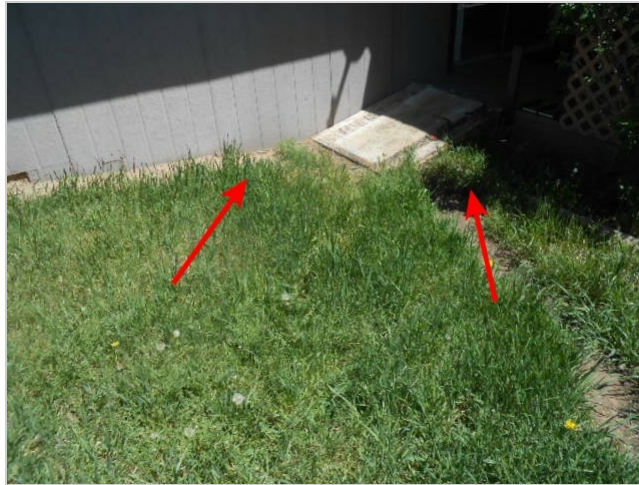
The exterior grading on the rear of the home was noted to be sloping towards the home and foundation. The grading in this area should be corrected to allow for proper drainage and to prevent water accumulation along the home and foundation.

This area of exterior grading on the rear of the home is sloping towards the home.

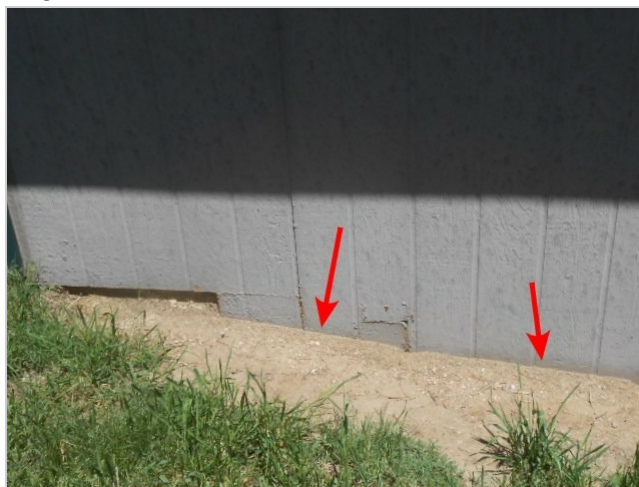
Some of the exterior siding on the rear of the home is in contact or is under the ground or earth. This condition can lead to wood rot or insect intrusion if not corrected. Further evaluation is recommended by a qualified contractor, prior to closing.

This section of siding on the rear of the home is in contact with the ground or earth.

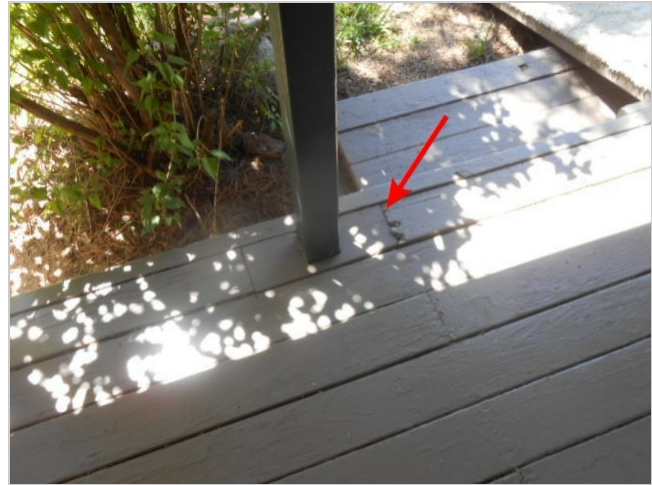
Loose or deteriorated deck boards on the rear deck.
