# HomeTeam<sup>®</sup>

### HOME INSPECTION REPORT

HomeTeam Inspection Service has made a visual inspection of 124 Sample Street. Enclosed please find a written, narrative report of our findings in accordance with the terms of our Inspection Agreement.

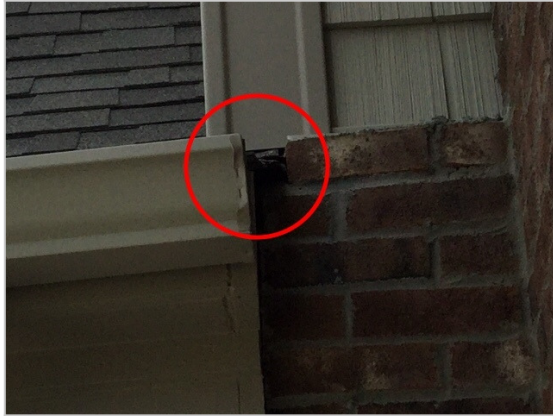
Photo 2

**A hole was noted on the front of the structure's exterior.** This condition does not have any effect on the structural integrity of the building. The areas should be repaired to prevent water intrusion. A raw 2x4 was seen from the side.

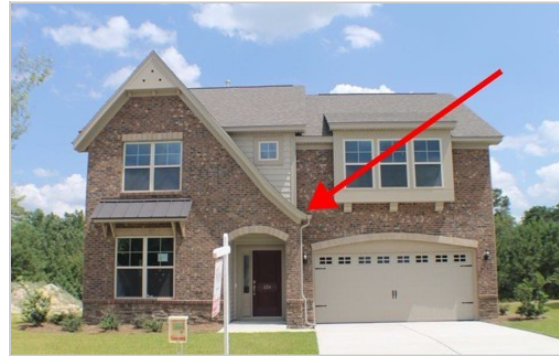
Photo 3

Right side of front door

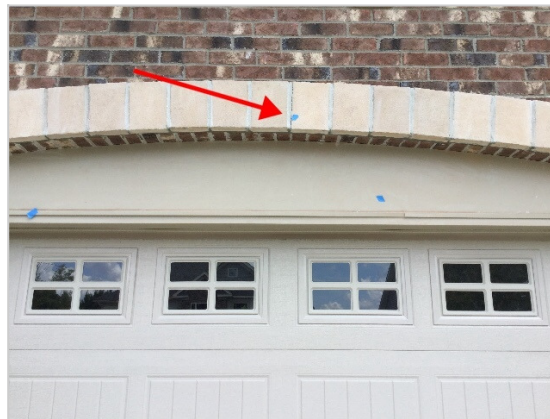
Photo 4

**Missing mortar was evident on the brickwork on the front of the structure above the garage.** There were no loose bricks noted. Small amounts of missing mortar are usually inconsequential. Extensive amounts of missing mortar can permit water intrusion. Consult with a qualified masonry contractor for repair estimates.

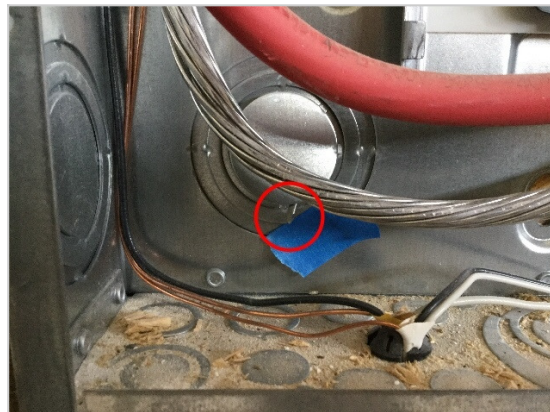
Photo 6

**Nail protruding through knockout in main panel.** This could be a safety concern and should be repaired.

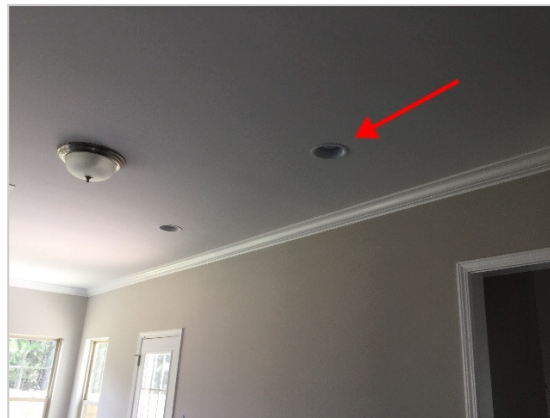
Photo 7

**A light fixture in the kitchen is loose** and should be secured.

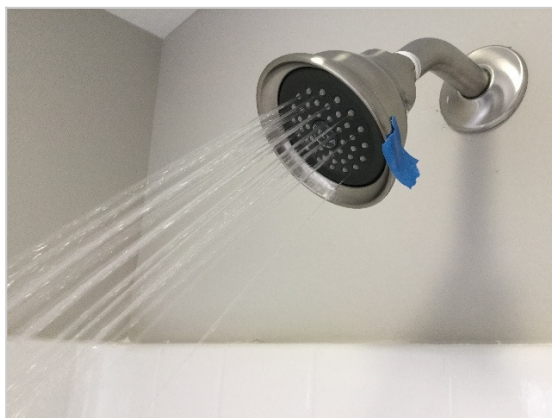
Photo 10

**Shower head in master bathroom has clogged holes.** Recommend replacement or cleaning for optimal functioning.

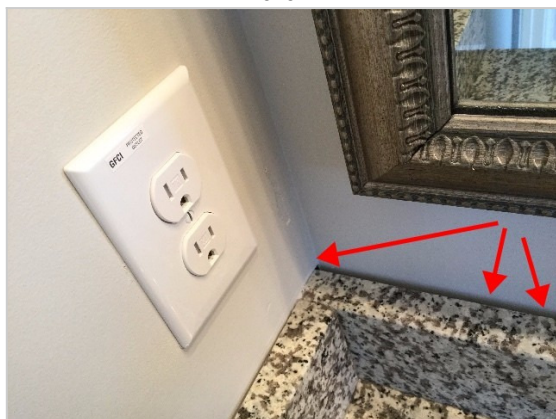
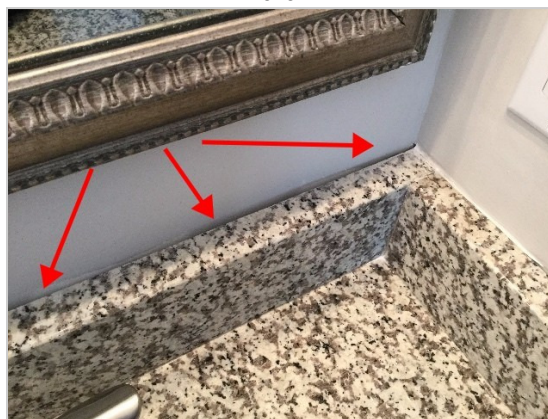
**Some of the caulk was missing from around the base of the tub and the master bathroom vanity in the master bathroom.** These areas should be sealed to prevent moisture penetration. Failure to keep walls sealed can cause deterioration and extensive moisture damage including mold growth to the interior walls, which is not always visible at the time of the inspection.

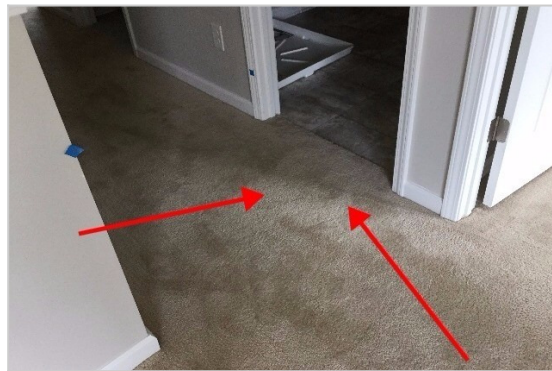
Photo 13

**Floor board near entrance to laundry room is loose (squeaks).** Floor board should be fastened more securely.

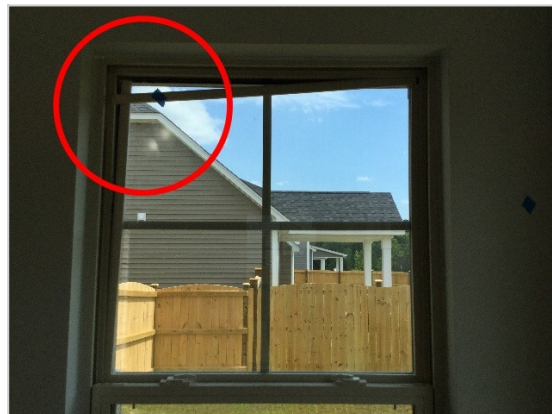
Photo 14

**Window frame is broken.** Recommend repair to avoid water intrusion or damage to glass.

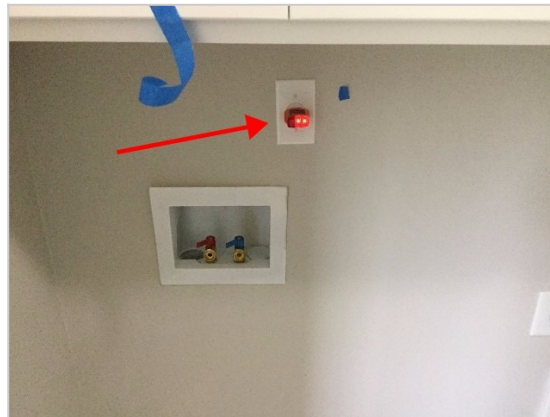
Photo 16

**No GFCI outlet located in the laundry room** and should be replaced.

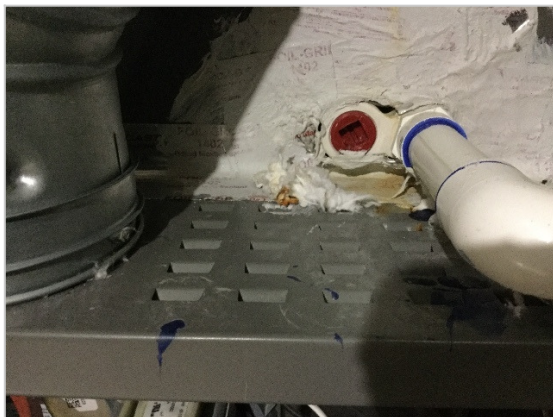
Photo 19

**A condensate leak was noted on the air handler drain line.** Repairs should be made by a qualified contractor.
