# HomeTeam<sup>®</sup>

### HOME INSPECTION REPORT

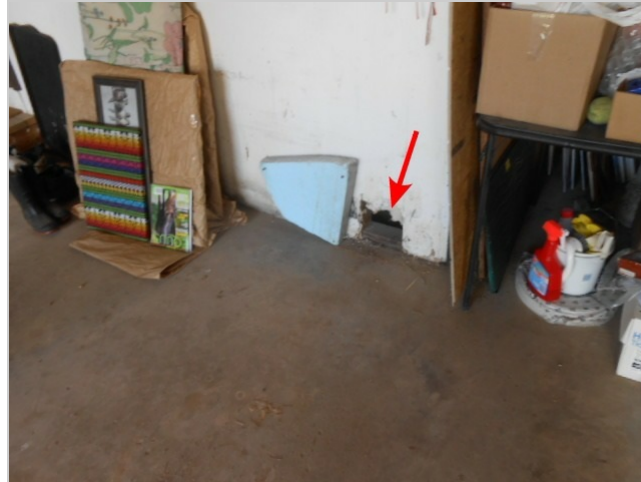
There was one firewall breach observed in the garage ( on the rear garage wall ) at the time of inspection. Firewall breaches are safety concerns which include holes or voids in the firewall separation between the

garage and home which should be sealed to prevent a garage fire from spreading easily into the home.

- There was one firewall breach observed in the garage ( on the rear garage wall ) at the time of inspection. Firewall breaches are safety concerns which include holes or voids in the firewall separation between the garage and home which should be sealed to prevent a garage fire from spreading easily into the home.

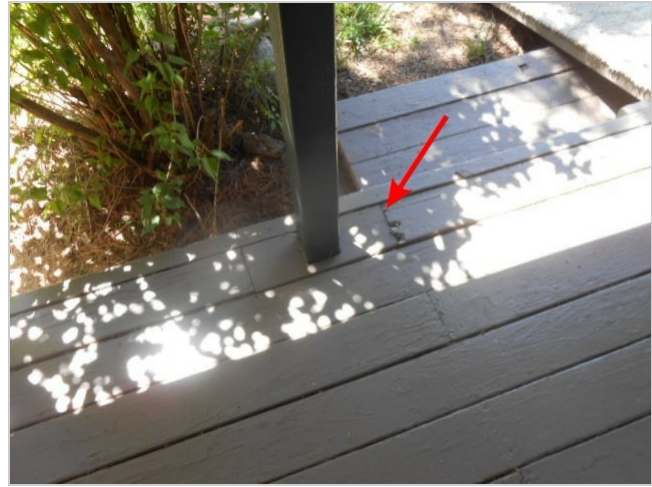
The underside of the deck was unable to be fully inspected due to the deck being very close to the ground or earth below. There were however several deck boards that were loose or were deteriorated indicating the need for further evaluation and repairs to the deck ( as needed ) by a qualified contractor, prior to closing.

Loose or deteriorated deck boards on the rear deck.

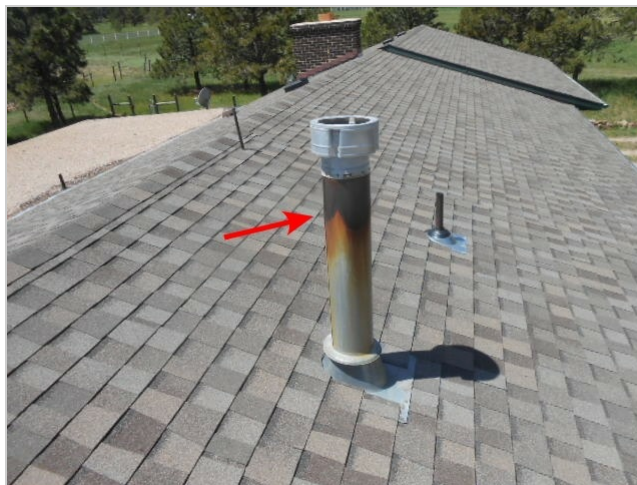
The furnace vent pipe ( which penetrates the roof line ) is rusted or deteriorated and is recommended to be replaced by a qualified HVAC contractor or roofer, prior to closing.

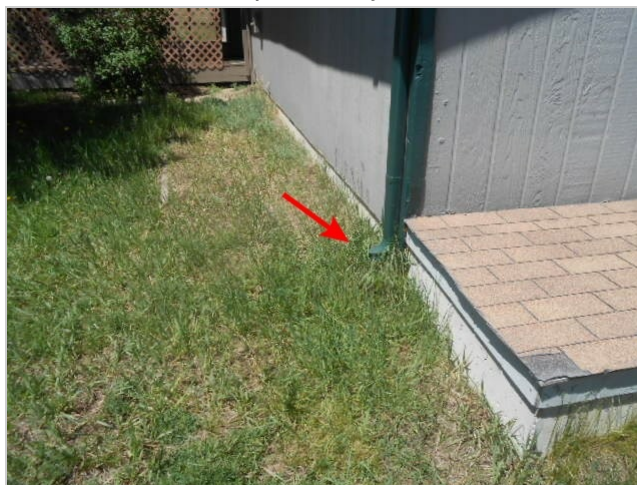
One of the downspouts on the left, rear of the home was missing the extension. This condition can allow for rain water to accumulate along the home and the possibility of water in the crawlspace if not repaired.

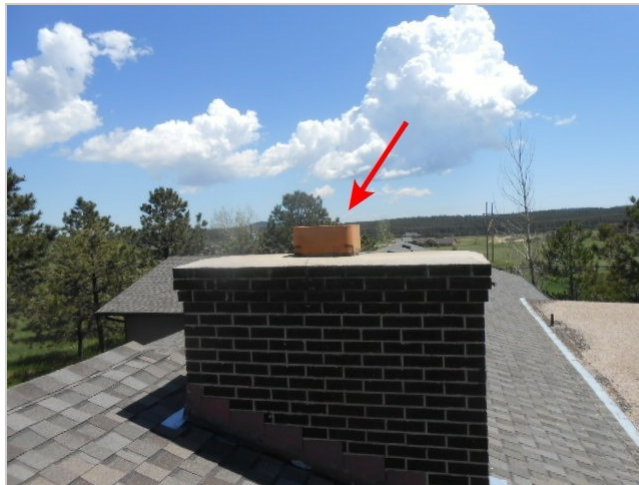
There was no rain hat on the chimney. This device is recommended to be installed by the seller ( prior to closing ) to prevent animals or rain water from entering the chimney and fireplace flue and causing damage to the home or to the metal flue damper inside the chimney.

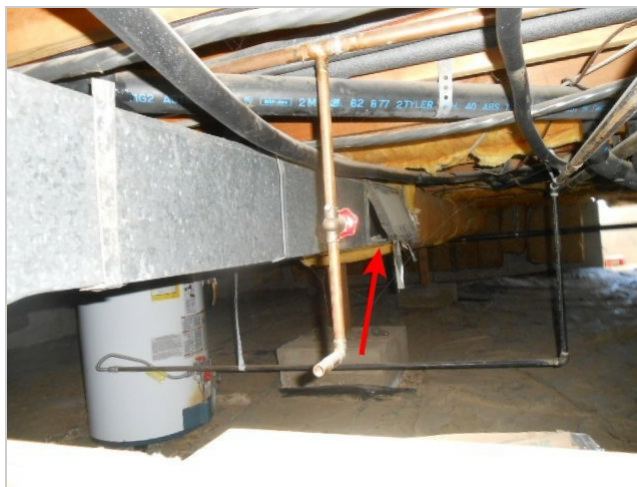
One of the heating supply or return ducts ( in the crawlspace ) has an opening which is recommended to be properly sealed to prevent heat loss into the crawlspace when the heating system for the home is in use.
