### HOME INSPECTION REPORT

The HomeTeam Inspection Service made a visual inspection of 123 Main Street, Anytown, USA 55555. Enclosed please find a written, narrative report of our findings in accordance with the terms of our Inspection Agreement.

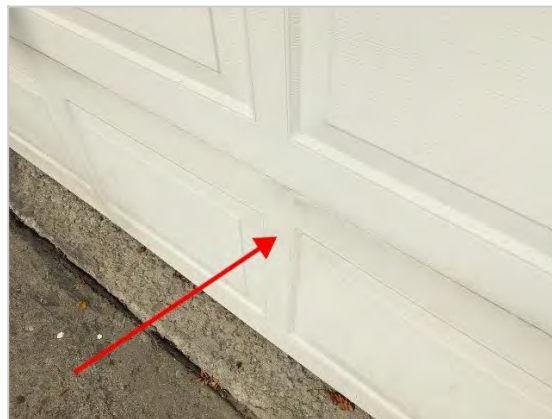
Photo 6

**The widest of the three garage door is dented from what appears to be impact.** The door was operating correctly at the time of the inspection. Care should be exercised to ensure that the door is not subjected to further impact, as the door may crack or fail.
