HOME INSPECTION REPORT

The HomeTeam Inspection Service made a visual inspection of 123 Anywhere St., City, ST 12345. Enclosed please find a written, narrative report of our findings in accordance with the terms of our Inspection Agreement.

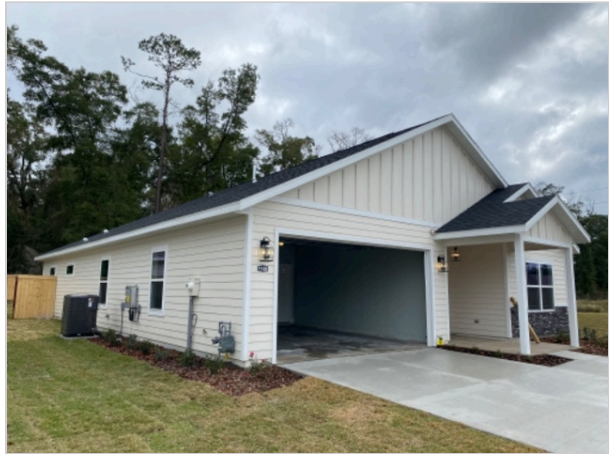
Photo 6

Damaged siding was observed on the right side of the structure. Consult with a qualified contractor for replacement.

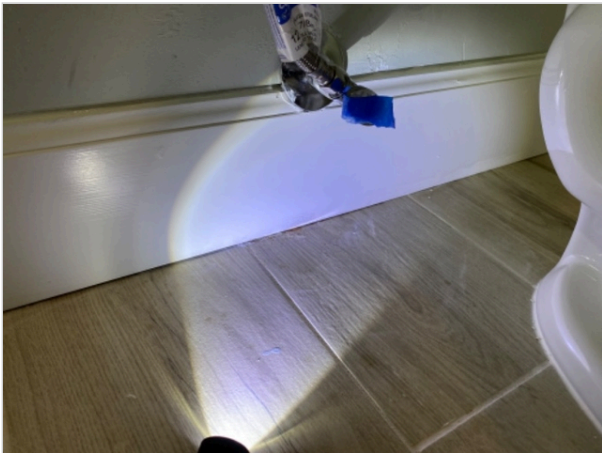
Photo 43

Leaks were observed at the toilet shut off in the Jack and Jill bathroom when in use. The tub and sink in the hall bathroom drain slowly. A licensed plumbing company should be called to evaluate the system and make any repairs.

The Jack and Jill toilet shut off is leaking.

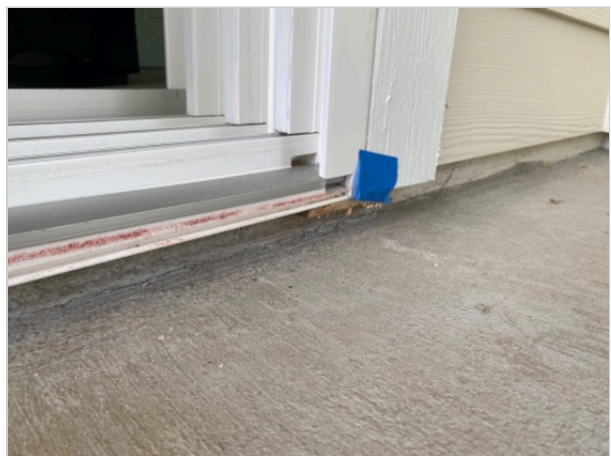
Photo 58

The rear sliding door threshold extends over the edge and is not supported properly. Recommend a qualified contractor to repair as needed.

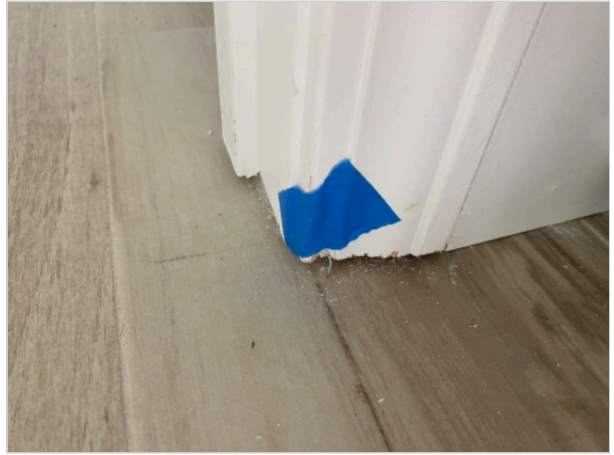
Photo 60

An exposed nail was observed at the guest bedroom/ jack & jill bathroom door frame that should be removed

and has been marked with blue tape to help the builder and contractors identify said issues.

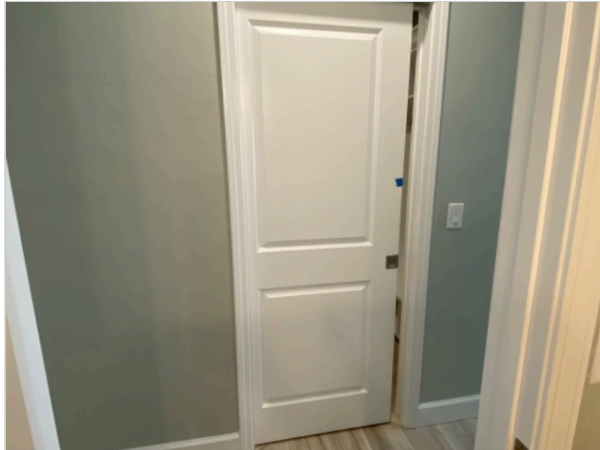
Photo 61

The pocket door for the laundry room is difficult to open and should be adjusted.
