HOME INSPECTION REPORT

The HomeTeam Inspection Service made a visual inspection of 123 Anywhere St., City, ST 12345. Enclosed please find a written, narrative report of our findings in accordance with the terms of our Inspection Agreement.

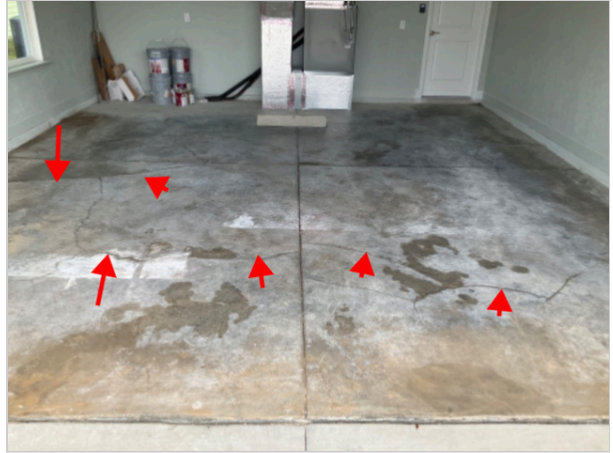
Photo 19

The garage floor had minor spider cracks observed. These cracks did not appear to be a structural issue. These cracks should be sealed and monitored.

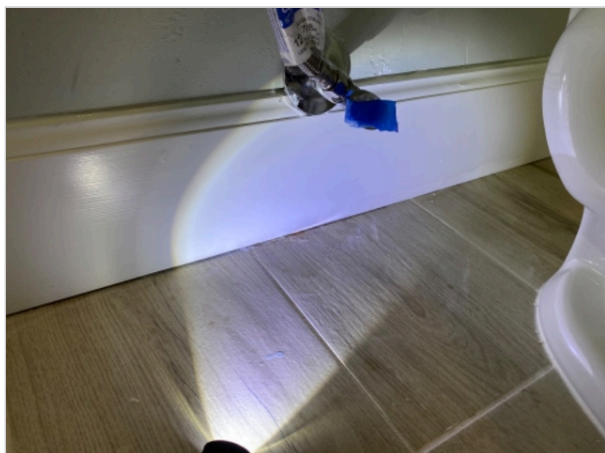
Photo 43

Leaks were observed at the toilet shut off in the Jack and Jill bathroom when in use. The tub and sink in the hall bathroom drain slowly. A licensed plumbing company should be called to evaluate the system and make any repairs.

The Jack and Jill toilet shut off is leaking.
