# HomeTeam<sup>®</sup>

### HOME INSPECTION REPORT

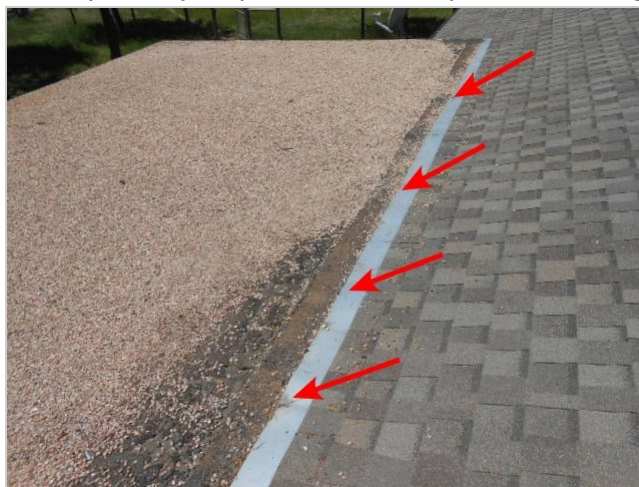
This transition roof flashing is loose or is not secured which can lead to roof leakage if not repaired.
