HOME INSPECTION REPORT

On Saturday, August 4, 2018 The HomeTeam Inspection Service made a visual inspection of 123 Sample Dr, Anytown, AZ 55555. Enclosed please find a written, narrative report of our findings in accordance with the terms of our Inspection Agreement.

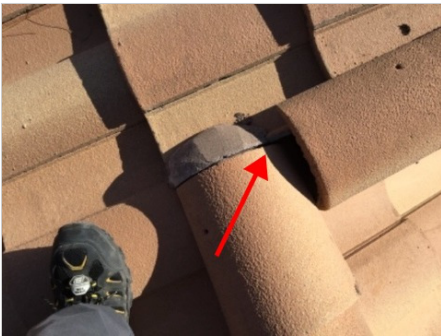
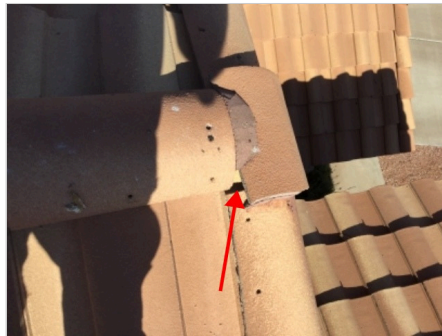
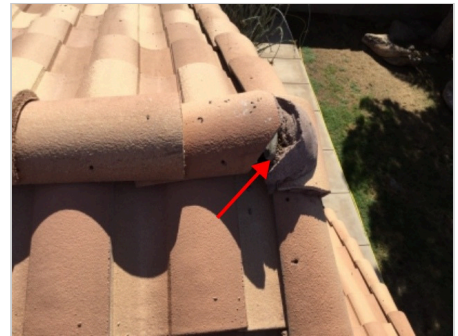
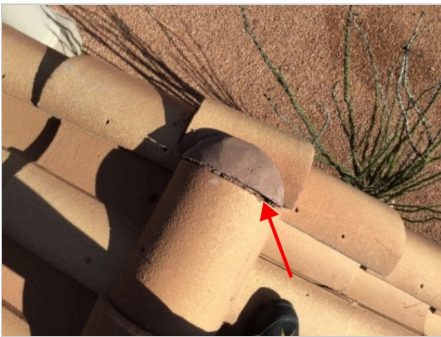
> **Concrete mortar packs missing or cracked were observed.** Suggest repair or replacement by a qualified roofing contractor.

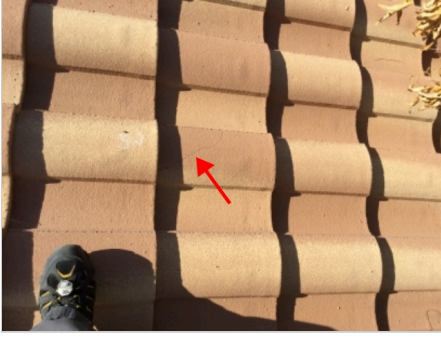
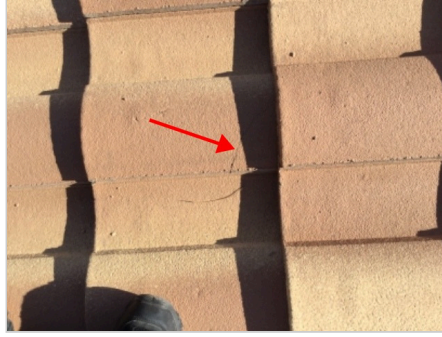
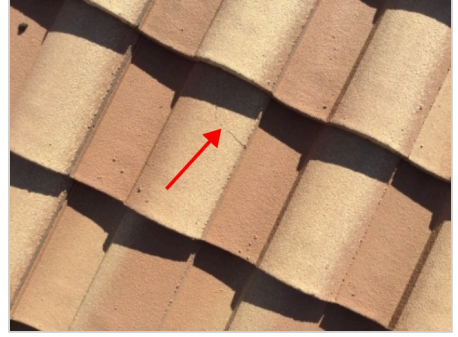
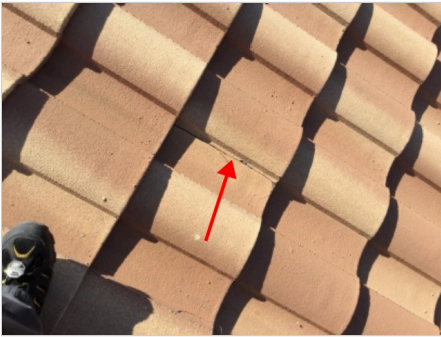
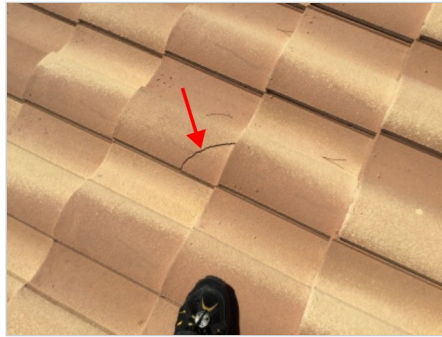
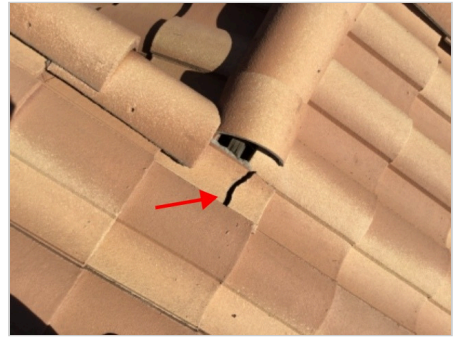
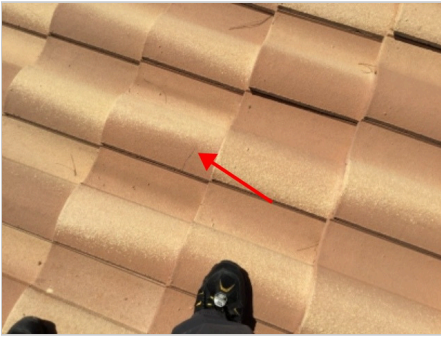
> **5 to 10 cracked, slipped, or missing concrete tiles were observed.** Suggest repair or replacement by a qualified roofing contractor.

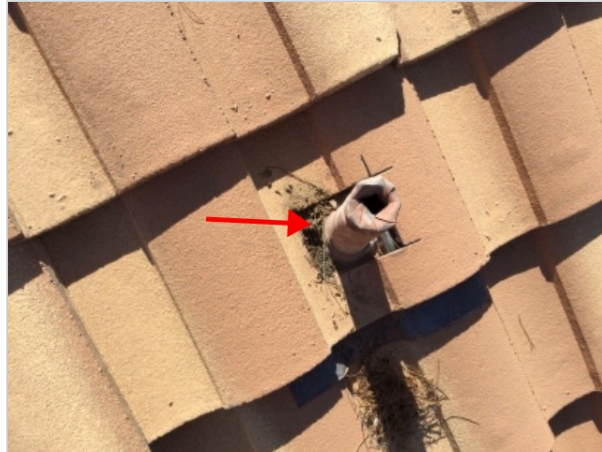
Photo 16

> **Excessive leaves and other debris were observed on roof.** This debris can trap moisture on roof and cause deterioration of the roofing material.

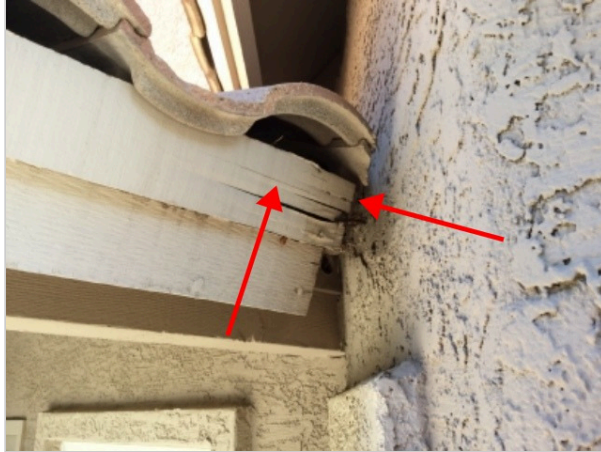
Rear Patio Area

> **Fascia board showing signs of previous moisture intrusion through either splitting, staining, warping or surface degradation.** Suggest evaluation by a qualified party to determine where moisture is/was being introduced. Once the moisture intrusion has been eliminated, the fascia boards should be repaired or replaced as necessary.

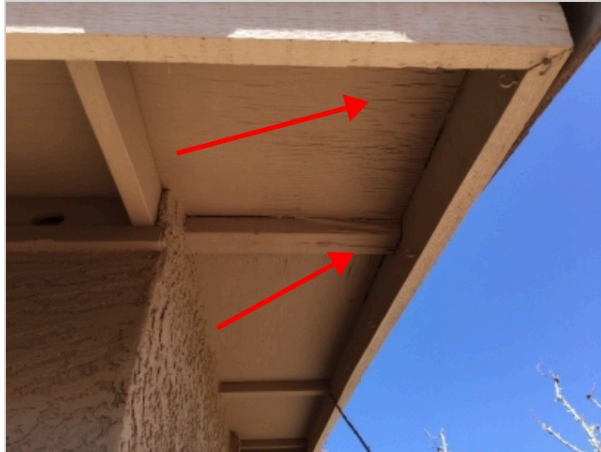
Front Left Corner

> **One under-eave areas found with evidence of prior moisture intrusion.** Suggest repair by a qualified roofing professional to fix moisture intrusion and assess damage to sheathing.

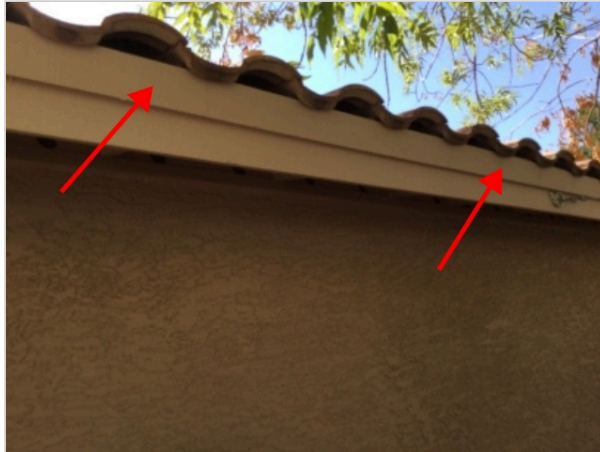
Right Side

> **Flashing is not installed at the fascia board, which may lead to water intrusion and damage.** Consult with a qualified roofer for installation or repair.

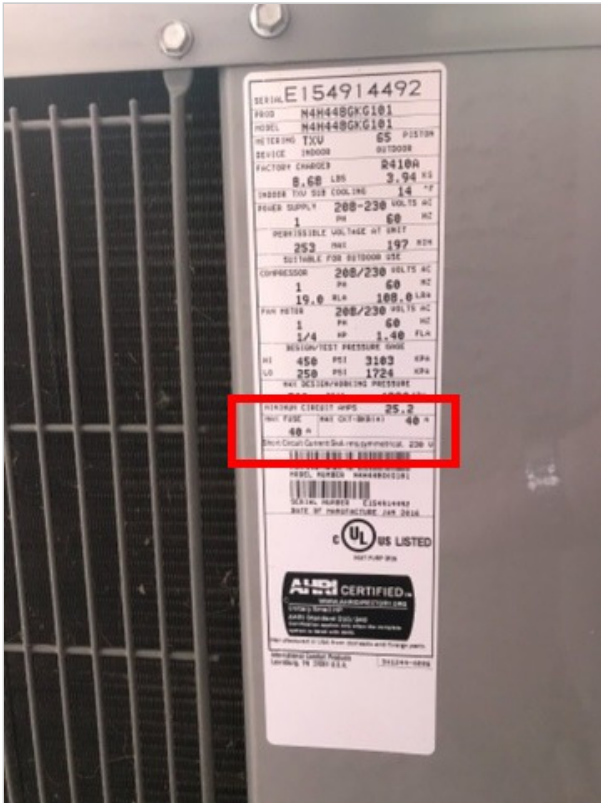
Outdoor Unit- Max Fuse 40 Amp

> HVAC unit does not have the correct fusing or breakers based on the information on the HVAC label. Suggest repair by a qualified HVAC technician or qualified electrician.

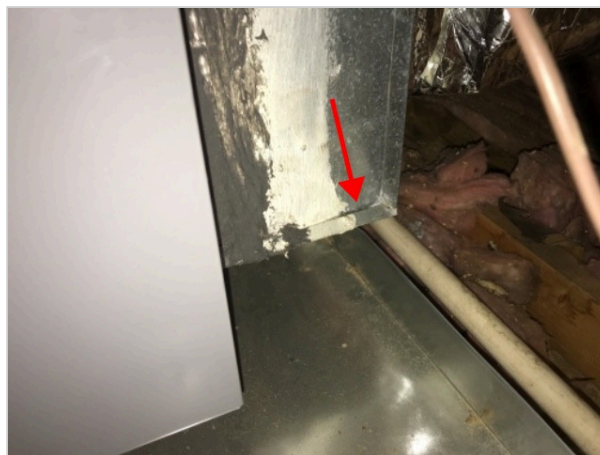
Right Side of Air Handler

> **At least one location on and around air handler where conditioned air is escaping into attic.** Suggest review and repair by a qualified HVAC technician to maximize cooling efficiency of system.

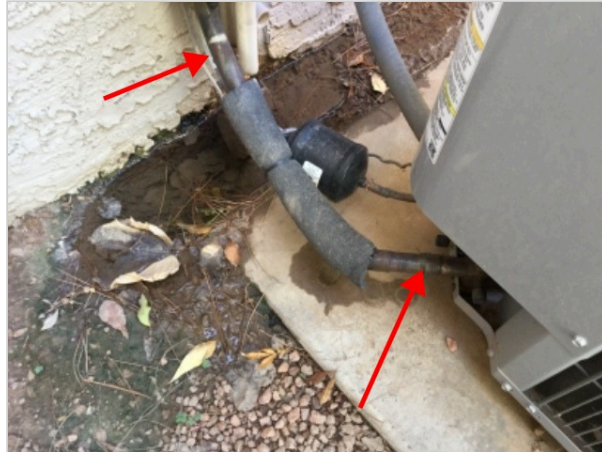
Photo 27

> **The insulation on the air conditioning line set is missing.** This could affect the efficiency of the system and should be replaced.

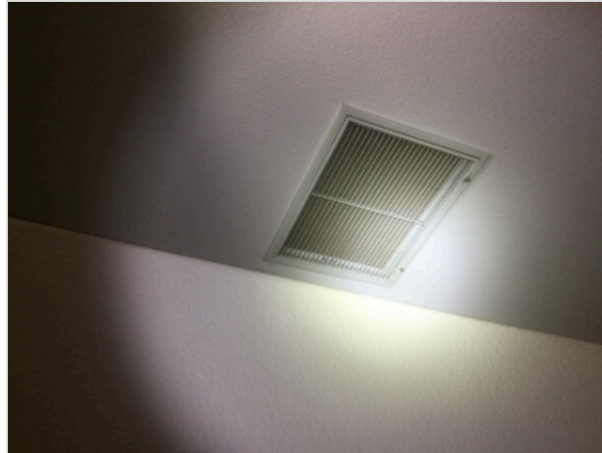
Photo 29

> **The air filter is very dirty and should be replaced.** Clogged and dirty filters affect the performance and efficiency of the HVAC system. A clogged filter can also cause damage to the system. The filter should be replaced immediately upon taking ownership of the structure.

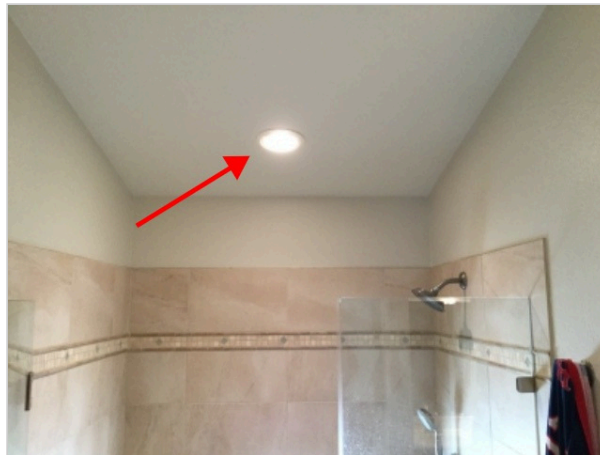
Photo 33

> The shower light installed in the master bath is not suitable for use in wet locations and may present a safety hazard. The fixture should be replaced or repaired.

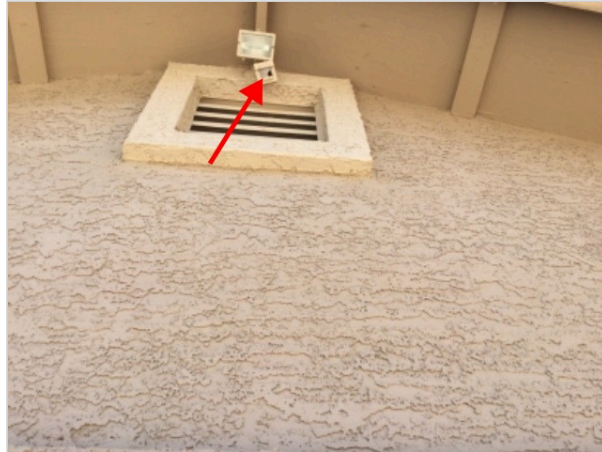
Above Garage Door

> At least one light fixture appeared to be broken. Suggest repair or replacement by a qualified party.

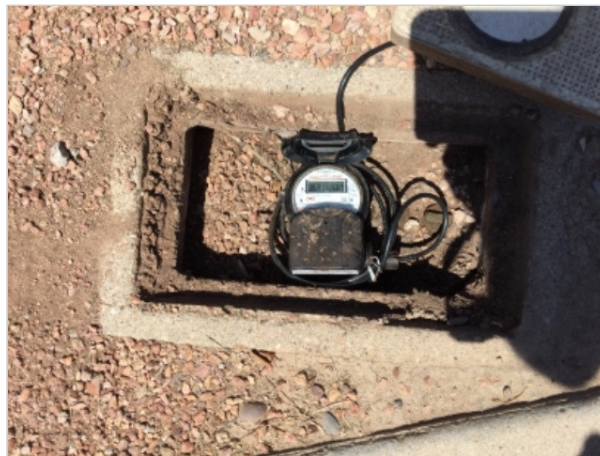
Photo 39

> **Water meter enclosure partially filled with rocks and dirt.** Suggest that this enclosure be cleaned out to allow access to water meter as well as meter shutoff actuation.

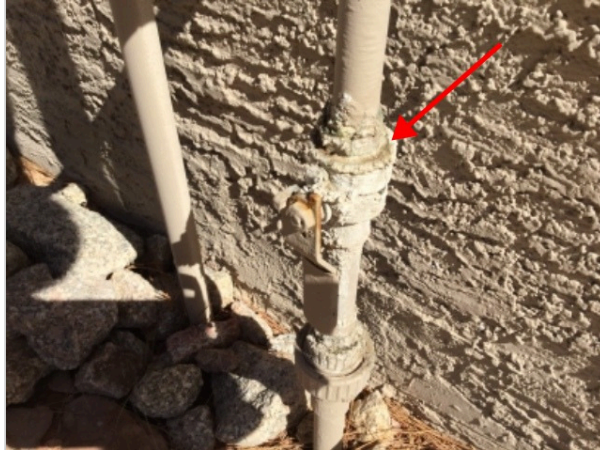
Rear Right Side

> Active water leaks were present at supply lines the time of the inspection. The affected areas should be repaired, and nearby or associated plumbing lines should be further assessed at the time of the repair.

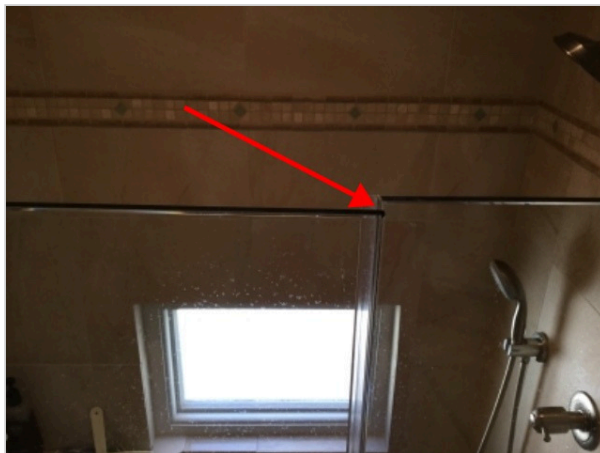
Master Bath

> **Shower door requires adjustment to ensure that the door closes properly.** Without adjustment, either the shower door or the stationary glass panel will eventually get chipped. Suggest repair by a qualified party such as the company that installed the shower door.

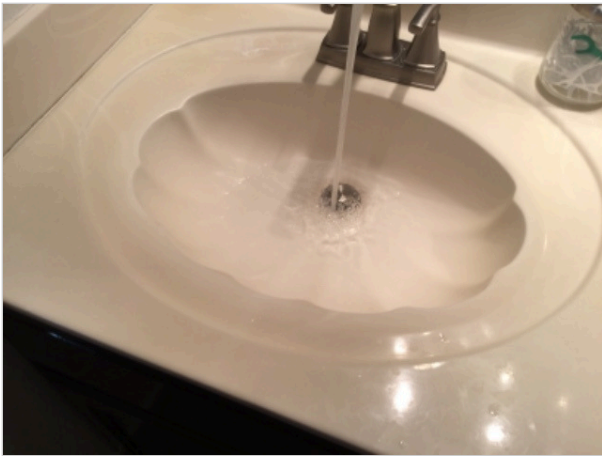
Master Bath- Left Sink

> **The sinks in both bathrooms drain very slowly,** indicating a possible obstruction in the drain line or vent.

HomeTeam recommends having the affected line cleared and other lines further assessed at the time of clearing.

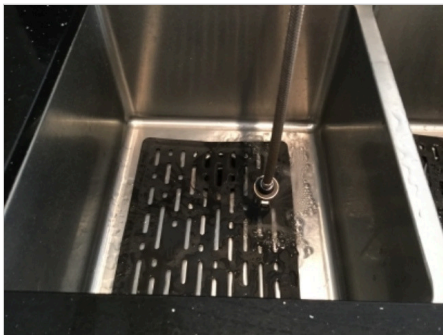
Kitchen Sink

> **Cross connections observed and noted.** Cross connections are a possibility wherever supply plumbing and solid or liquid waste could come together and contaminate potable water with waste to create a serious health issue. Home inspection standards require the inspector to look for and call out any cross connections observed.

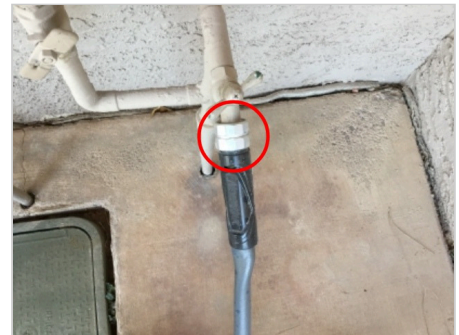
No Vacuum Breaker

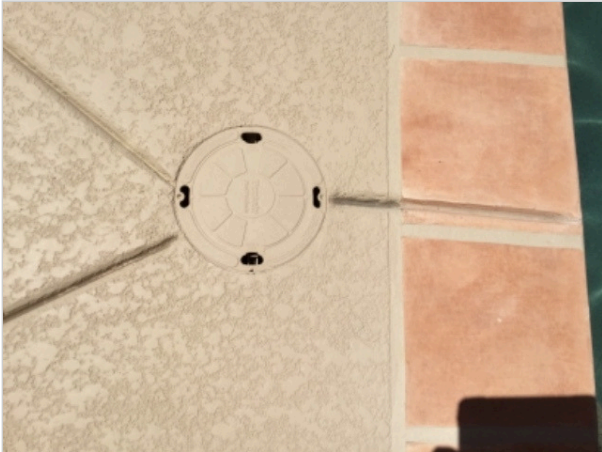
> The self-fill system appeared to be damaged and/or inoperable at the time of the inspection. This could preclude proper water levels and functioning of the pool circulatory and filter systems. Recommend they be evaluated by a pool specialist for repair or replacement as necessary.

Cover Painted in Place

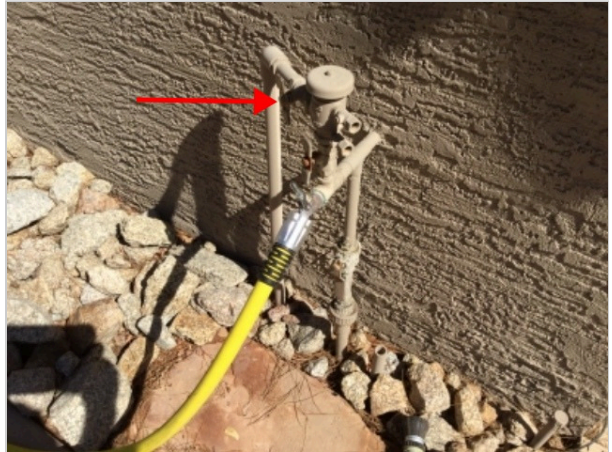
Valve Off

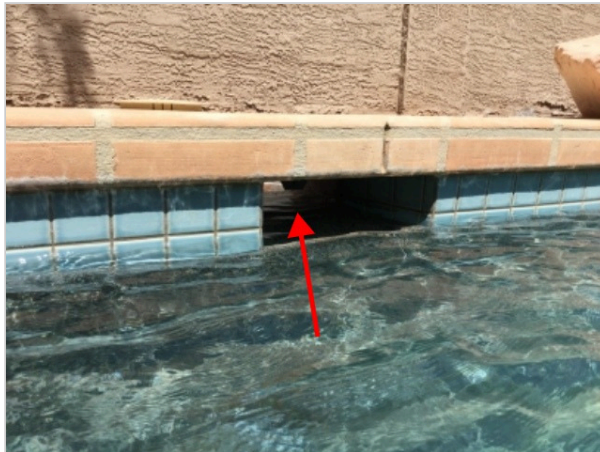
Photo 62

> **Weir valve on skimmer is missing or damaged.** The weir valve functions to keep debris pulled into skimmer from floating back into pool/ spa. Suggest repair or replacement by an authorized party.

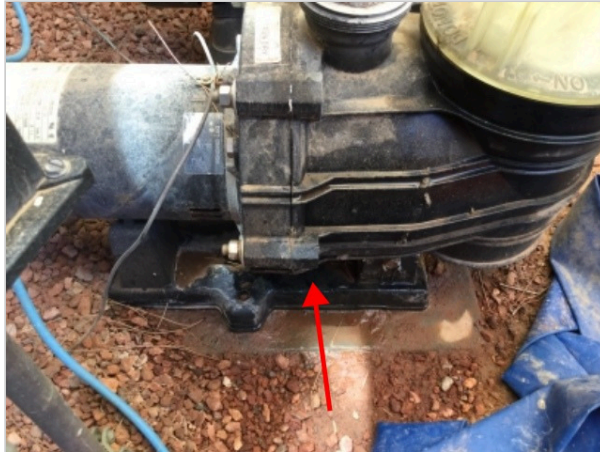
> **Leaks were observed in the pool circulatory system.** In addition to water loss and issues this could introduce air into the system and cause damage to the pump and filter. Recommend that the cause of the leak be determined and corrected by a qualified party to ensure proper function of the circulation and help prevent damage to components.

Water Feature Pump Leaking

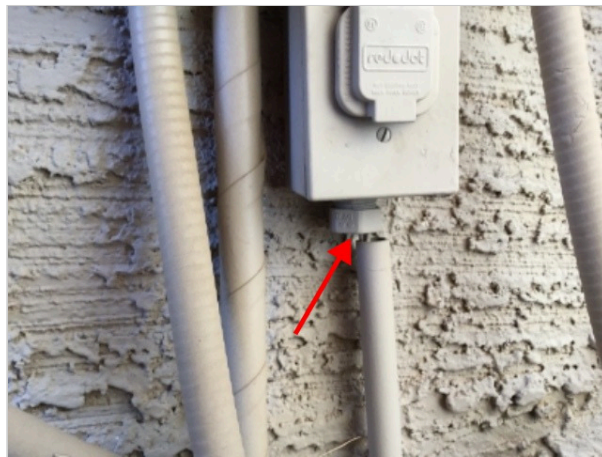
Pool Light Power

> **Conduit has separated in at least one area.** Suggest repair by a qualified electrician to insure that wiring is properly protected.

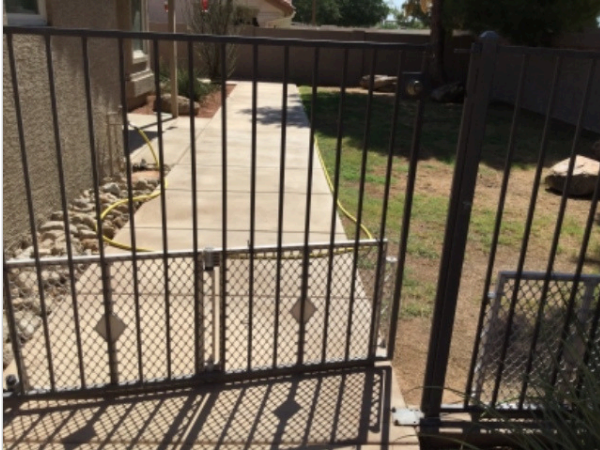
Spring Requires Adjustment

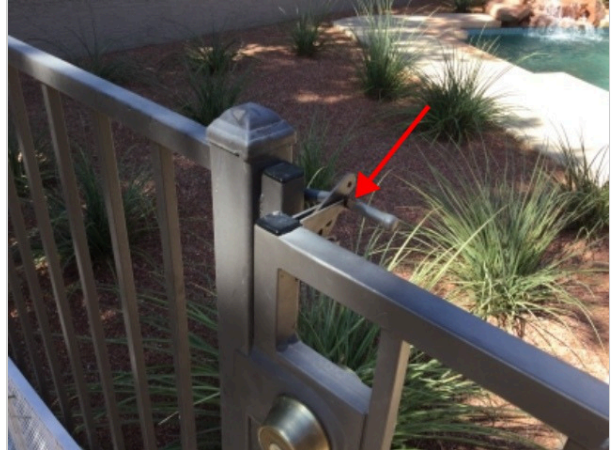
Gate Requires Adjustment
