**HomeTeam**<sup>®</sup>  
INSPECTION SERVICE

### HOME INSPECTION REPORT

*This summary provides a simplified overview of the results of the Friday, April 13, 2018 inspection at 123 Sample Drive, Woodbridge, VA 22191. Be sure to read the full body of the inspection report; it contains much more detail about the property. Any additional evaluations we've recommended must be performed prior to the conclusion of the inspection contingency period.*

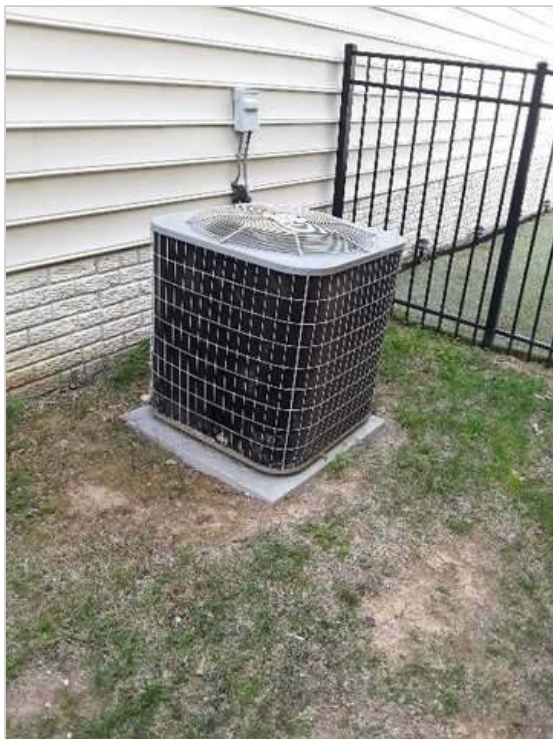
2. Outdoor air conditioner condensing units will typically last approximately 12-15 years before needing to be replaced. An outdoor condensing unit will last longer by doing regular maintenance. The subject condensing unit has been in service for approximately 13 years and was functioning at the time of inspection. The label on the unit was not legible due to wear and therefore the model and serial numbers were not available. The unit may potentially be at or nearing the end of its usable life.

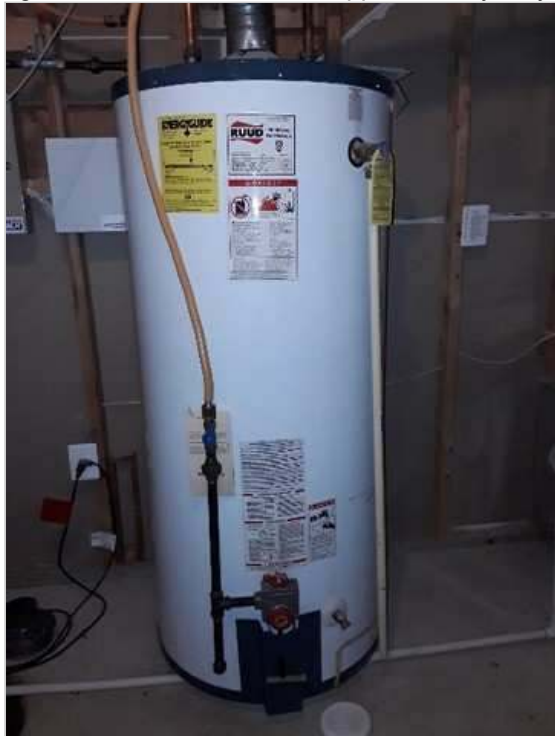
2. Most tank-type water heaters last 10 to 20 years, with the average age of replacement between 12 and 14 years. The age of the water heater was approximately 14 years old and was most likely at or nearing the end of its useful life.

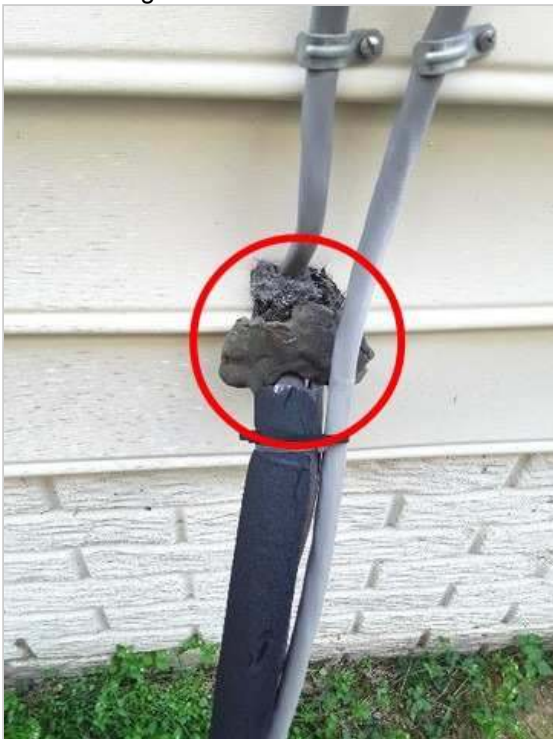
1. The lineset needs to be resealed where it passes through the exterior wall of the home to prevent water and/or insects from entering the home.

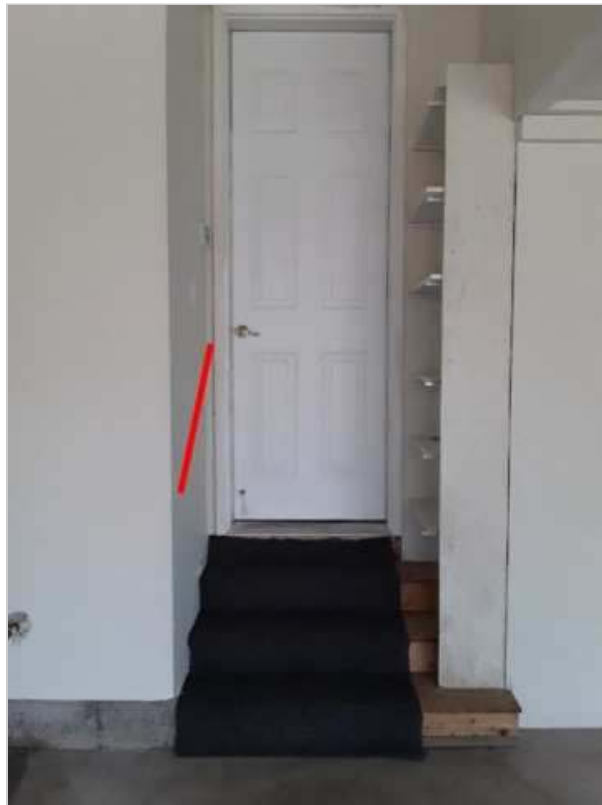
There was no handrail on the stairs leading to the garage. This can be a safety concern.

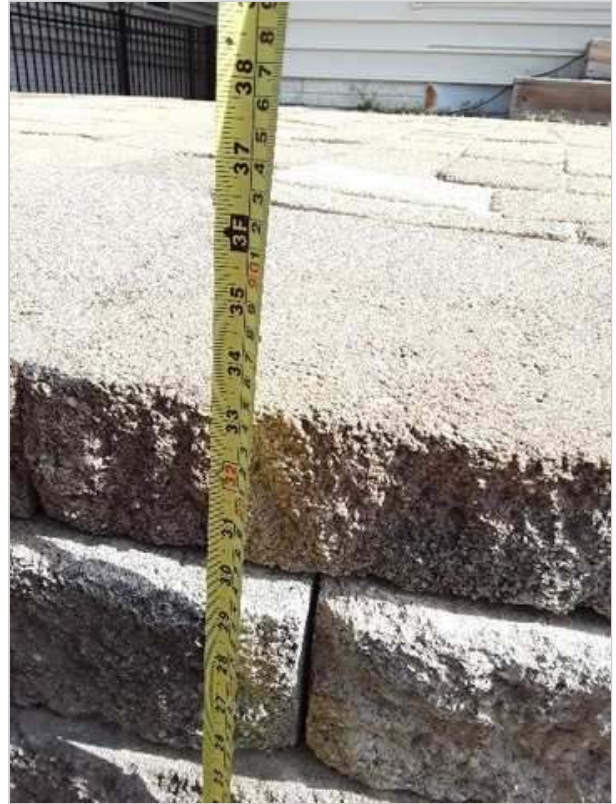
The earth beneath the cement paver patio in the rear of the home over time has started to erode away causing the pavers to shift creating several trip hazards found on the walkways around the house. In order to remedy the safety concern it will take extensive landscaping to relevel all of the pavers and the earth beneath them. Consult with a qualified contractor for estimates on repairs.

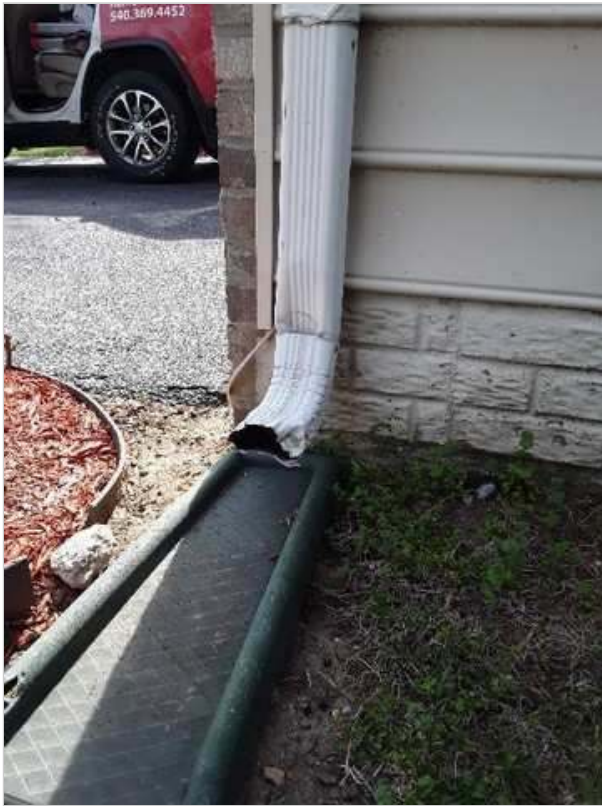
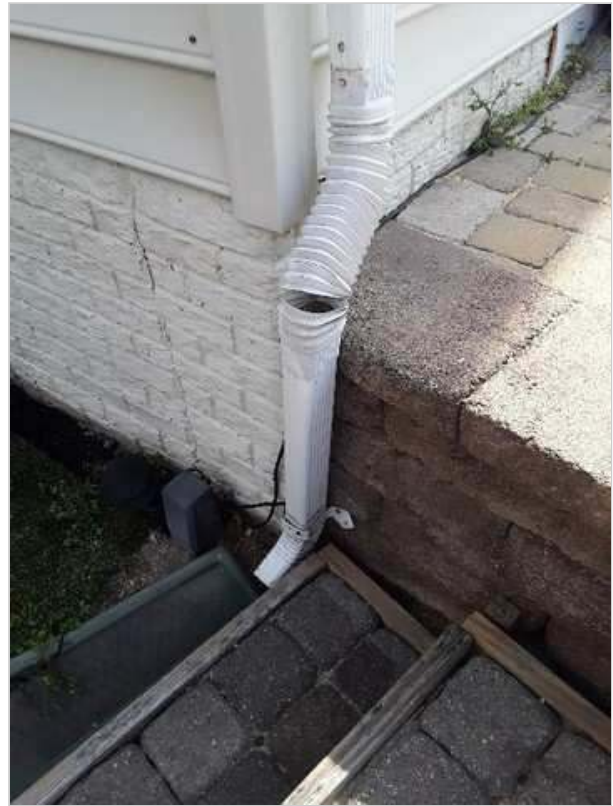
The right front and the right rear downspouts were damaged. This may restrict or improperly flow the water away from the foundation and should be corrected.

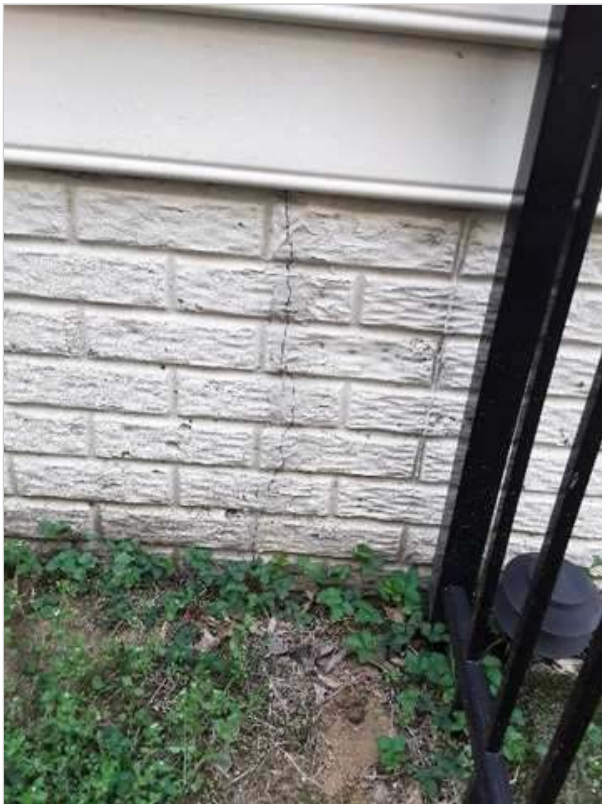
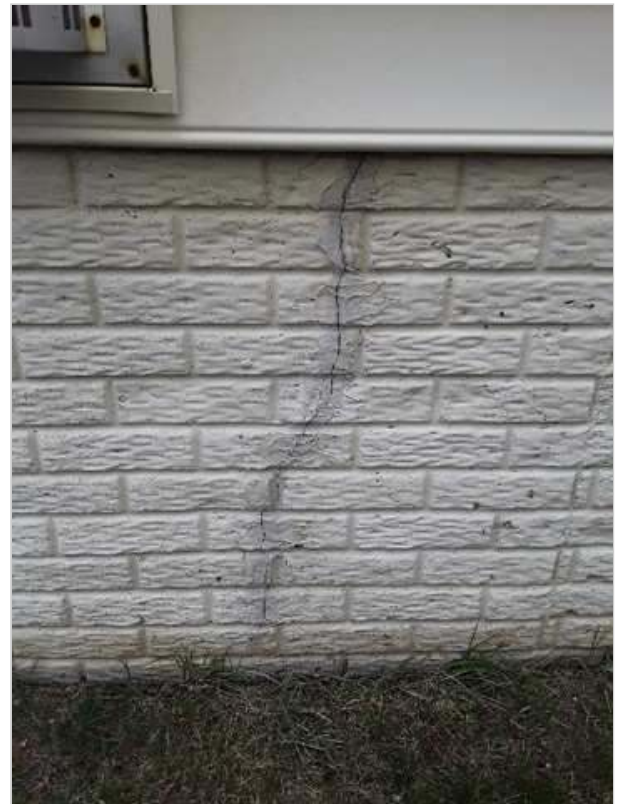
There were several minor, settlement cracks observed on the foundation. The cracks were 1/16-inch or less in width. These cracks are common and usually insignificant. All buildings experience some settlement. Settlement cracks most often occur within the first few years after construction as the soil under the structure accommodates itself to the load of the structure. However, the significance of cracks cannot always be judged by a single inspection. All cracks should be monitored for significant changes in characteristics. Consult with a company specializing in foundation repair if there is a marked change in the size or dimension of a crack.

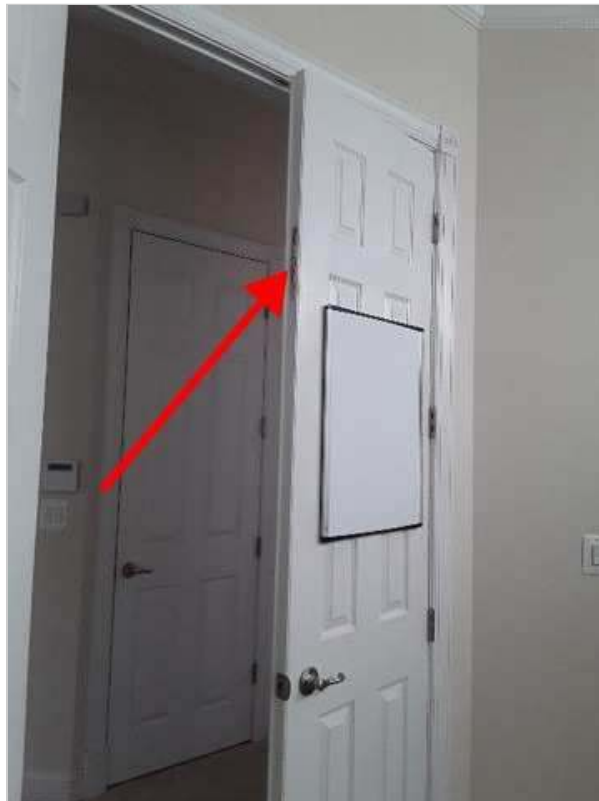
The latch was missing hardware on one of the door leading to the office on the main floor.

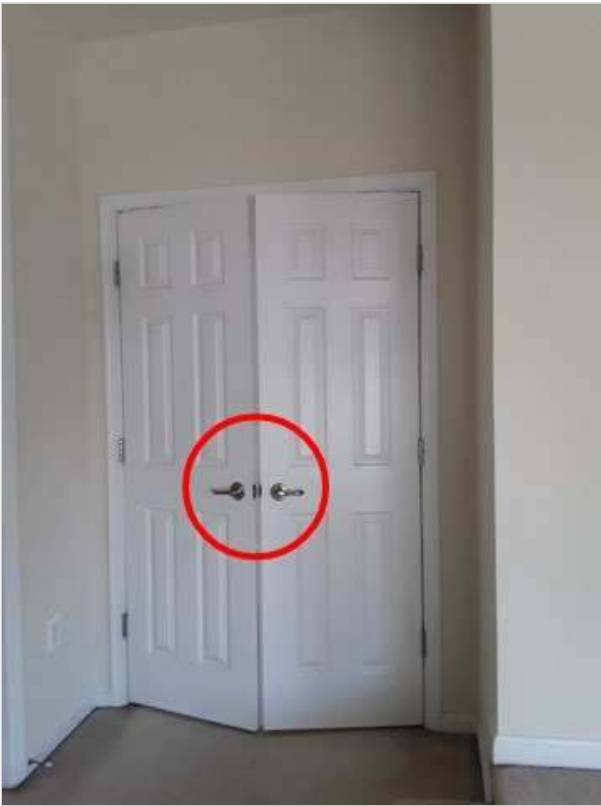
The french doors leading to the master bedroom did not latch properly,. This is normally easily corrected by a slight adjustment in the striker plate.

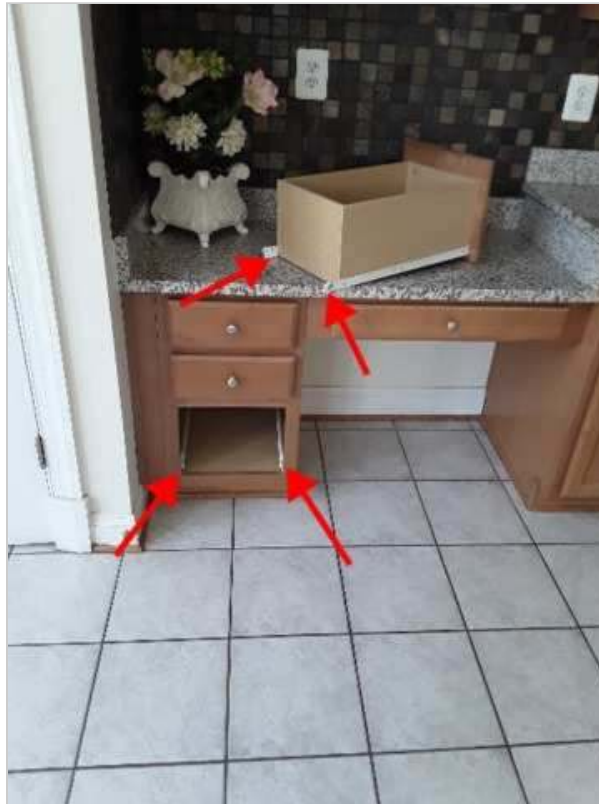
The drawer slides were bent on one of the kitchen drawers.

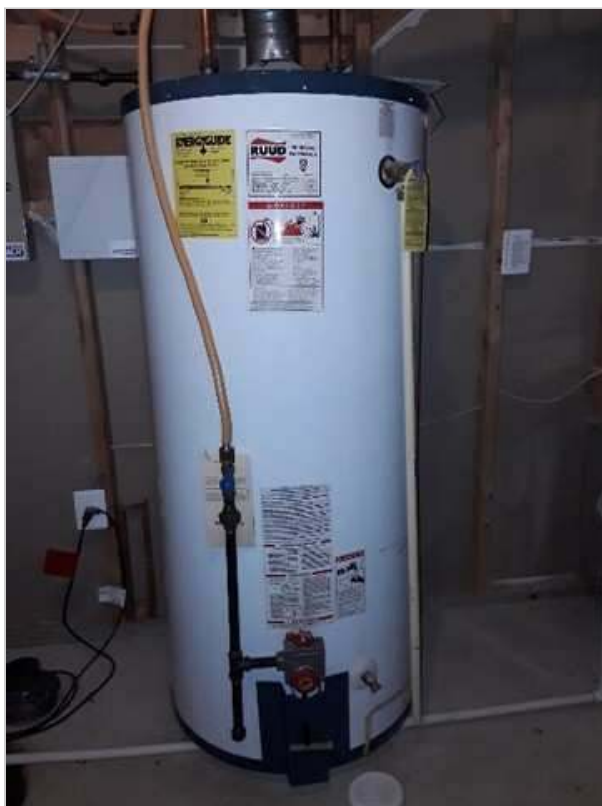
Most tank-type water heaters last 10 to 20 years, with the average age of replacement between 12 and 14 years. The age of the water heater was approximately 14 years old and was most likely at or nearing the end of its useful life.

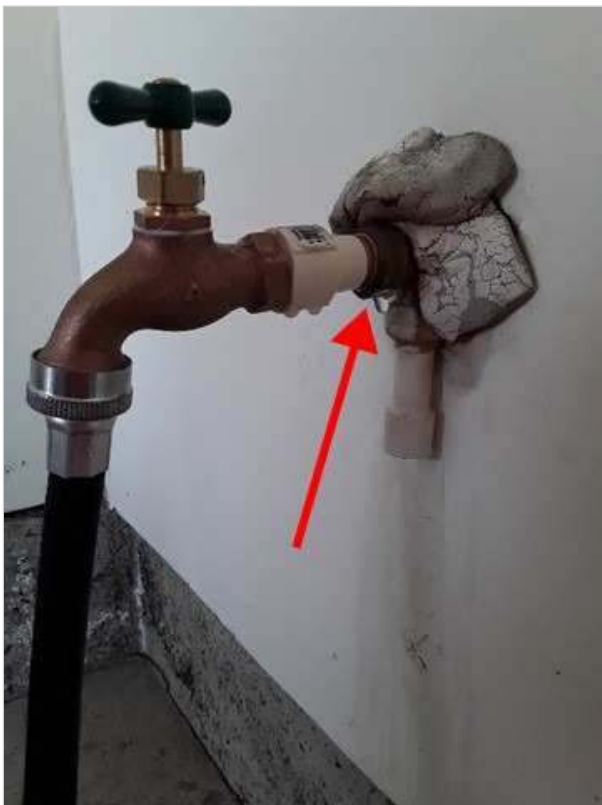
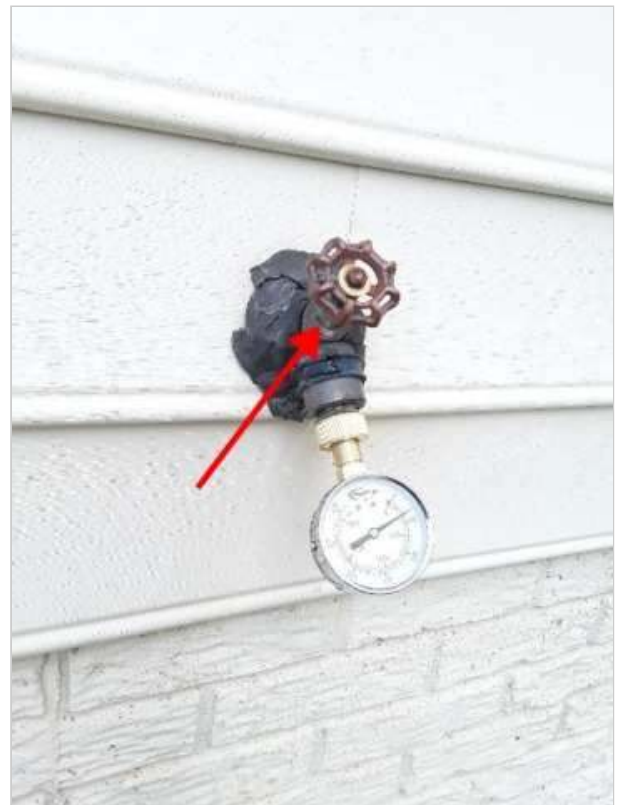
The left hose bib and the hose bib in the garage leaked when tested. Consult with a qualified contractor for repair.

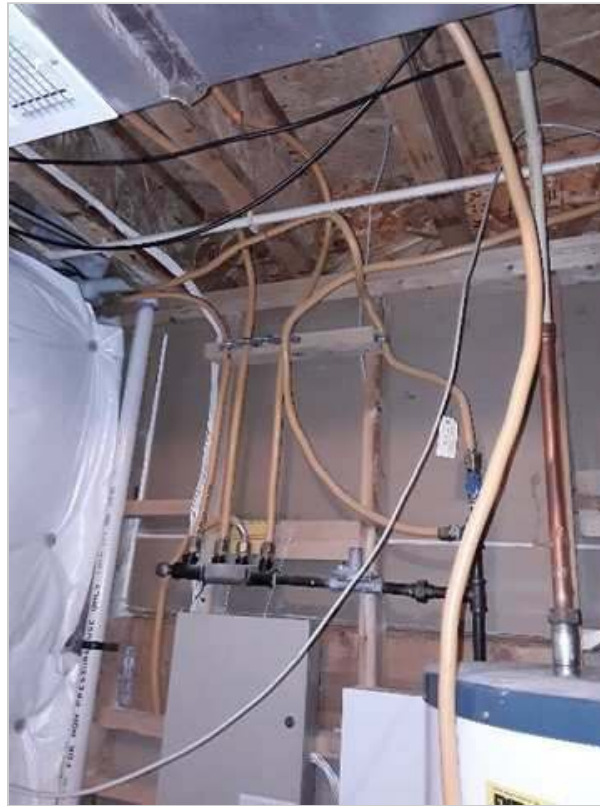
There was no bonding on the CSST gas plumbing found within the home. Manufacturers believe that this product is safer if properly bonded and grounded by the manufacturer's installation instructions. Proper bonding and grounding of the product should be determined by a contractor licensed to perform the work in the Commonwealth of Virginia.

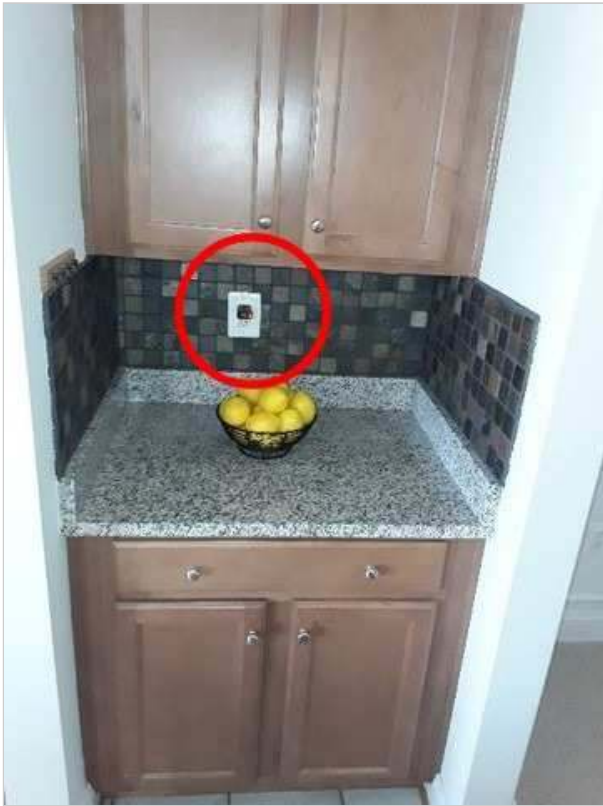
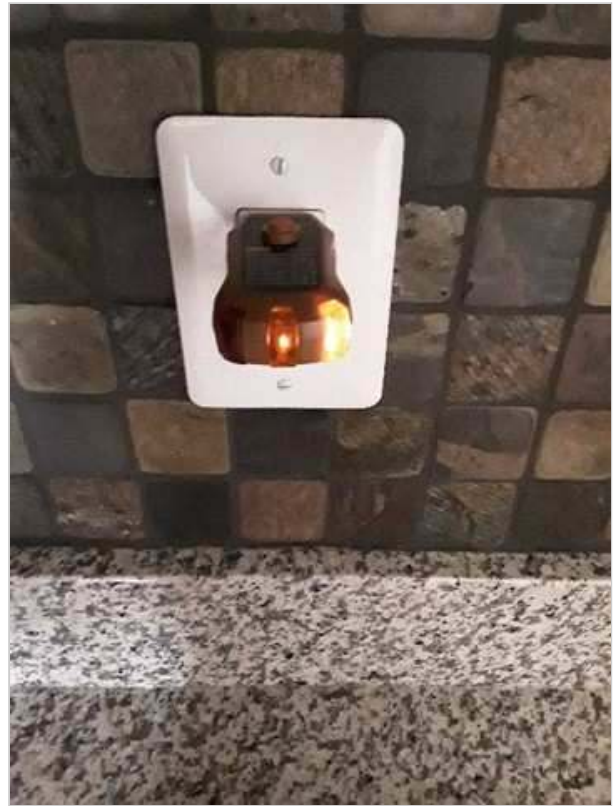
The GFCI outlet located in the kitchen is defective and should be replaced by a qualified electrician.

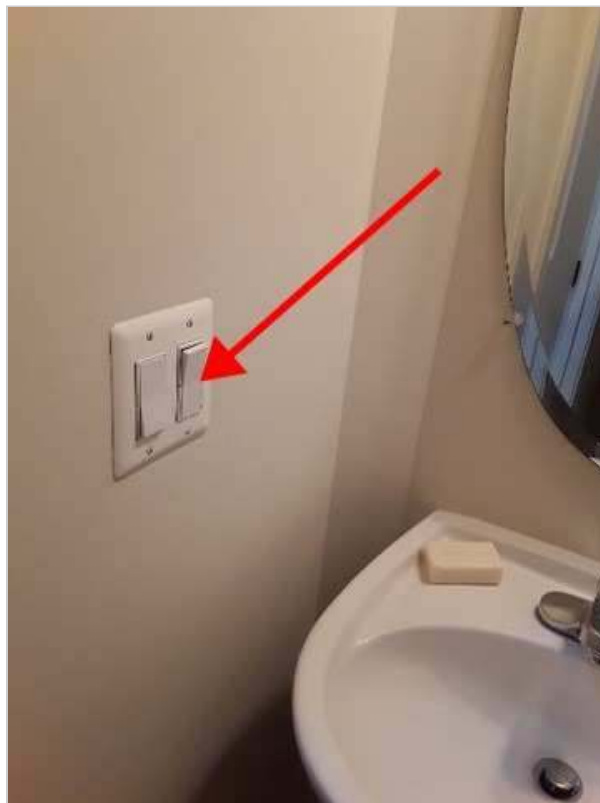
A broken switch was noted in the main level half bath. This could be a shock hazard due to exposed electrical contacts. The affected outlet(s) should be replaced by a qualified contractor.

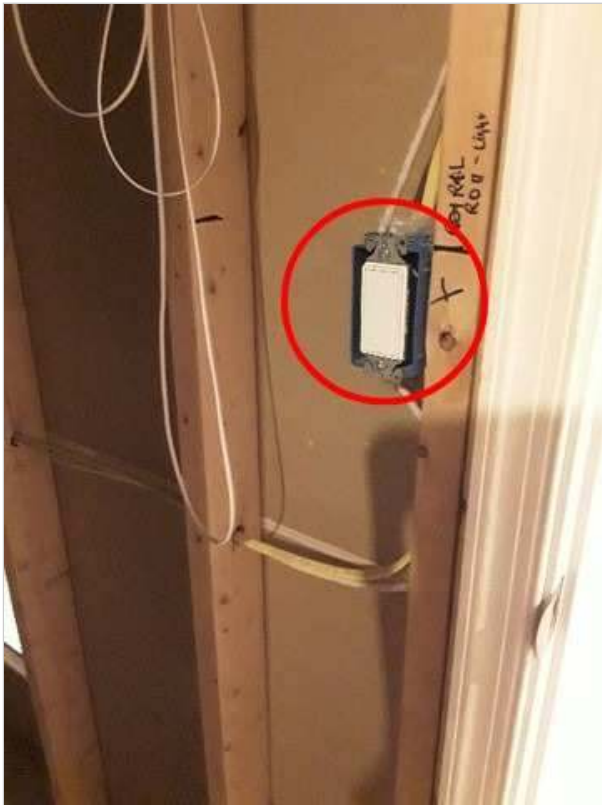
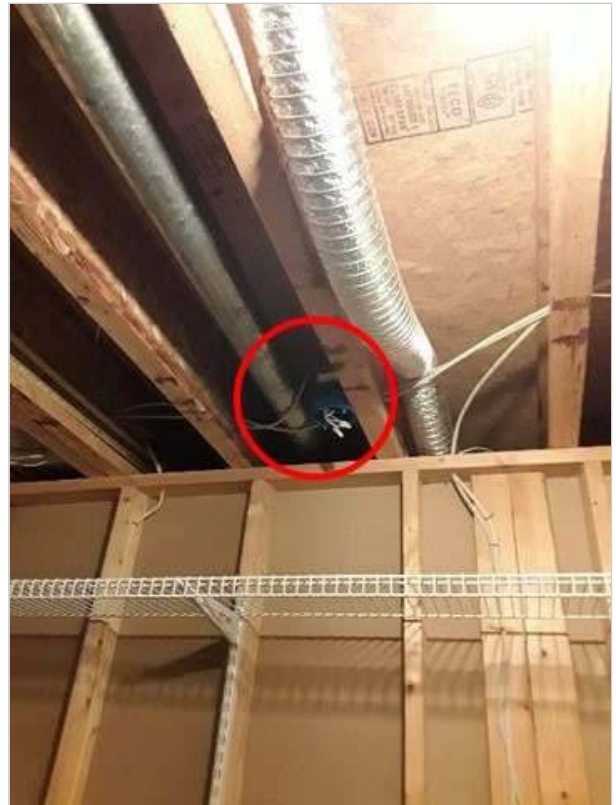
One or more devices were missing a switch/junction box/outlet cover in the mechanical/plumbing room. All switch/outlet boxes should be properly covered to avoid a shock hazard. Electrical related repairs should be performed by a qualified electrician.

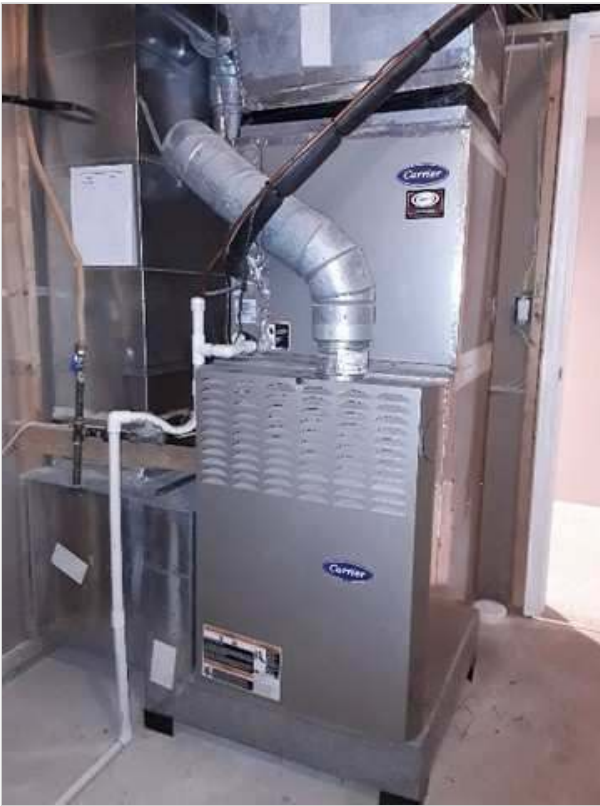
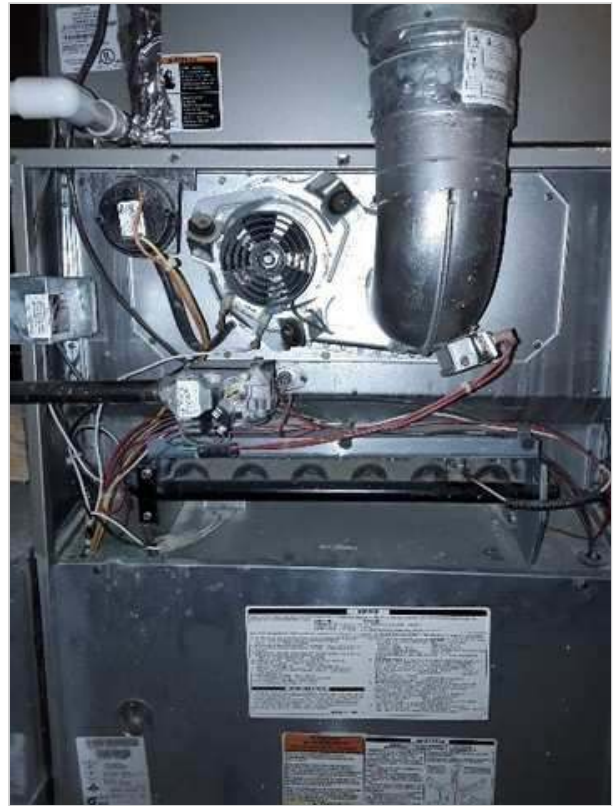
The average gas furnace will last about 15 years before needing to be replaced. A gas furnace will last longer by doing regular maintenance. The subject gas furnace has been in service for approximately 13 years and may be at or nearing the end of its usable life.

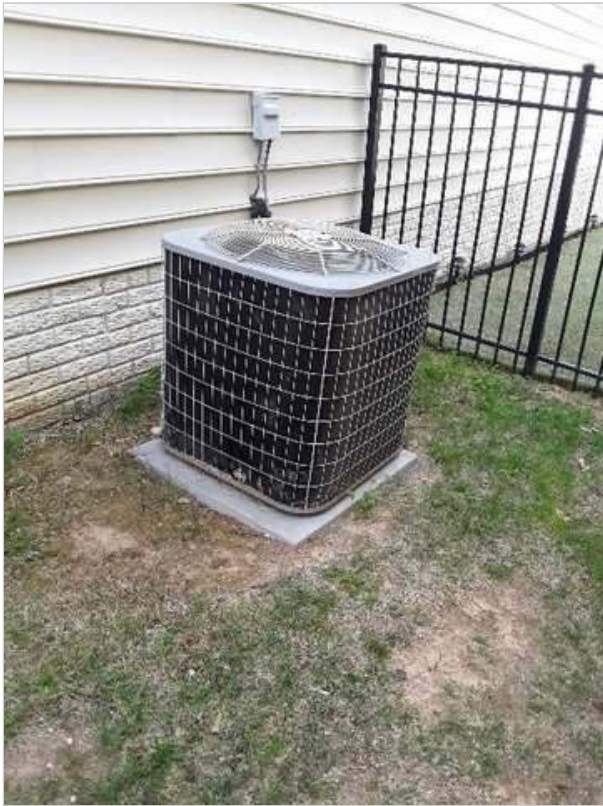
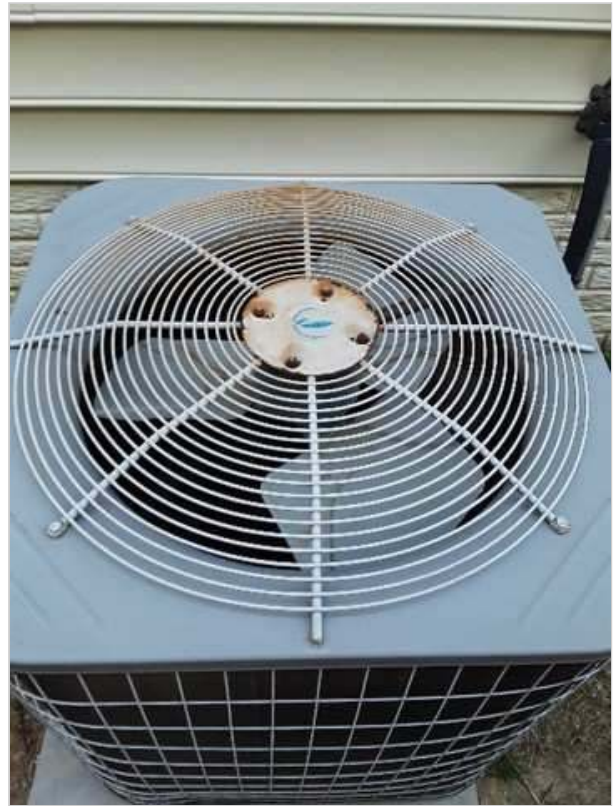
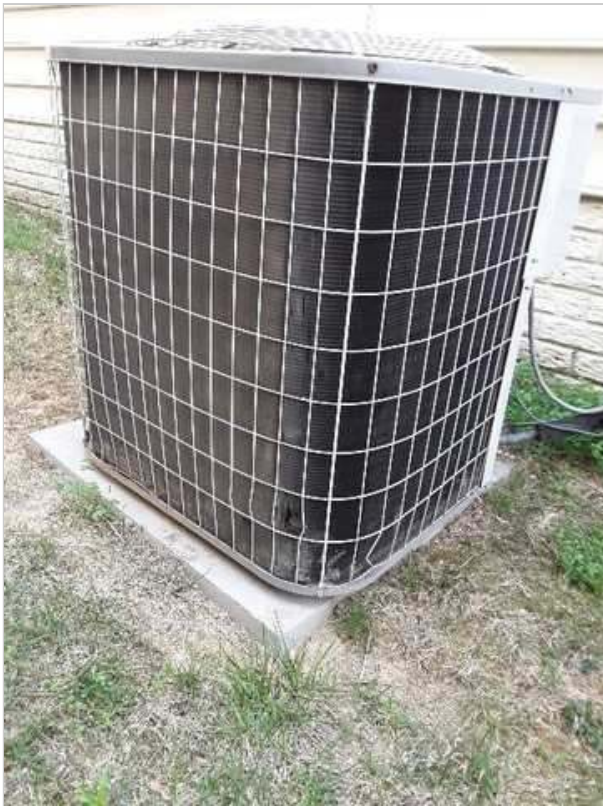
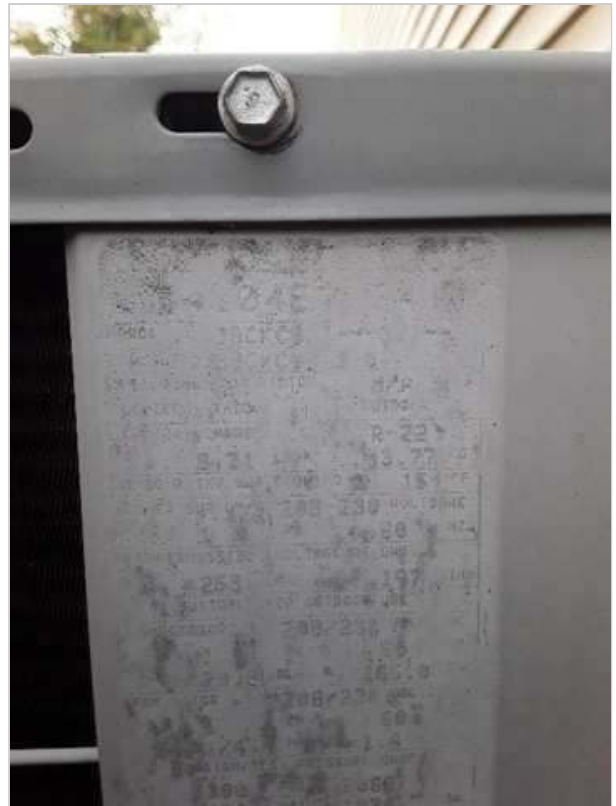
Outdoor air conditioner condensing units will typically last approximately 12-15 years before needing to be replaced. An outdoor condensing unit will last longer by doing regular maintenance. The subject condensing unit has been in service for approximately 13 years and was functioning at the time of inspection. The label on the unit was not legible due to wear and therefore the model and serial numbers were not available. The unit may potentially be at or nearing the end of its usable life.

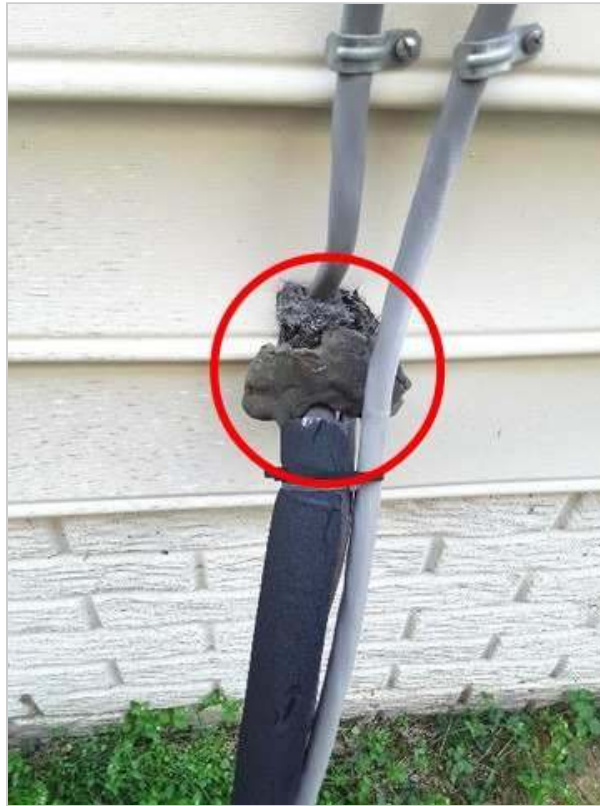
The lineset needs to be resealed where it passes through the exterior wall of the home to prevent water and/or insects from entering the home.

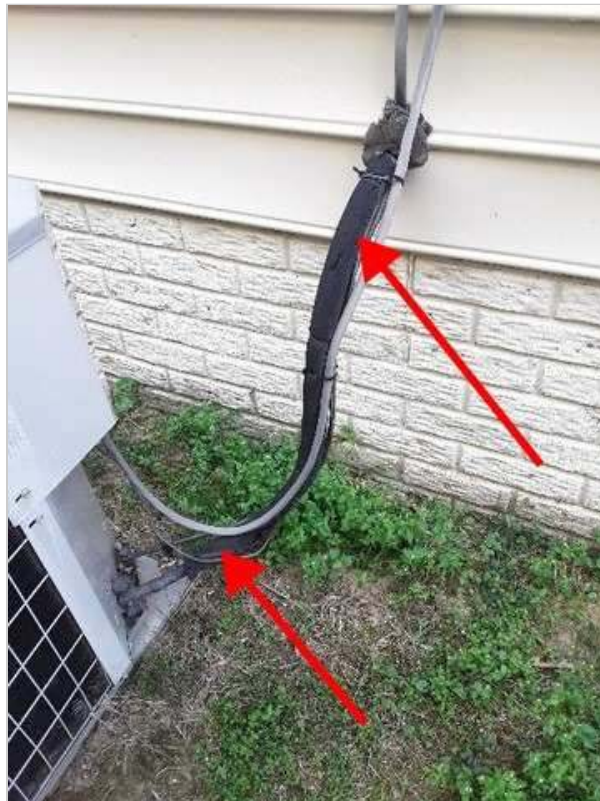
The insulation on the exterior air conditioning line set is dry-rotted. This could affect the efficiency of the system and should be replaced.
