HOME INSPECTION REPORT

The HomeTeam Inspection Service made a visual inspection of 123 Main Street, Anytown, USA 55555. Enclosed please find a written, narrative report of our findings in accordance with the terms of our Inspection Agreement.

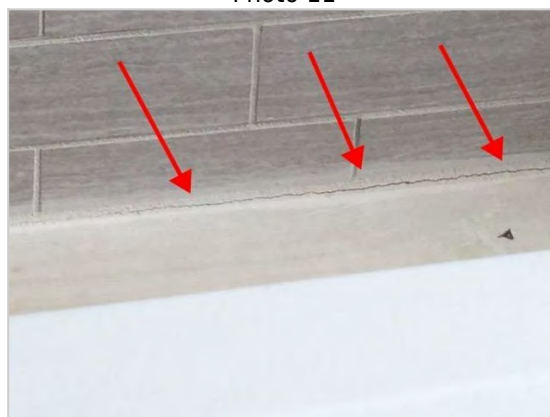
Photo 11

Some of the caulk was missing from around the tub in the master bathroom. These areas should be sealed to prevent moisture penetration. Failure to keep walls sealed can cause deterioration and extensive moisture damage including mold growth to the interior walls, which is not always visible at the time of the inspection.

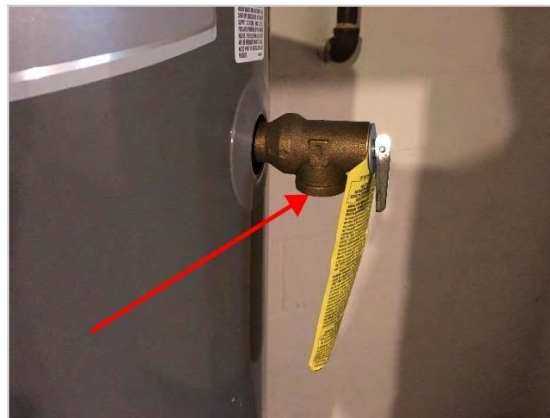
Photo 12

There was no drip leg installed on the T&P valve of the water heater. The drip leg directs water from the T&P valve toward the floor. A drip leg terminating within six-inches of the floor should be installed.
