HOME INSPECTION REPORT

On Monday, August 7th, 2023 The HomeTeam Inspection Service made a visual inspection of 123 Sample Dr, Anytown, WA 12345. Enclosed please find a written, narrative report of our findings in accordance with the terms of our Inspection Agreement.

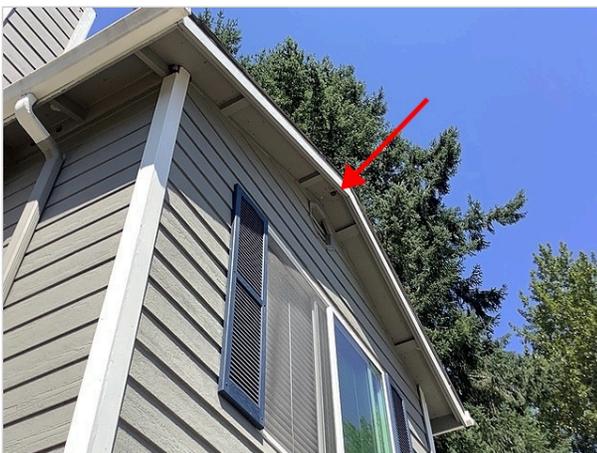
Photo 1

Holes were noted on the front of the structure's exterior. This condition does not have any effect on the structural integrity of the building. The areas should be repaired to prevent water intrusion.

Multiple locations around the exterior

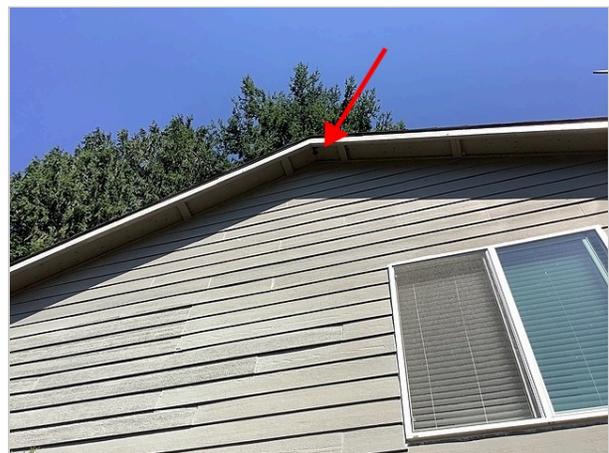
Photo 2

Wasp nests were found underneath some of the eaves around the structure of the house. Recommend licensed pest control company apply periodic insect treatment.

Multiple locations around the exterior

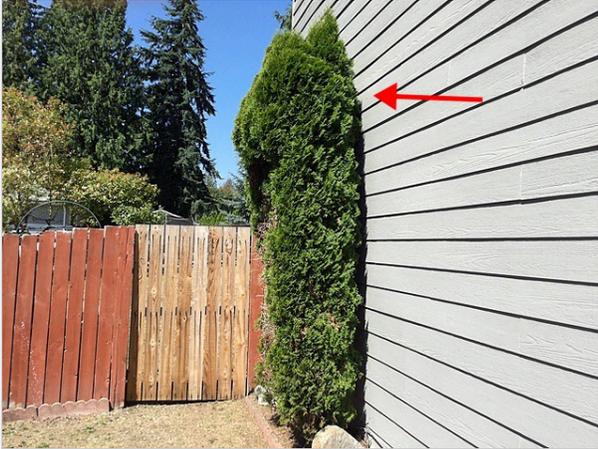
Photo 3

Plant and/or tree overgrowth was observed against the structure. HomeTeam recommends trimming or removing this growth to prevent possible damage including insect infestation, moisture buildup, and impact damage to the roof and structure.

Left side

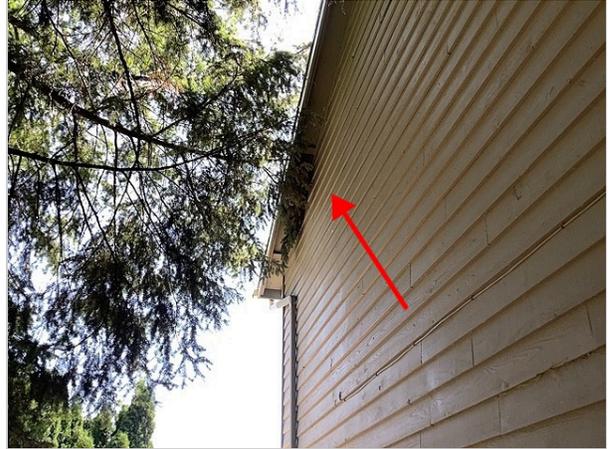
Photo 4

Right side of house

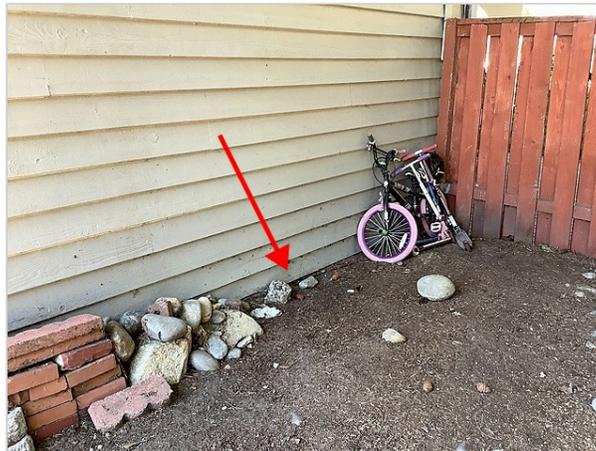
Photo 5

Siding in contact with the ground. When the ground makes contact with any siding material the ground can wick moisture into the siding and prevent proper drainage of moisture from the siding. This excess moisture can lead to wood rot or premature material defects in the siding over time. Recommend creating a 6 inch gap between siding material and the soil.

Right side of house

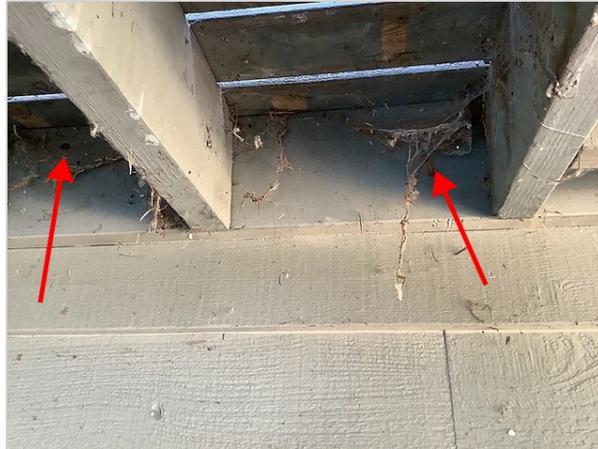
Photo 6

The ledger board for the deck is nailed to the structure rather than bolted. Generally accepted deck construction techniques require the deck to be bolted to the structure at regular intervals. The porch is quite small and may very well be unaffected by the use of nails over bolts, however it is not recommended. Consult with a qualified contractor to anchor the deck to the structure with bolts.

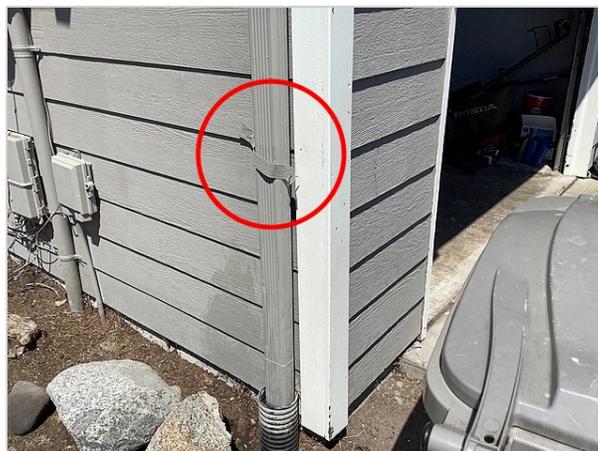
Photo 13

Gutters were in need of repair at the time of the inspection. Clogged or damaged gutters can cause roof drainage water to drain at the base of the foundation, causing basement water problems. Overflow from gutters can cause damage to fascia that is not visible or apparent at the time of the inspection. The gutters should be repaired.

Front left corner of house

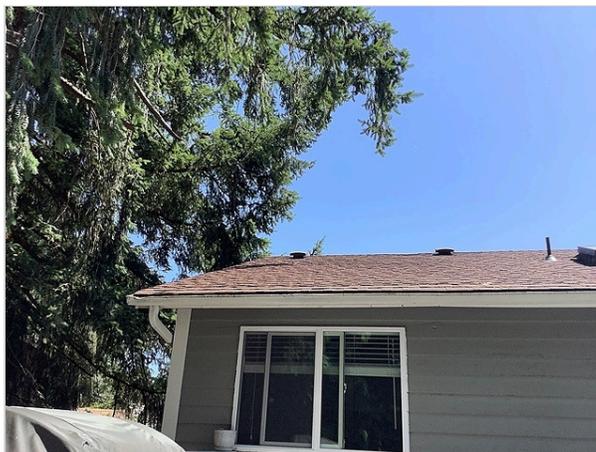
Photo 15

Tree branches were hanging over, or making contact with the roof. The trees should be cut back away from the roof to avoid damage to the roofing material.

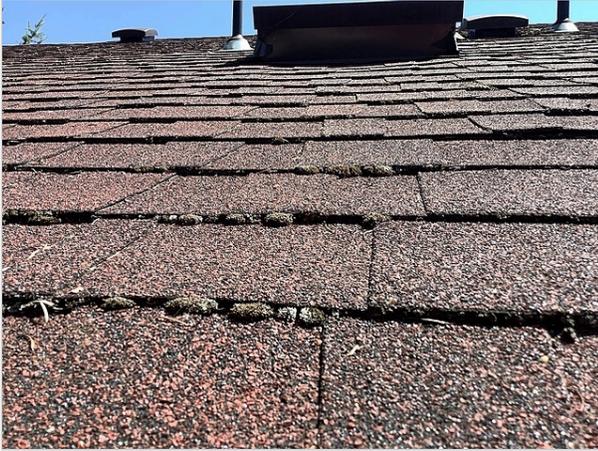
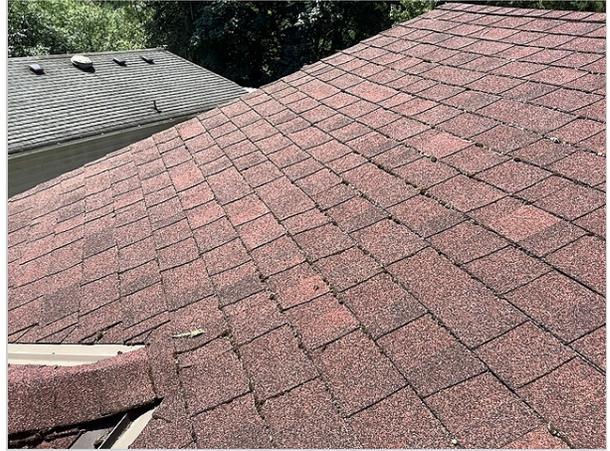
Moss observed on roof covering. Moss growth around roof shingles, tiles or other components can deteriorate the

roof covering's ability to properly shed water and protect the structure underneath. Recommend remediation.

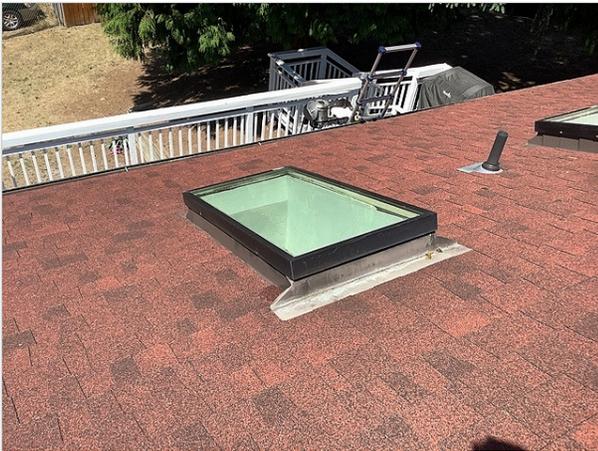
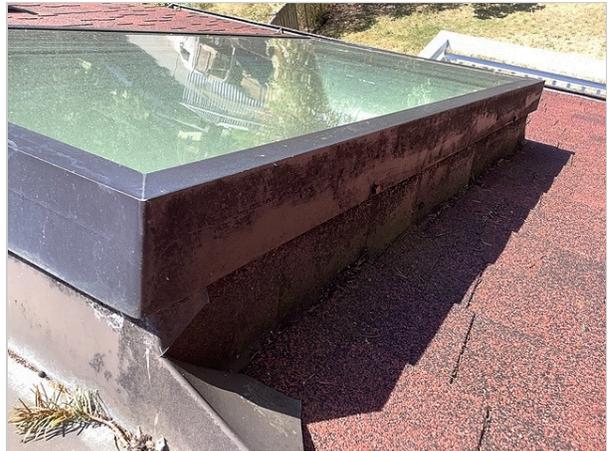
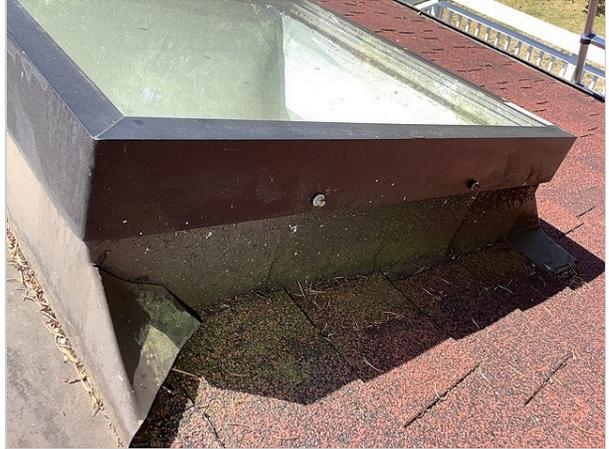
The roof has skylights. Water stains were visible at the time of the inspection. The roof sheathing in the attic appears to be black and from repeated water intrusion. The absence of staining is not necessarily conclusive proof that a skylight does not leak. Skylights in general have historically been problem areas for water intrusion, and whether or not signs of previous water intrusion were observed at the time of the inspection, the client should maintain vigilance for any water intrusion. If any is observed, the areas should be sealed and further assessed to prevent future water intrusion.

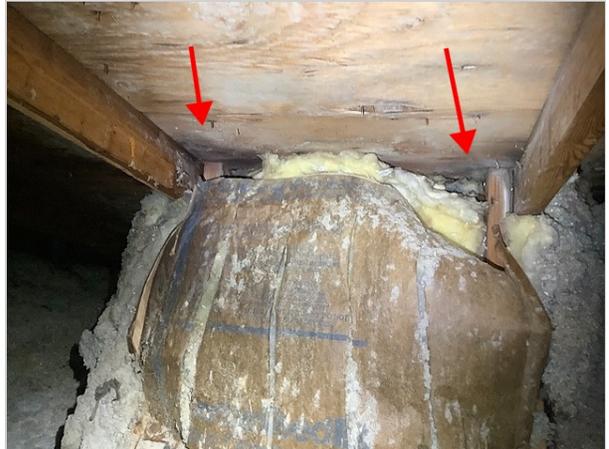
Photo 23

Sheathing in attic around skylight penetration

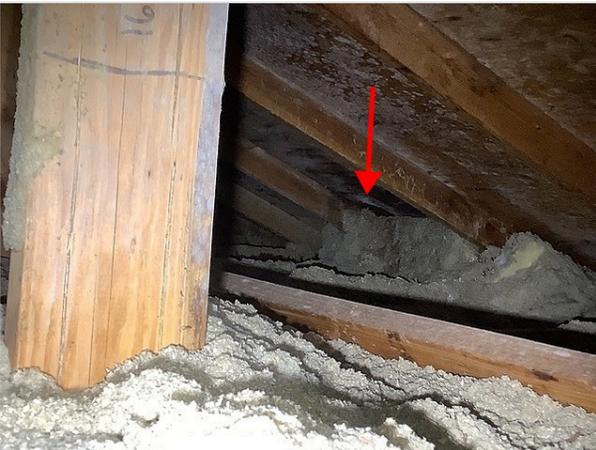
Photo 24

Sheathing in attic around kitchen skylight penetration

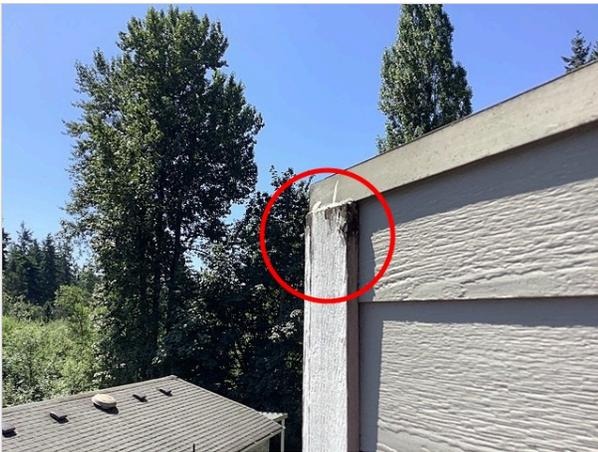
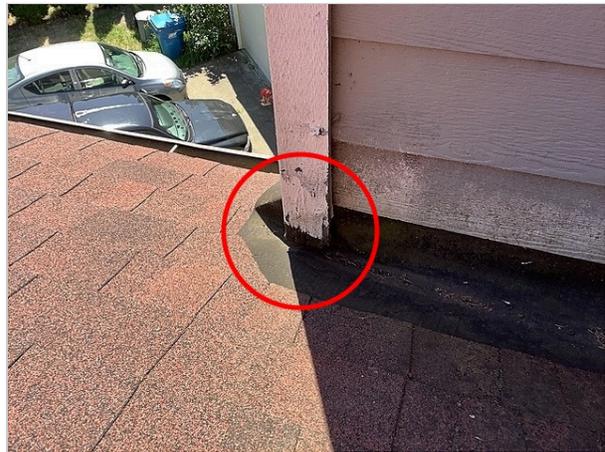
Exterior painted wood surfaces on the flu chase were moderately deteriorated. Wooden surfaces, particularly those exposed to the elements, should be repaired and refinished to prevent further deterioration and water intrusion.

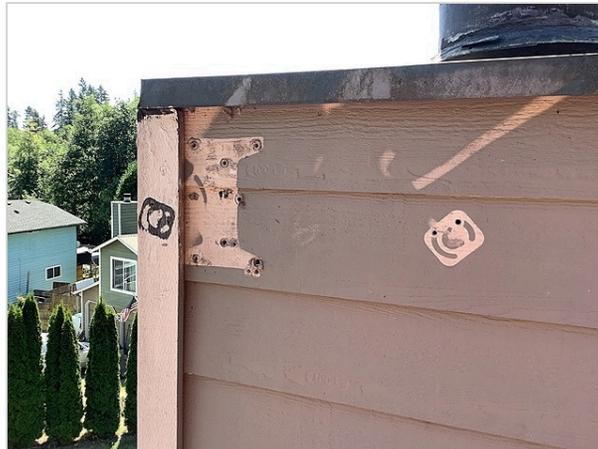
Photo 28

Holes were noted on the flu chase. This condition does not have any effect on the structural integrity of the building. The areas should be repaired to prevent water intrusion.

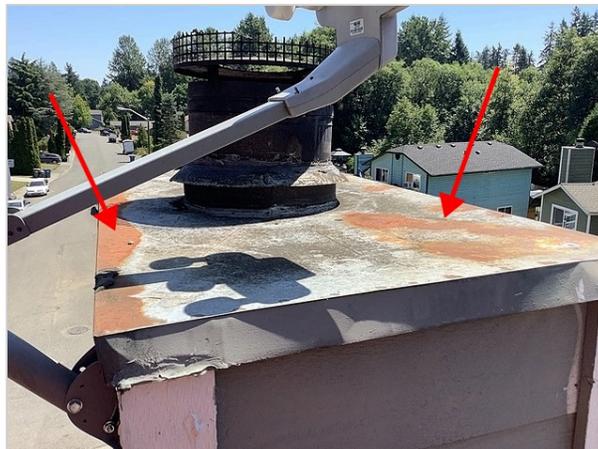
Photo 29

The metal flue chase cap is rusted. Over time, this may lead to water intrusion. No points of visible water intrusion were evident, although our view was limited. As a maintenance item, the rust should be removed and the metal cap painted and sealed to help prolong the life of the cap and reduce the potential for water intrusion.

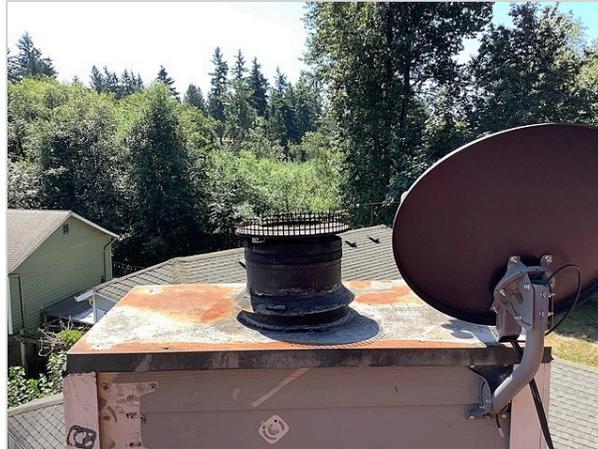
Photo 30

The chimney is missing a rain cap. A rain cap should be installed to prevent excessive water intrusion and deterioration of the chimney and its components.

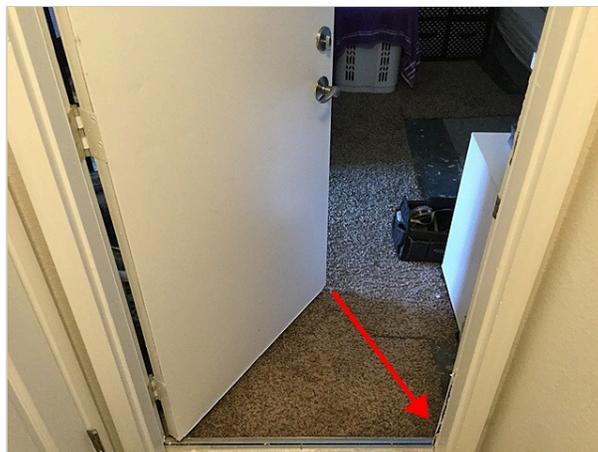
Photo 31

The man door to the garage does not close automatically, because there is no spring return at any of the hinges. As a fire safety feature, garage man door's must be able to close if left open. Recommend installing spring return hinges to one or two of the door hinges.

Garage man door

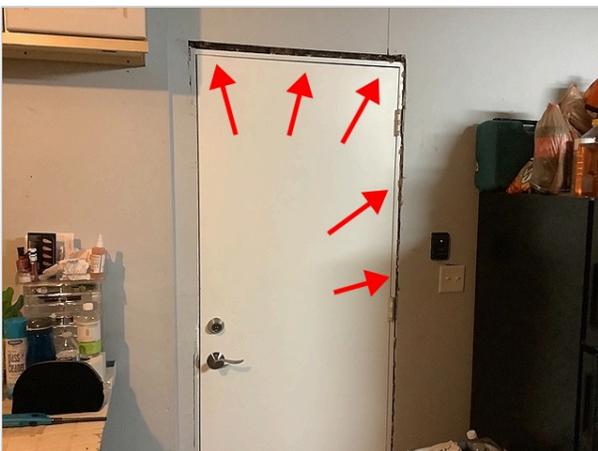
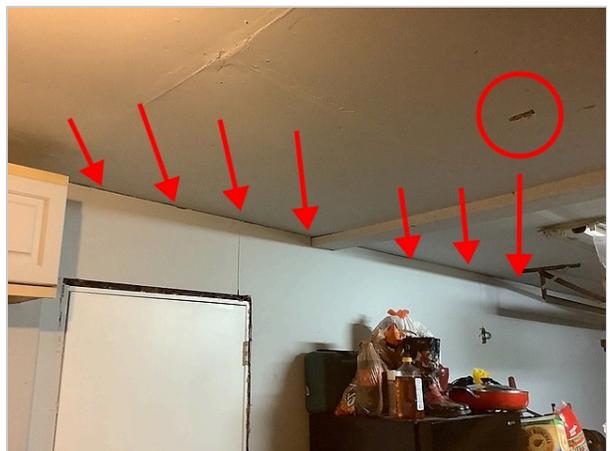
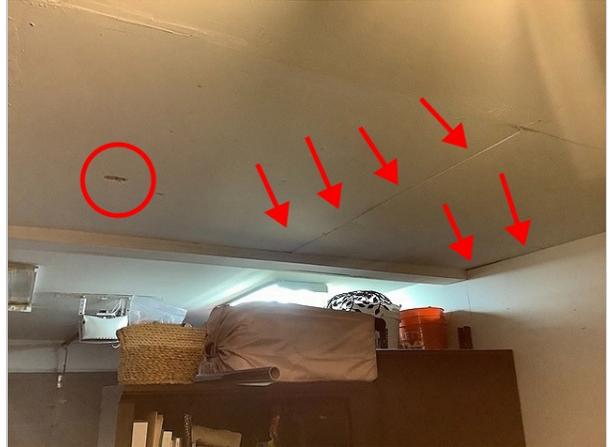
There were some firewall breaches observed in the garage at the time of inspection. Firewall breaches are safety concerns which include holes or voids in the firewall or sheet rock separation between the garage and home. These voids are recommended to be sealed to prevent a garage fire from spreading into the home.

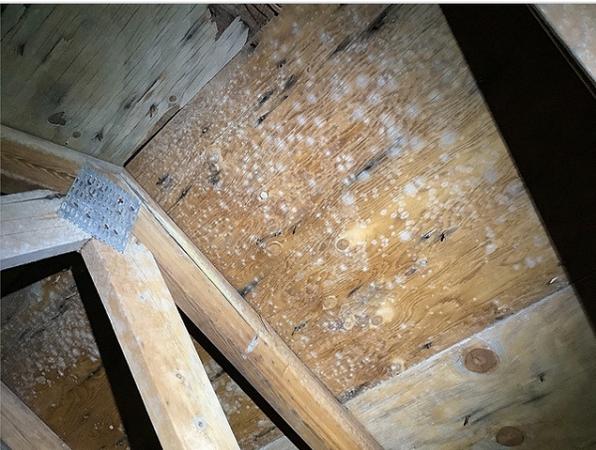
Photo 43

Parts of the attic show signs of previous water intrusion. The areas were dry at the time of the inspection. Multiple moisture readings were taken and reading were lol below 6% moisture content. The buyer should maintain vigilance in monitoring the areas for any recurrence of the previous issue and should rectify any issues immediately upon observing them.

Previous fungal growth

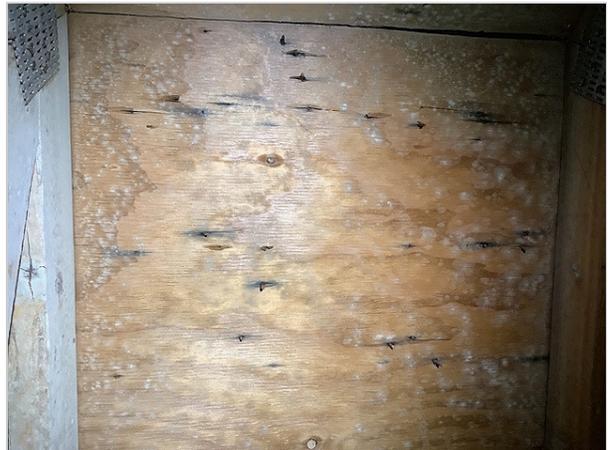
Photo 44

Rusted nails and black spots around nail holes

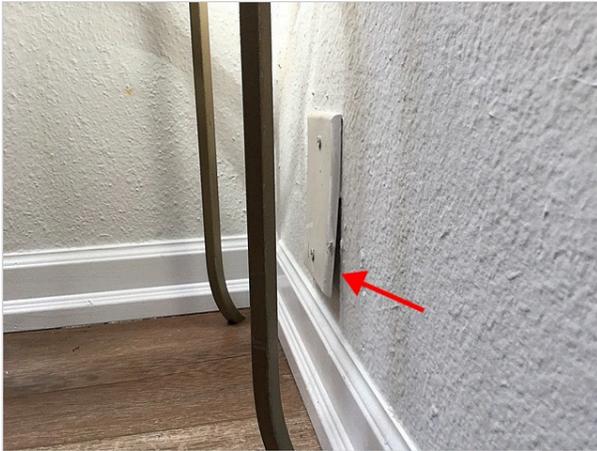
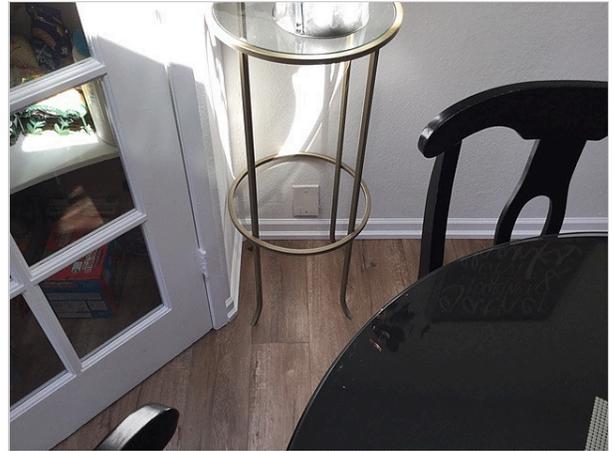
The purpose of a cover plate is to block access of fingers, etc. from contact with energized materials. Recommend filling in gap(s) with appropriate finishing materials and/or proper installation of electrical device, whichever is required.

Kitchen

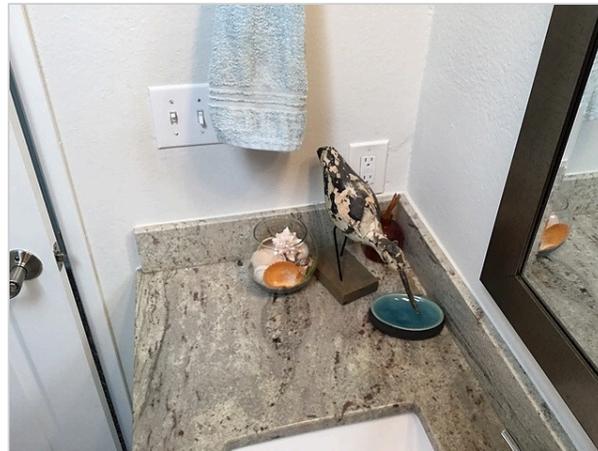
Photo 52

The GFCI outlet located in the second floor hallway bathroom is either defective and need some repair or is downstream of another GFCI that I cannot locate. The unit shows a green light for power, but has no power.. The device flashes a red blinking light and periodically makes a tripping sound all by itself. Ground fault circuit interruption is designed to prevent shock hazard in the event of a ground fault. Recommend replacement of the device by a qualified professional.

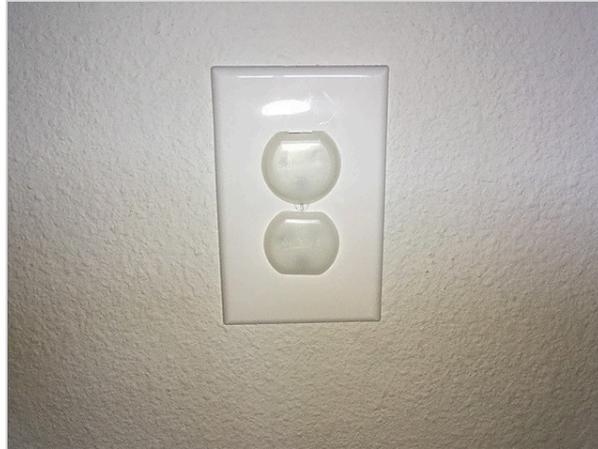
Photo 53

Several receptacles had child safety covers and were not inspected .

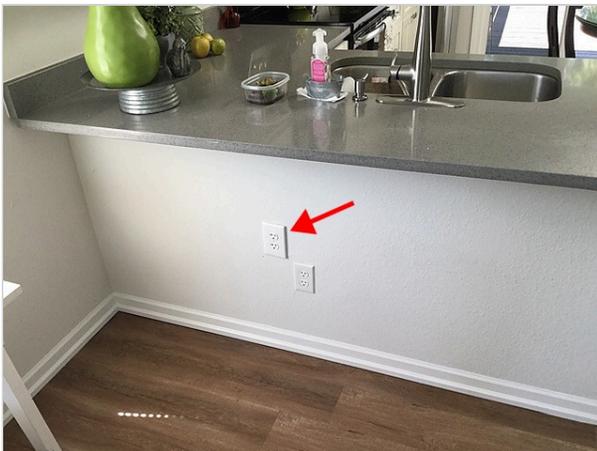
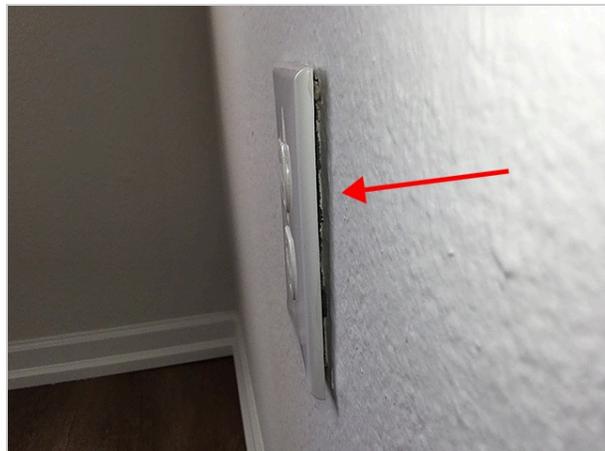
An unsecured outlet box was discovered in the living room. A properly secured box with cover plate will prevent manipulation by fingers or objects. Recommend securing box properly by a licensed professional.

Living room

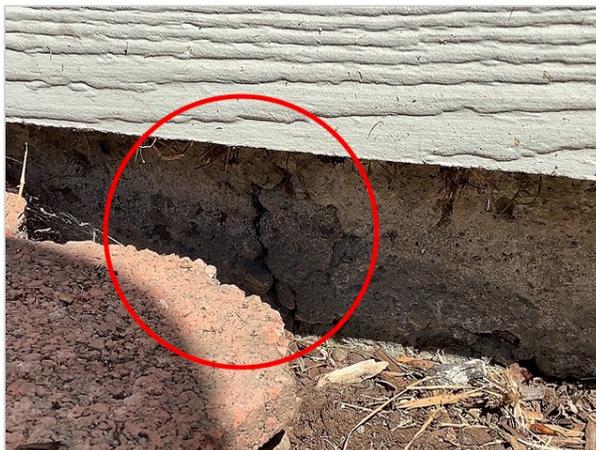
Photo 56

Small cracks were observed on the foundation. The cracks were 1/16th-inch or less in width. The homeowner should monitor these cracks for any changes, and if changes are noted, should contact a structural repair company for further analysis. Below-grade cracks are highly susceptible to water intrusion during times of heavy rain. Water staining from previous water intrusion was not visible. HomeTeam recommends sealing these cracks if a watertight crawlspace is desired.

Left side of house

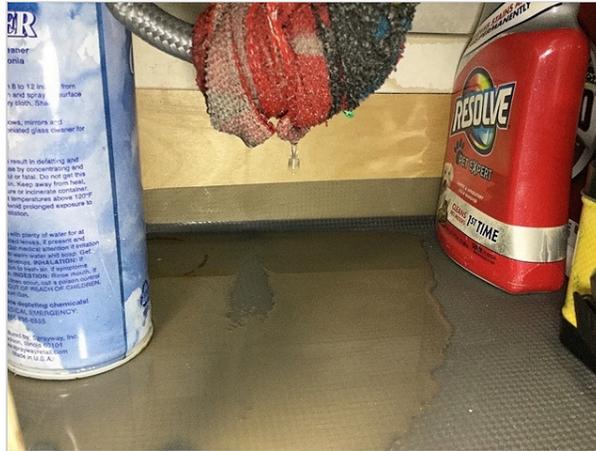
Photo 57

A leak was observed at the faucet extension hose of the kitchen sink. The affected area should be repaired or replaced to prevent water intrusion and should be further assessed at the time of repair.

Kitchen sink

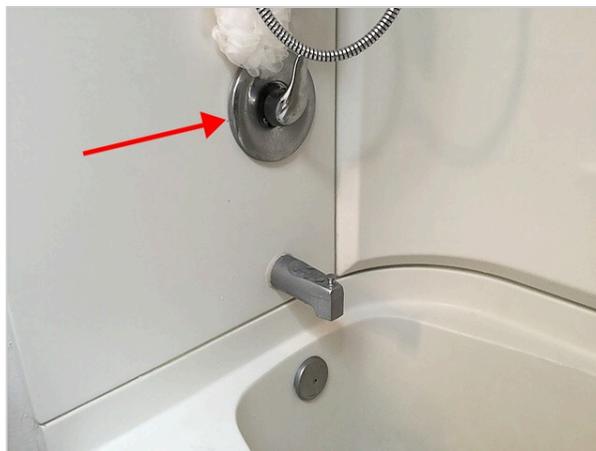
Photo 58

The tub hot/cold fixture in the upstairs bathroom appears to not be installed to proper alignment. The hot and cold selections are misaligned. Hopefully this does not allow water to leak behind the insert. Recommend reinstalling fixture to proper alignment and monitoring the floor and walls around the insert for softness and staining. Recommend also removing insert panels at time of repair to check for water damage behind the panels.

Upstairs hallway bathroom

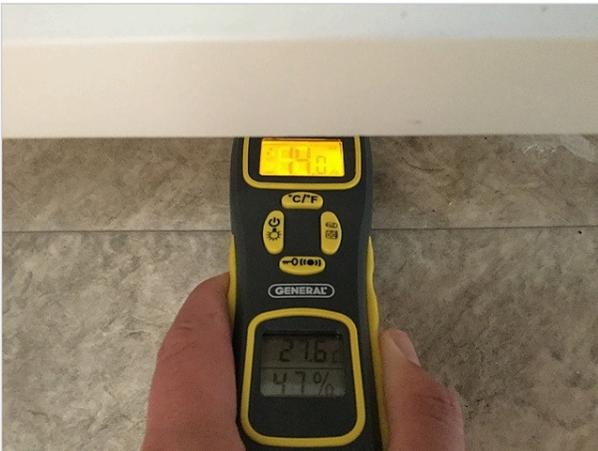
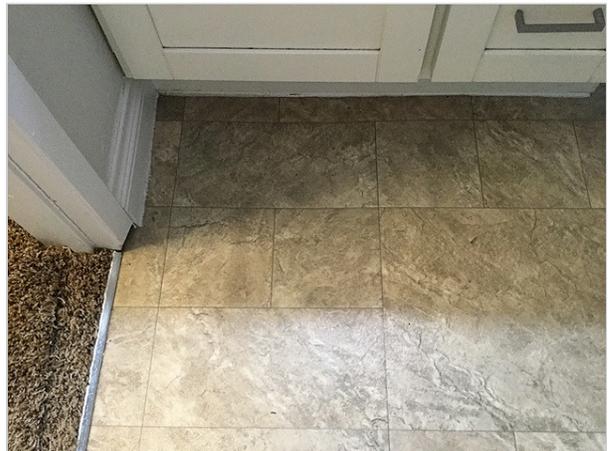
An area of the downstairs hallway bathroom floor appears sunken and feels soft. Moisture metering did show elevated moisture levels. This may or may not be indicative of internal damage from water or pests, poor workmanship, or other factors. Beyond the results of a visual inspection of the sub-flooring, if available, an evaluation by a licensed professional is recommended.
