*HOME INSPECTION REPORT*

On Monday, March 31, 2025 The HomeTeam Inspection Service made a visual inspection of 123 Anywhere St., City, ST 12345. Enclosed please find a written, narrative report of our findings in accordance with the terms of our Inspection Agreement.

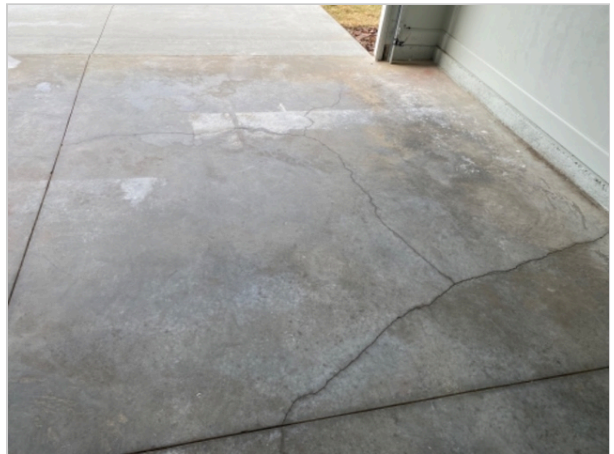
The garage floor had minor spider cracks observed. These cracks did not appear to be a structural issue. These cracks should be sealed and monitored.

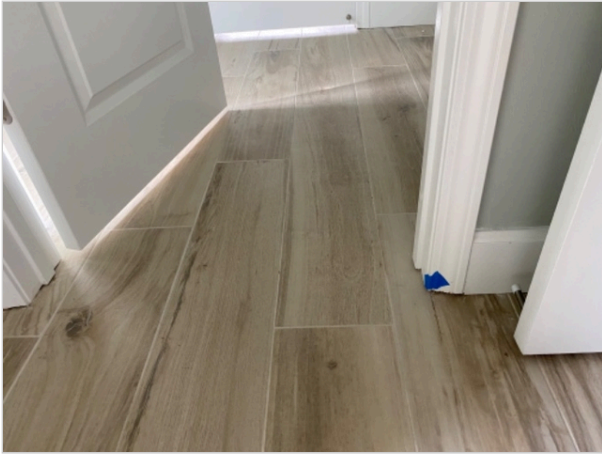
**An exposed nail was observed at the guest bedroom/ jack & jill bathroom door frame that should be removed**

**and has been marked with blue tape to help the builder and contractors identify said issues.**
