### HOME INSPECTION REPORT

On Monday, March 31, 2025 The HomeTeam Inspection Service made a visual inspection of 123 Anywhere St., City, ST 12345. Enclosed please find a written, narrative report of our findings in accordance with the terms of our Inspection Agreement.

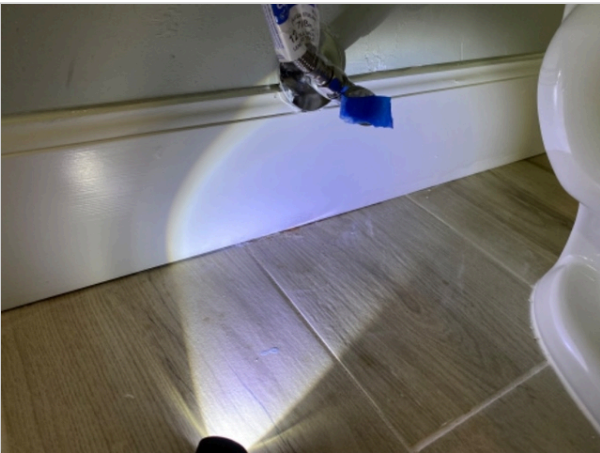
**Photo 43**

Leaks were observed at the toilet shut off in the Jack and Jill bathroom when in use. The tub and sink in the hall bathroom drain slowly. A licensed plumbing company should be called to evaluate the system and make any repairs.

The Jack and Jill toilet shut off is leaking.

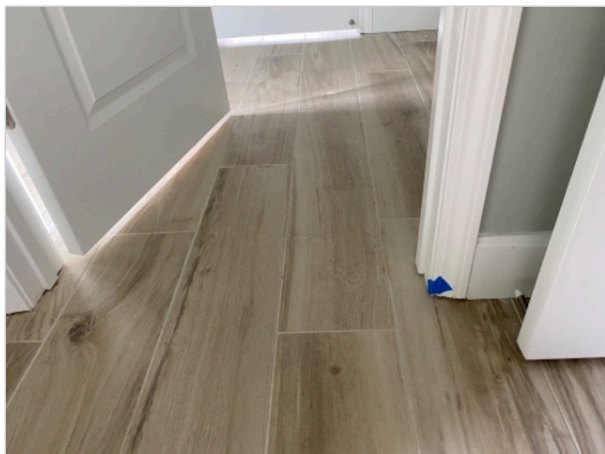
**Photo 59**

**An exposed nail was observed at the guest bedroom/ jack & jill bathroom door frame that should be removed**

**and has been marked with blue tape to help the builder and contractors identify said issues.**
