HOME INSPECTION REPORT

**123 Sample Drive
Anytown, TX 55555**

PROPERTY INSPECTION REPORT

Prepared For:	Bill Sample	
	(Name of Client)	
Concerning:	123 Sample Drive, Anytown, TX, 55555	
	(Address or Other Identification of Inspected Property)	
By:	Inspector 1 Inspector 2	9-29-2017
	(Name and License Number of Inspector)	(Date)
	(Name, License Number of Sponsoring Inspector)

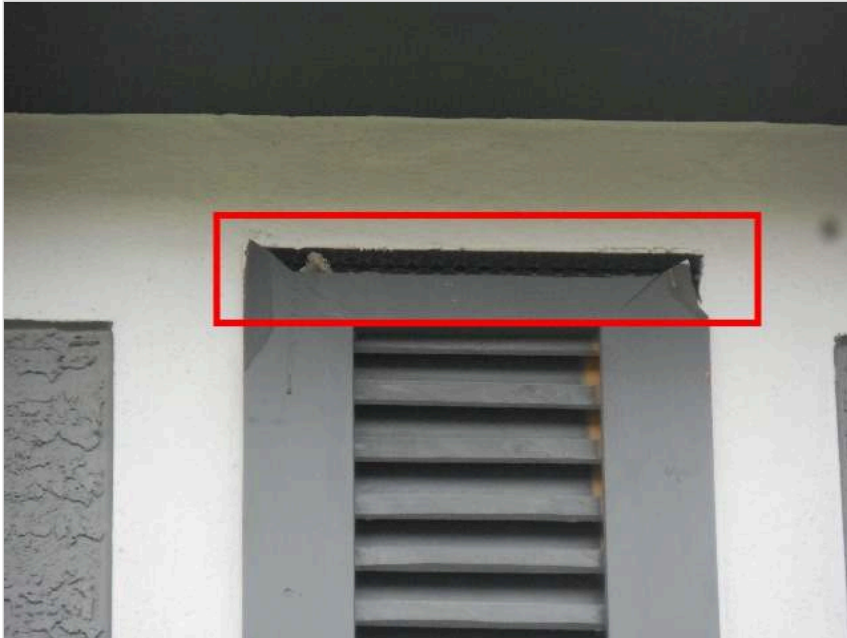
Deficiencies:
 Trim was damaged at the top of the front facing gable vent. Recommend repairing and sealing.

Part of trim damaged/missing at front gable vent.

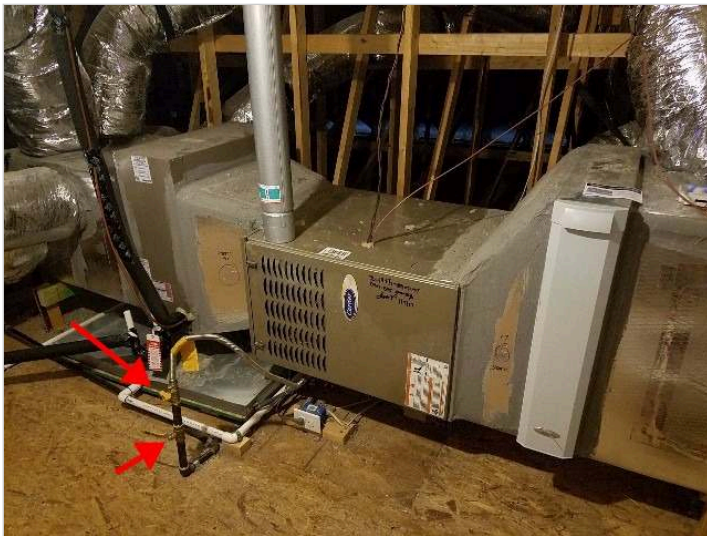
The heating units would not come on. Both unit gas valves and systems were OFF at the time of the inspection (at the units) and did not appear to be activated by the builder. After attempting to temporarily turn on the gas and units for testing they still did not respond. Recommend the builder activated the units (bleed gas lines) and demonstrate operation during final walk-through.

view of lower HVAC unit: gas and heater system off.
