HOME INSPECTION REPORT

The HomeTeam Inspection Service made a visual inspection of 123 Anywhere St., City, ST 12345. Enclosed please find a written, narrative report of our findings in accordance with the terms of our Inspection Agreement.

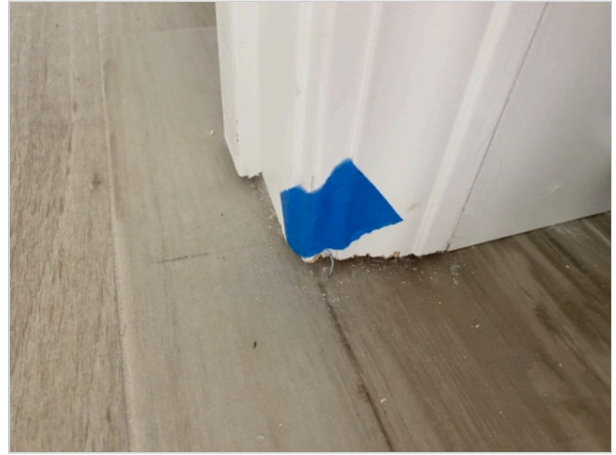
Photo 60

An exposed nail was observed at the guest bedroom/ jack & jill bathroom door frame that should be removed

and has been marked with blue tape to help the builder and contractors identify said issues.
