HOME INSPECTION REPORT

Address of Inspection: **123 Sample Drive, Louisville, KY**

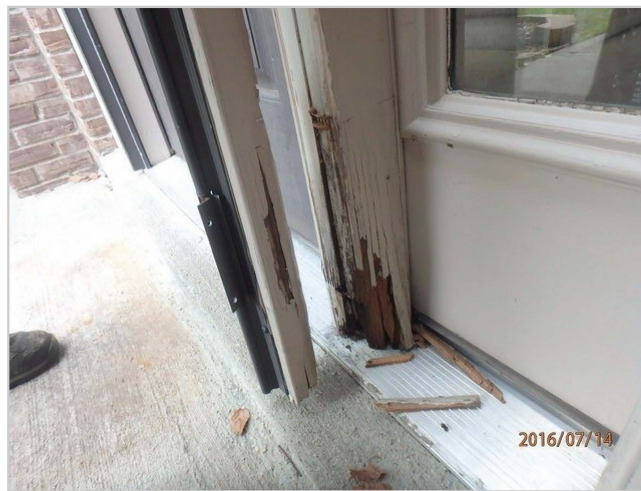
Photo 1

Rotted wood was present on the front door . The areas should be repaired and further evaluated at the time of repair.

example of rotted wood around the front door

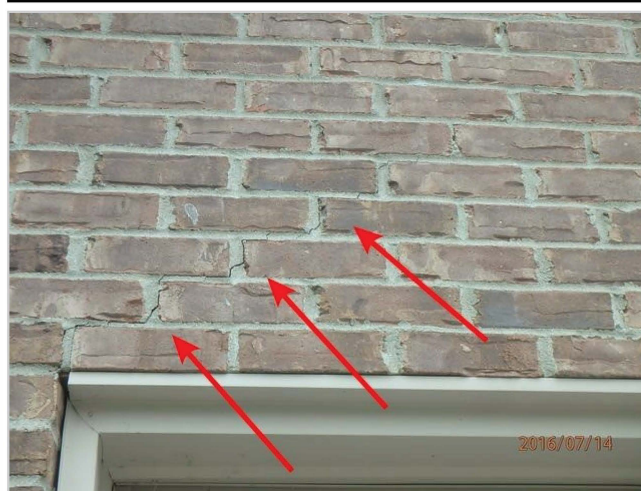
Photo 2

Cracks were present on the brick veneer of the home. The cracks were located on the front. The cracks are common and do not usually have any structural significance. No structural concern on the brick veneer was noted. All cracks should be monitored for significant changes in characteristics. The cracks should be sealed to prevent water intrusion behind the brick.

mortar crack

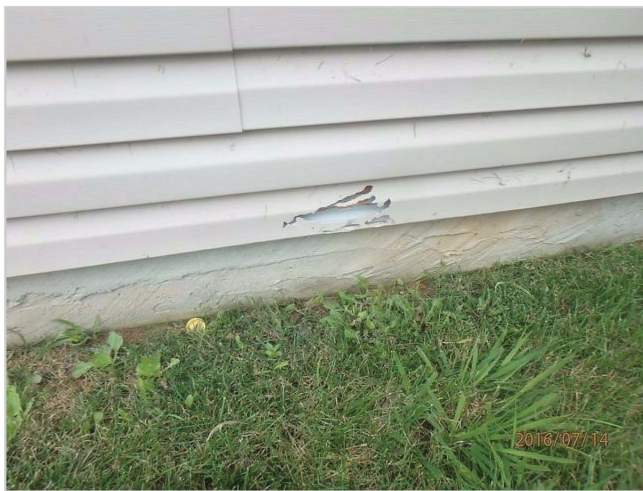
Photo 3

Holes were noted on the right and back sides of the home's exterior. This condition does not have any effect on the structural integrity of the building. The areas should be repaired to prevent water intrusion.

example of damaged siding

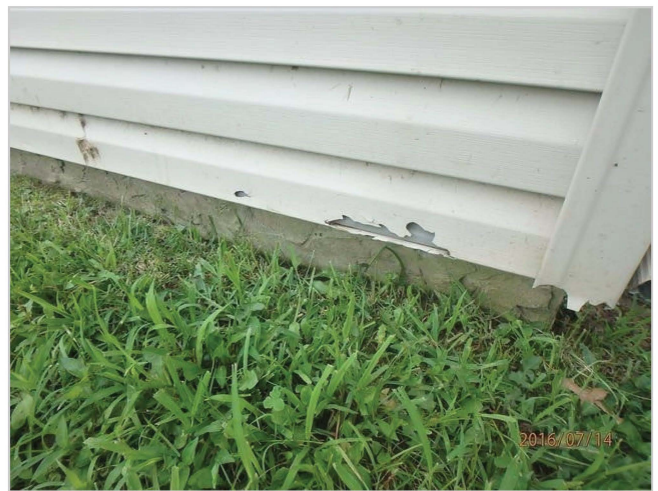
Photo 4

example of damaged siding

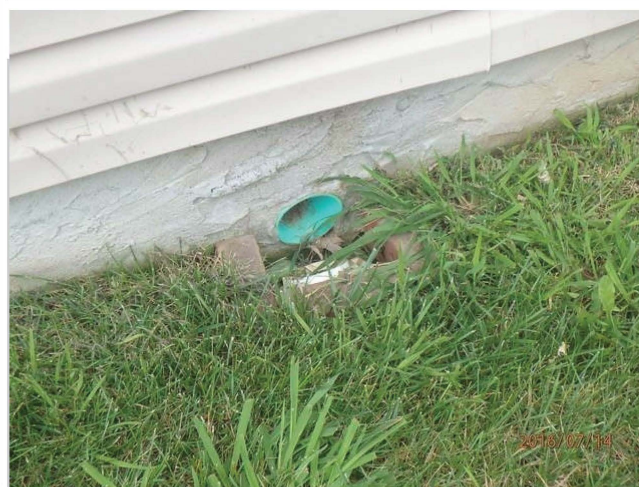
Photo 5

The dryer vent cover is missing. The vent cover should be repaired or replaced to prevent birds or other small animals from entering the home.

missing dryer vent cover

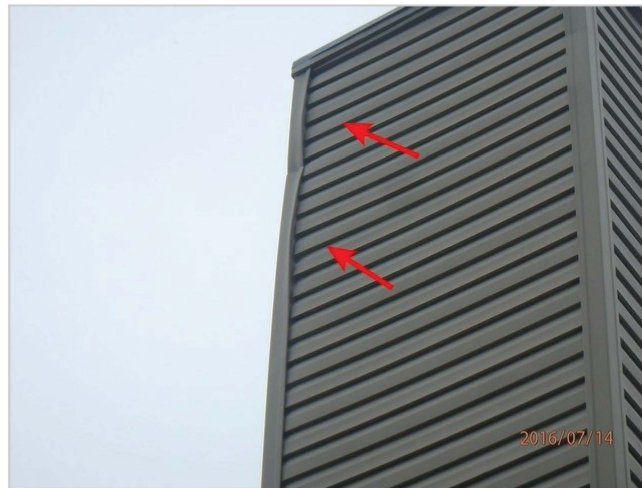
Photo 6

NOTE- Although the vinyl on the flue chase is not loose there are areas that appear to be buckled. These areas should be monitored for any needed repairs and repaired as necessary

buckled vinyl

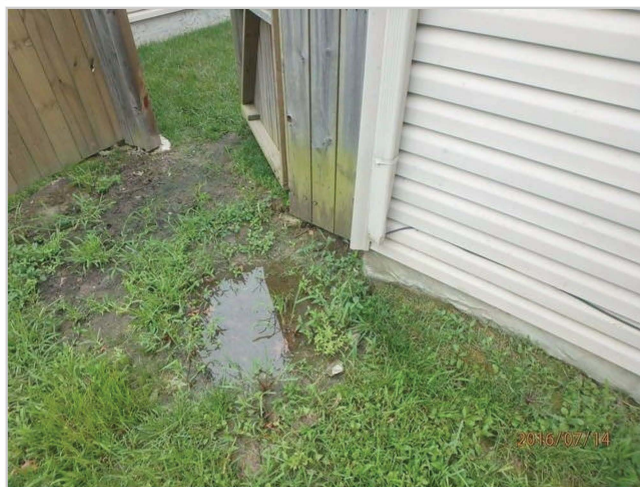
Photo 8

Several downspouts were draining at or too close to the base of the foundation. To reduce the likelihood of water problems at the base of the home, all roof drainage should be directed at least six feet from the base of the foundation.

several downspouts are draining adjacent to the foundation

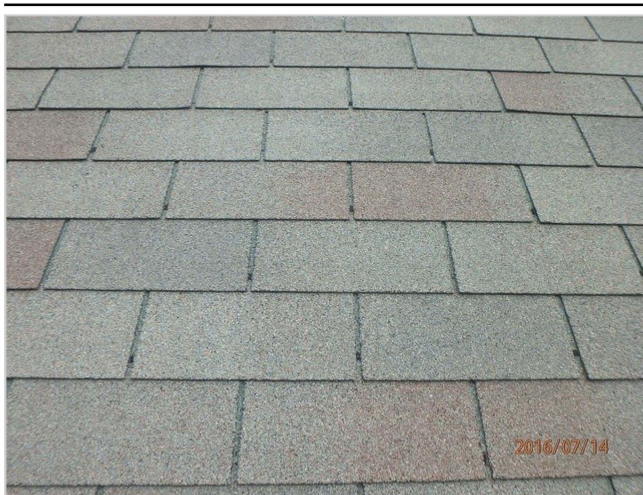
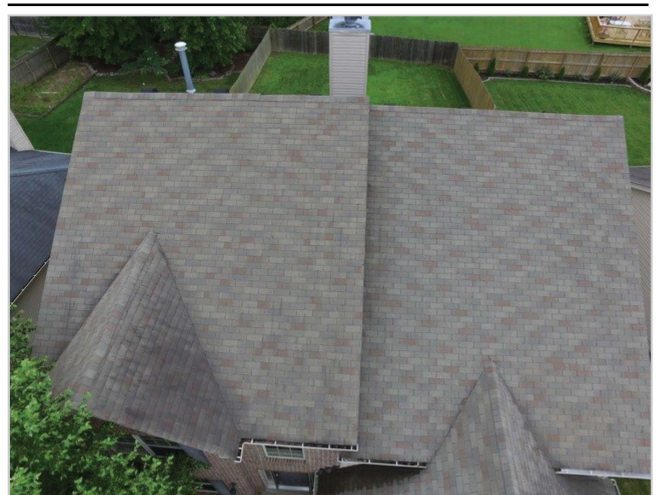
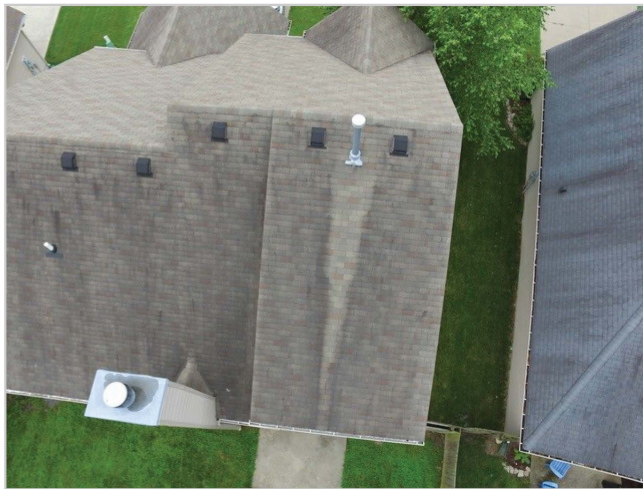
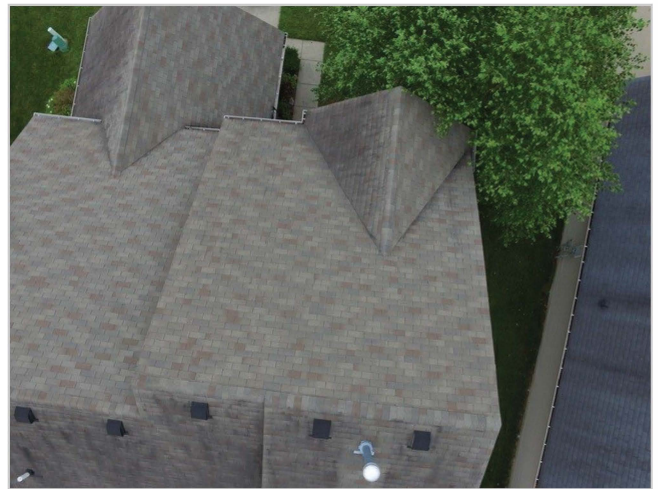
The roof shingles exhibited light curling and moderate surface wear. Several areas were tested for lifted edges, and lifted edges were not observed. Nail pops were observed. Evidence of a hail event was not observed.

These conditions indicate the roof shingles were in the second half of their useful life.

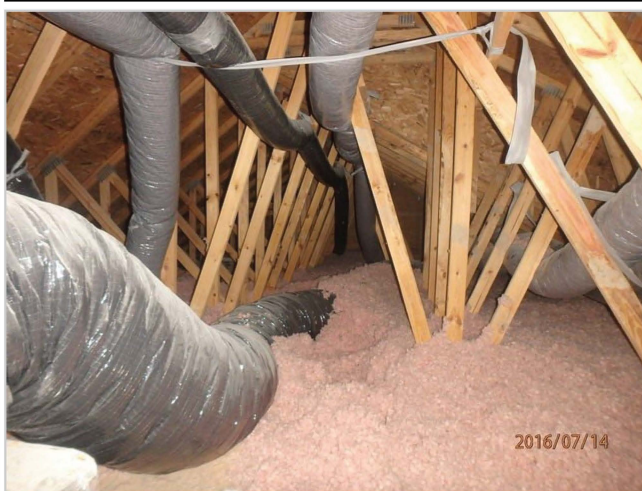
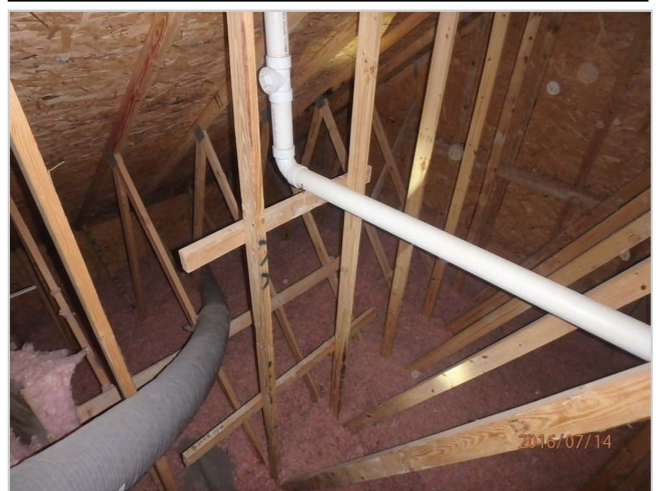
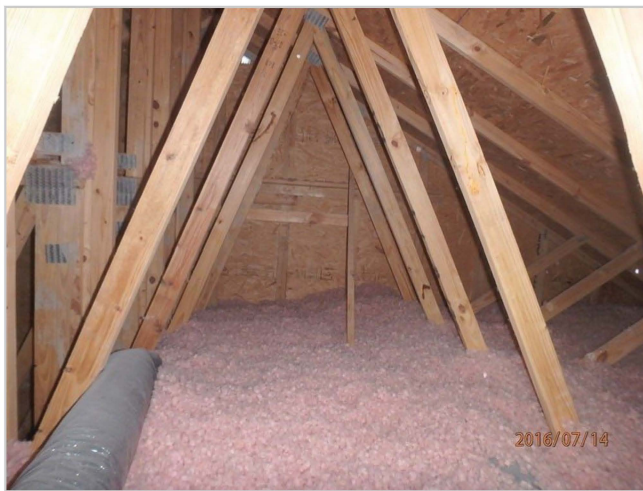
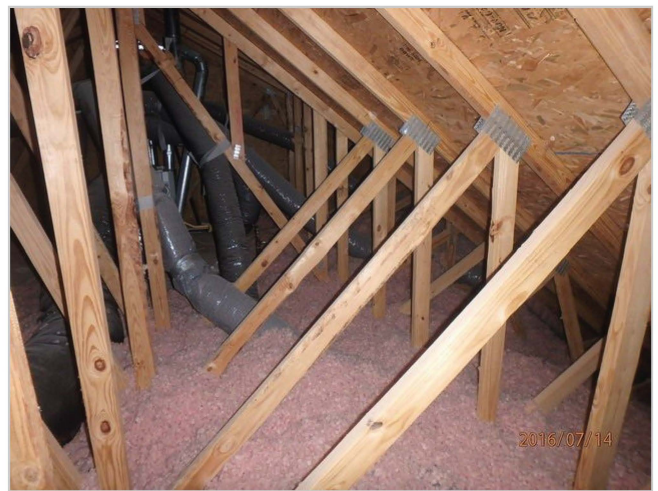
Parts of the attic show signs of previous water intrusion. The areas were dry at the time of the inspection. The buyer should maintain vigilance in monitoring the areas for any recurrence of the previous issue and should rectify any issues immediately upon observing them.

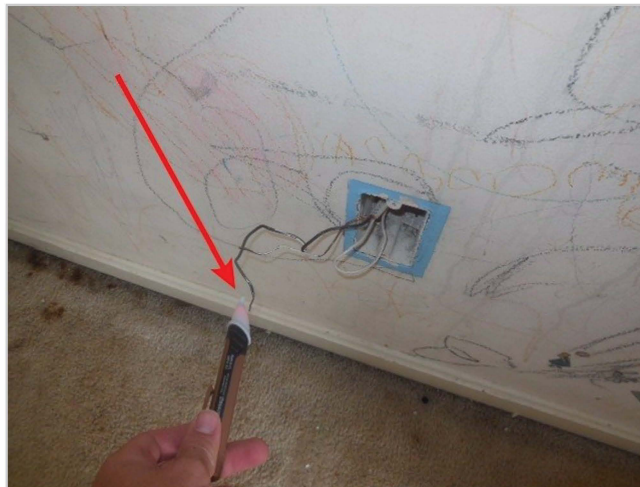
Photo 18

Exposed live wires were observed in the upstairs right bedroom. The wires should either be disconnected at the source or properly terminated in an approved, covered electrical box. Consult with a qualified electrician for repair and further assessment.

Exposed live wires.

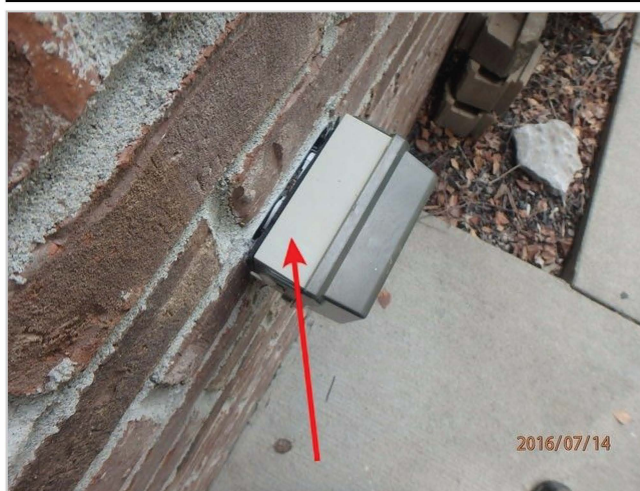
Photo 19

One exterior outlets were not properly covered, potentially allowing rainwater to enter the circuit. Outlet covers designed for use in wet locations should be installed on all exterior outlets.

outlet is not properly covered

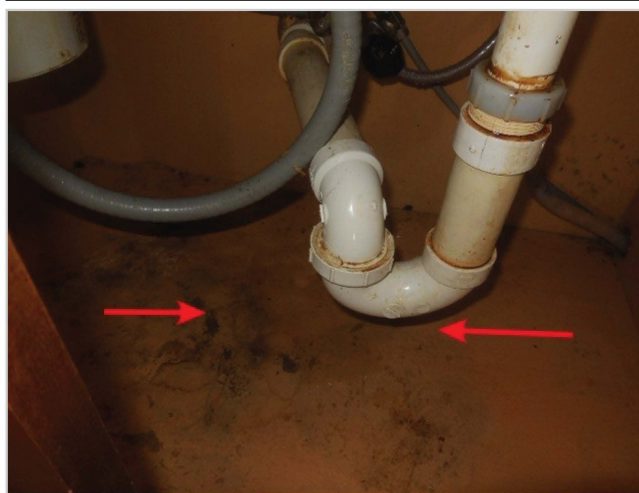
Photo 20

The drain line under the kitchen sink leaks and should be repaired to prevent further water intrusion. At

the time of repair, all drain lines should be further assessed.

Drain line leaks under the kitchen sink.

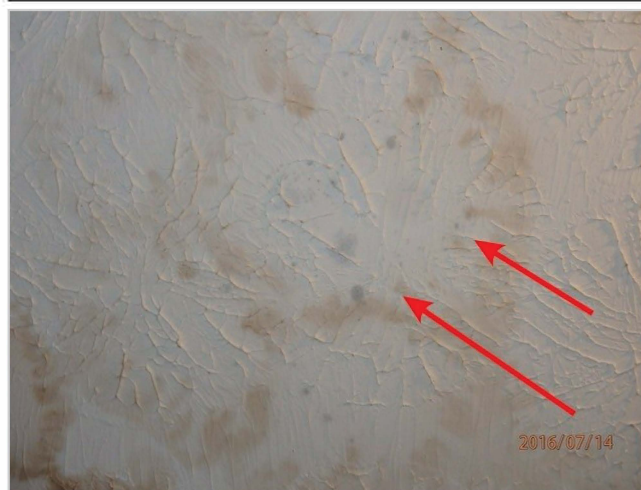
Photo 23

Mold-like growth is visible in the structure (garage). The EPA has helpful information that may assist the buyer (<http://www.epa.gov/mold/moldresources.html>). HomeTeam recommends having the areas tested to determine presence, type and relative concentration of mold spores, and professionally remediated by a reputable mold remediation company, which may include removing and replacing affected segments. A mold remediation company may uncover additional areas or issues requiring repair or remediation.

mold like growth in the garage

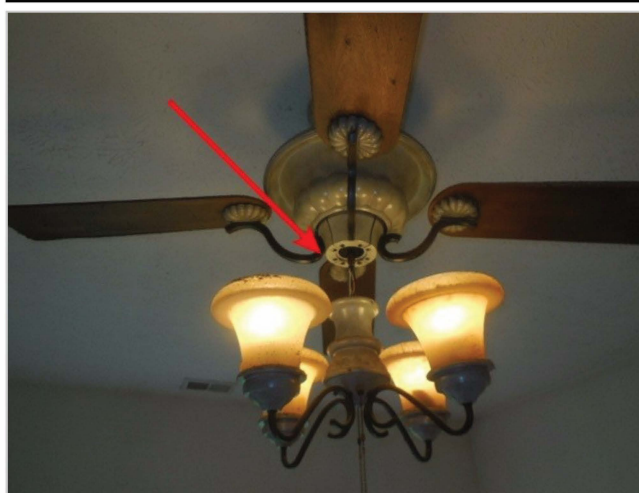
Photo 24

A light fixture in the master bedroom is loose and should be secured.

Loose light fixture.

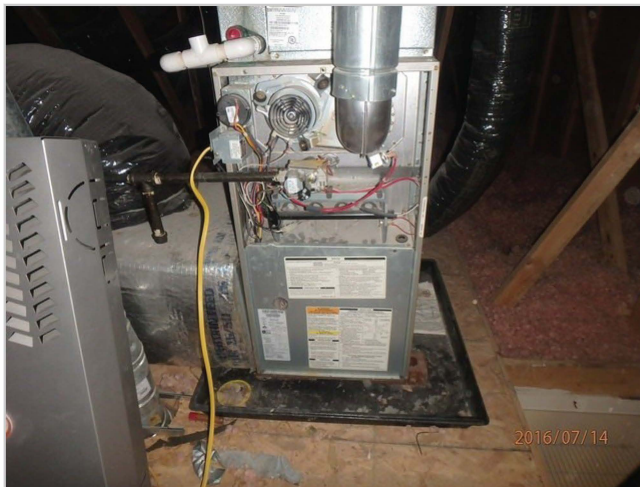
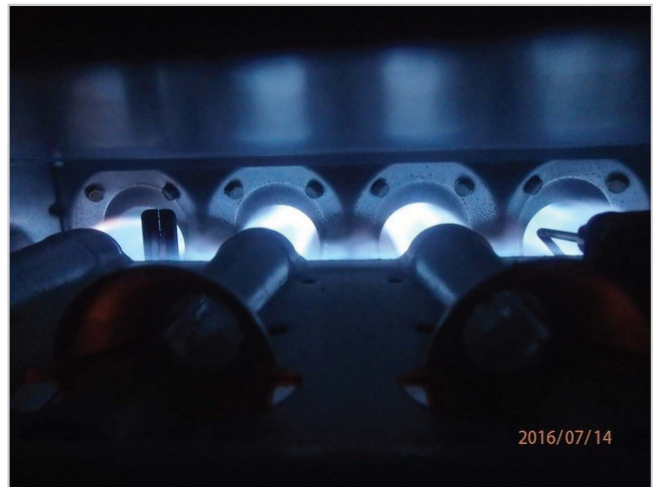
Because of its condition and performance at the time of the inspection, **the furnace requires cleaning and servicing by a professional HVAC technician.** At that time, the technician will test refrigerant levels, service the equipment to improve its performance, and perform other tests beyond the scope of the home inspection to assess and identify any additional areas that may require attention.
