HOME INSPECTION REPORT

**123 Sample Drive
Anytown, TX 55555**

PROPERTY INSPECTION REPORT

Prepared For:	Bill Sample	
	(Name of Client)	
Concerning:	123 Sample Drive, Anytown, TX, 55555	
	(Address or Other Identification of Inspected Property)	
By:	Inspector 1 Inspector 2	9-29-2017
	(Name and License Number of Inspector)	(Date)
	(Name, License Number of Sponsoring Inspector)

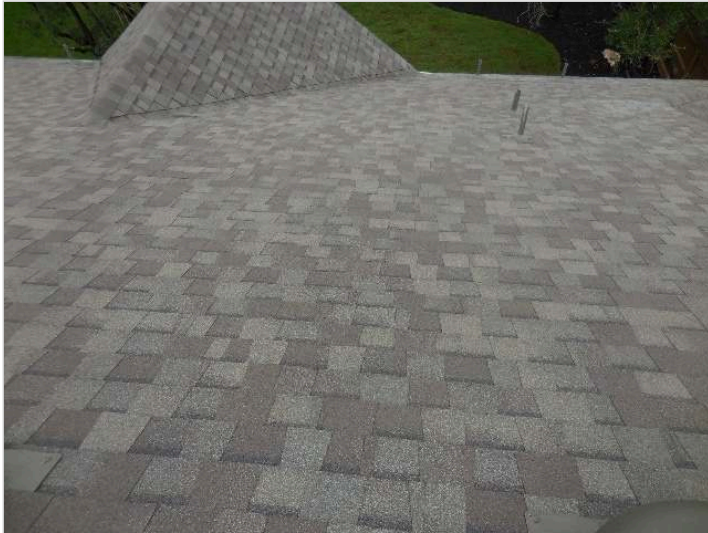
The roof appeared to be new.

View of roof covering (back).

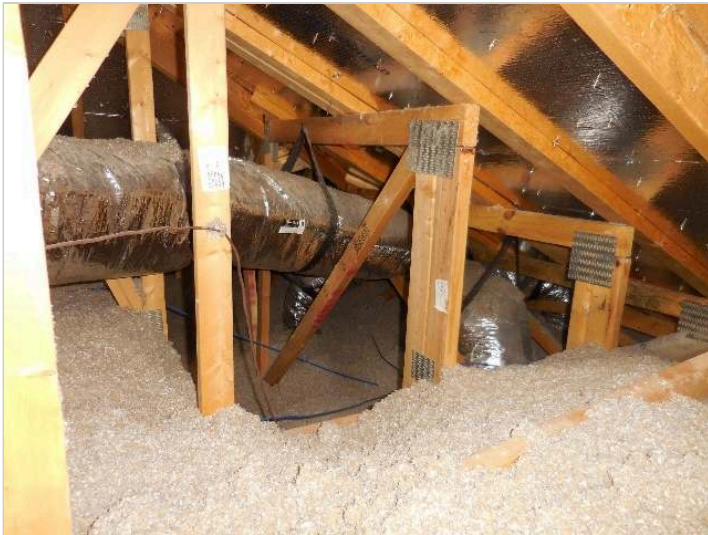
The attic was partially accessible. The roof structure was constructed of a 2x4 truss system with OSB with radiant barrier decking. It was ventilated with roof, gable and soffit vents.

View of upper attic space (over common room).

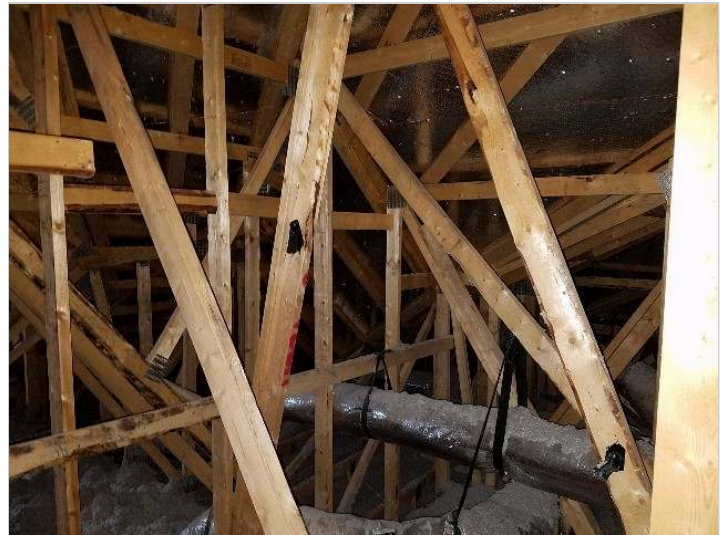
view of Texas attic space (left side).

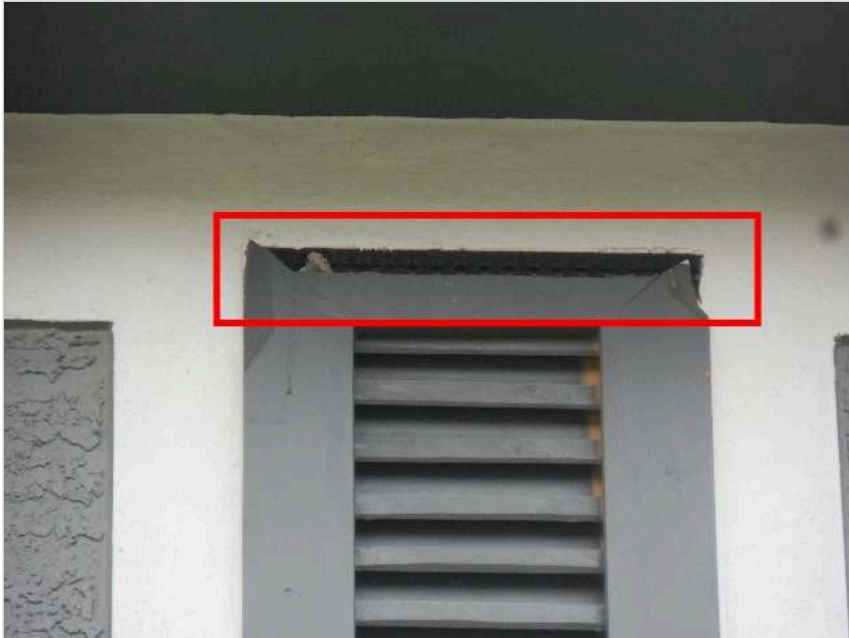
Trim was damaged at the top of the front facing gable vent. Recommend repairing and sealing.

Part of trim damaged/missing at front gable vent.

- Trim was damaged at the top of the front facing gable vent. Recommend repairing and sealing.
- The sub-panel cover in the utility room was causing some of the breakers to trip when the panel door was closed (door hitting breaker handles). Recommend adjustment.

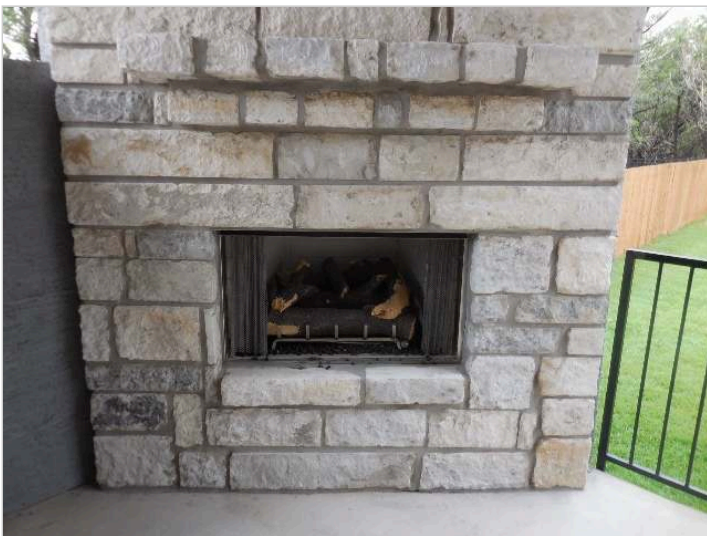
The ventless gas fireplace on the back exterior patio was proper.

View of patio fireplace.

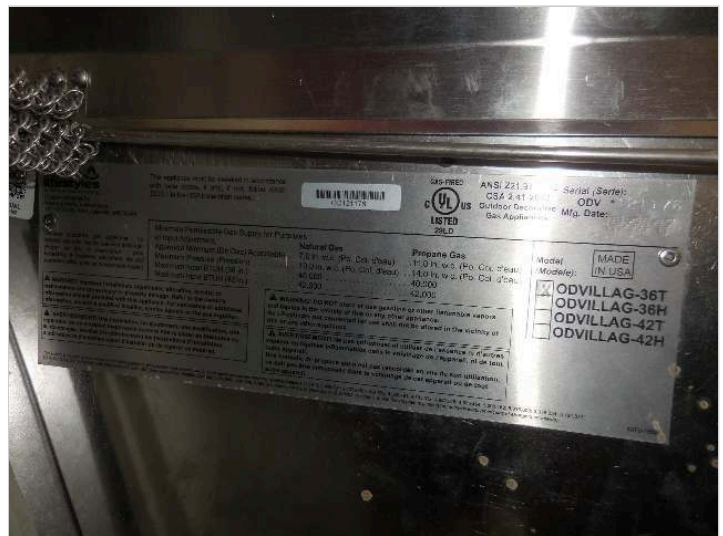
View of fireplace data plate.

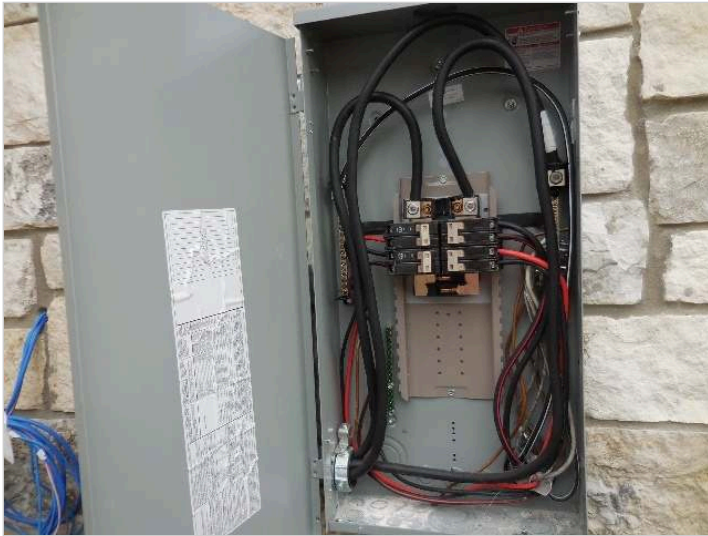
There was an underground service lateral with stranded aluminum wires to the main entrance panel located on the side of the house. An earth ground wire was present but we were not able to verify the grounding system. The feeder wires to the sub-panel(s) were both copper and aluminum. The sub-panel for the household branch circuits was located in the utility room.

View of main electrical panel.

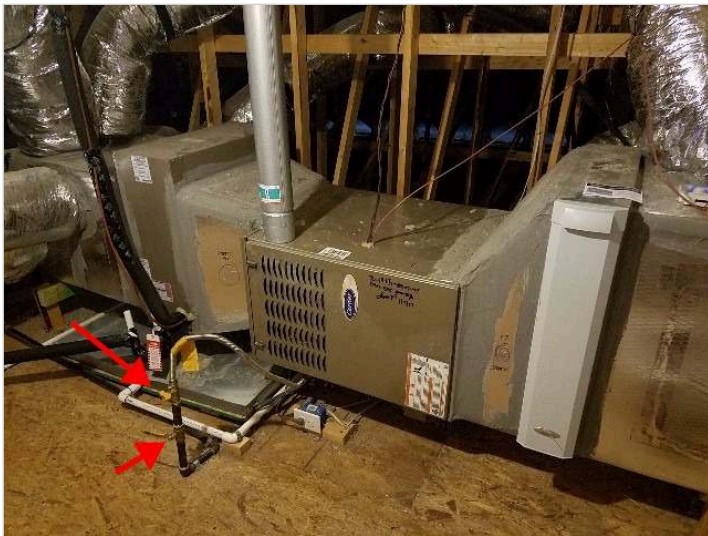
The heating units would not come on. Both unit gas valves and systems were OFF at the time of the inspection (at the units) and did not appear to be activated by the builder. After attempting to temporarily turn on the gas and units for testing they still did not respond. Recommend the builder activated the units (bleed gas lines) and demonstrate operation during final walk-through.

view of lower HVAC unit: gas and heater system off.

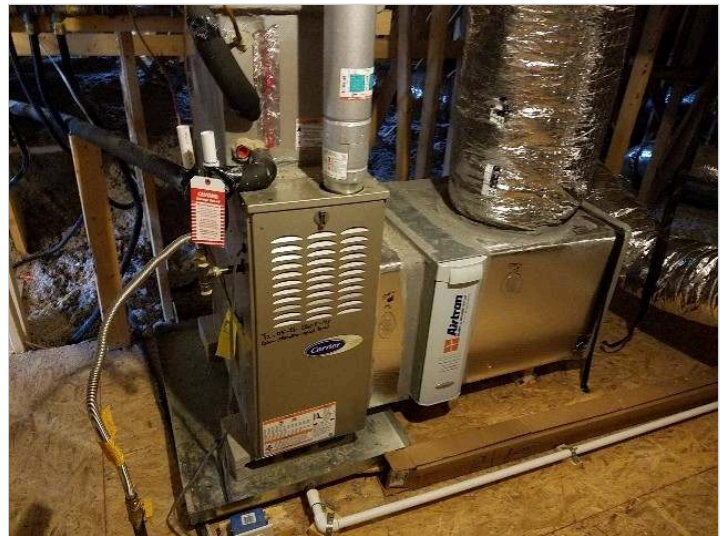
view of upper HVAC unit.

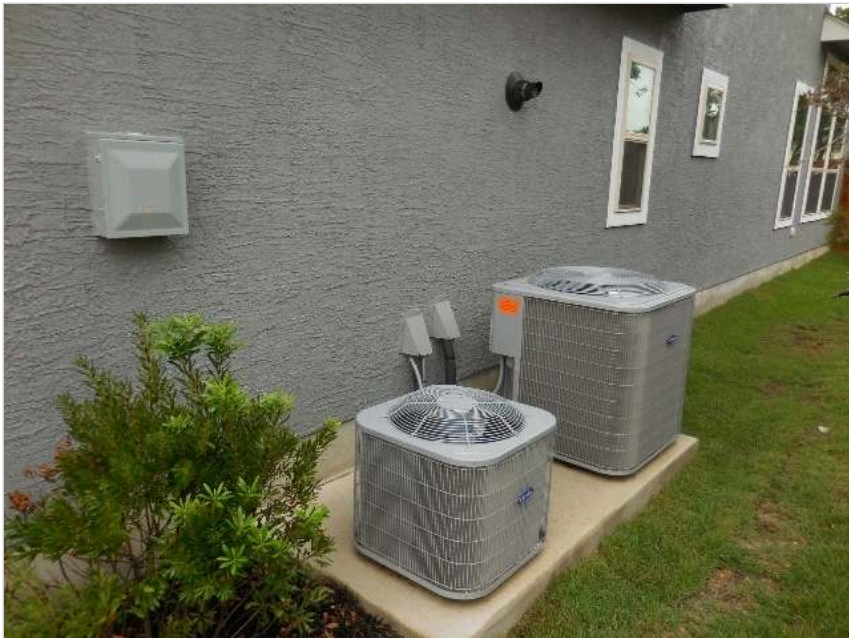
The HVAC exterior compressor and condenser unit(s) were manufactured in 2017 by Carrier.

The cooling unit(s) was/were functioning properly at the time of the inspection with a 15-20 degree temperature differential.

View of condenser units.

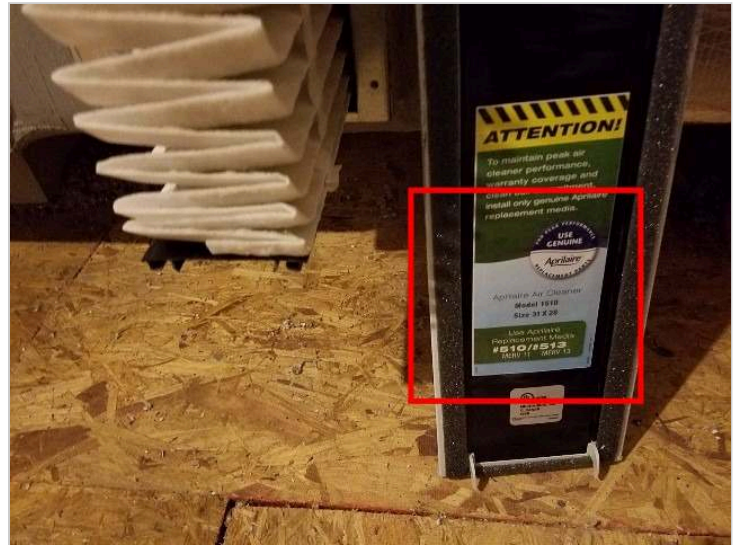
lower HVAC unit filter media type/size.

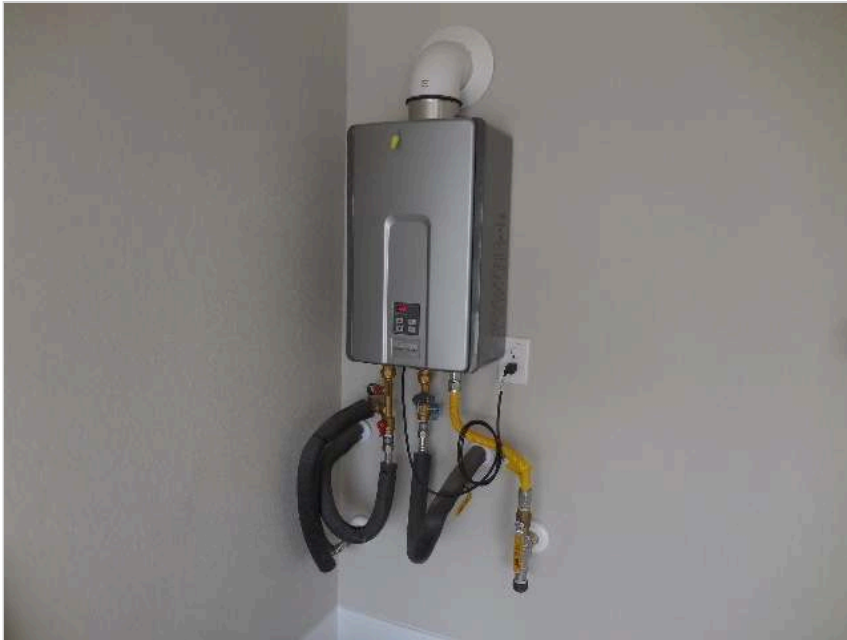
(none) There were no visible deficiencies noted on the water heater(s) at the time of inspection.

View of tankless water heater in garage.

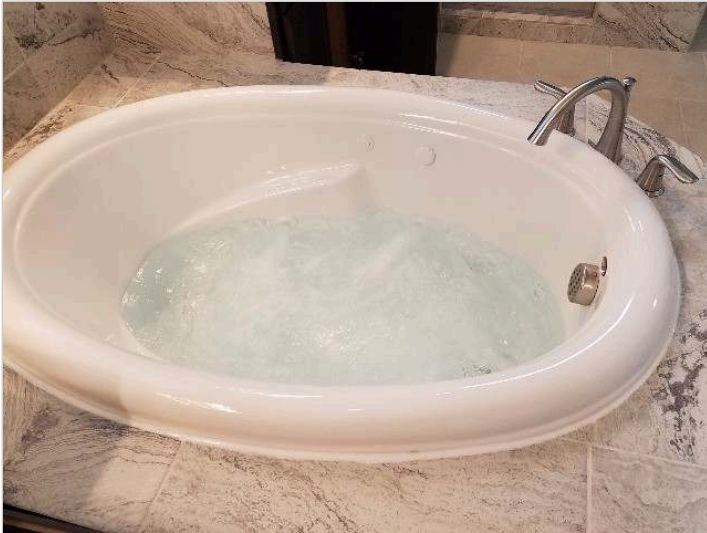
view of spa tub.

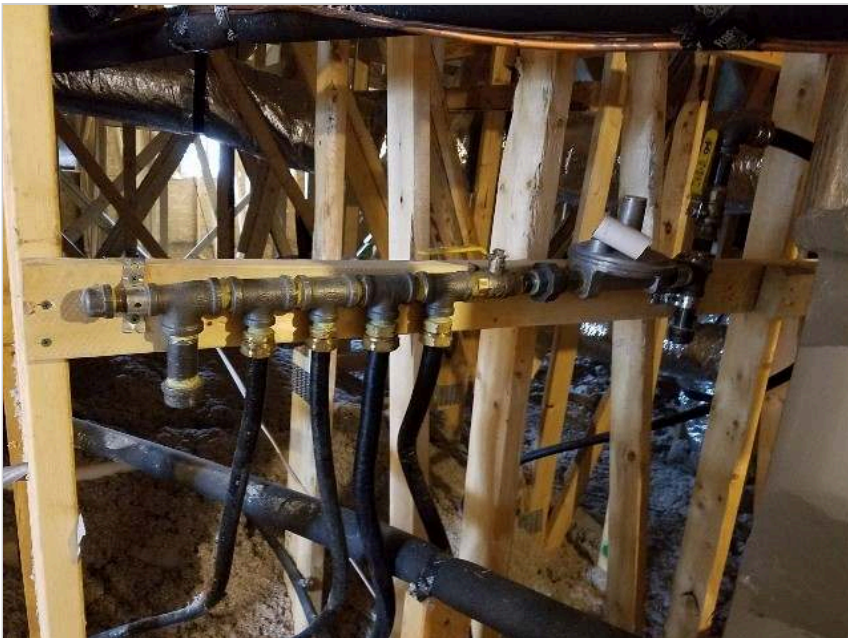
Corrugated Stainless Steel Tubing (CSST) was used in the gas supply system and we were unable to verify proper adherence to the manufacturer's bonding instructions. Bonding to the gas supply system was observed at the gas supply line next to the gas meter.

CSST manifold in attic space.

(New Homes with CSST) It is recommended that you consult with your builder and have them certify proper CSST bonding according to the specific manufacturers instructions. CSST Advisory Notes: The lack of suitable electrical bonding may increase the potential for lightning strikes to cause arcing at the CSST gas piping and may result in perforation of the piping, gas leaks, and fires. Proper adherence to the manufacturer's bonding instructions should lower the risk of electrical arcing and related damage. It is recommended that you retain a licensed electrician (or certified CSST specialist) for further evaluation of the installation and that corrective action be taken as needed.

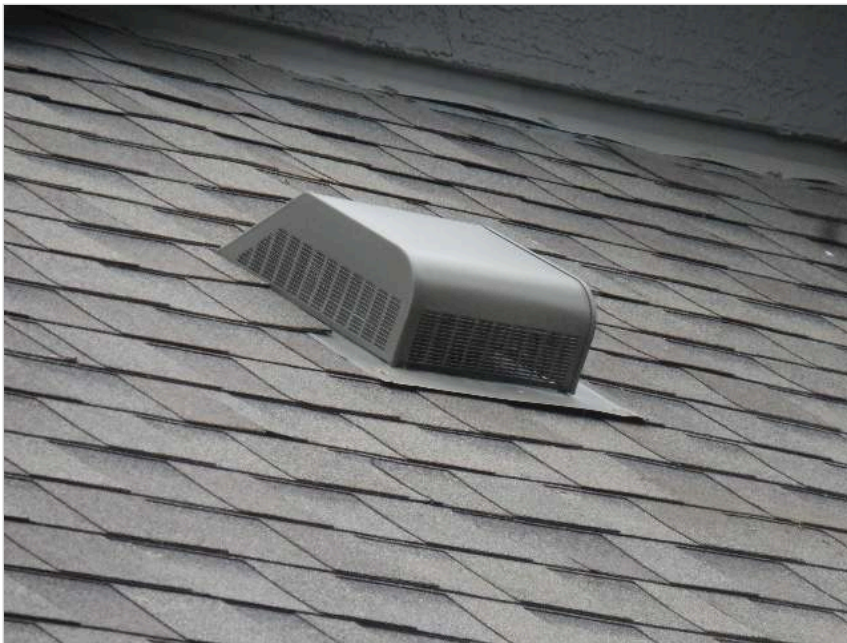
The dryer vent has a screened or grated termination cover which collects lint and is a potential fire hazard. Recommend removing and replacing with an appropriate dryer cover with back-draft damper

Screened dryer vent cover.
