HOME INSPECTION REPORT

On Wednesday, July 24, 2019 The HomeTeam Inspection Service made a visual inspection of 123 Sample Dr, Anytown, TN . Enclosed please find a written, narrative report of our findings in accordance with the terms of our Inspection Agreement. Although maintenance items may have been addressed verbally at the time of inspection, they may not be included in the enclosed report.

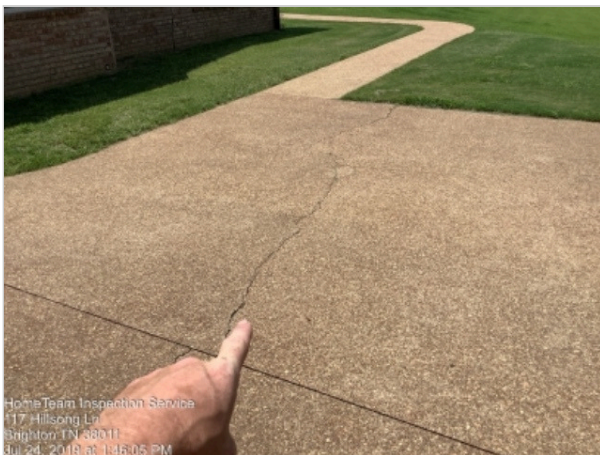
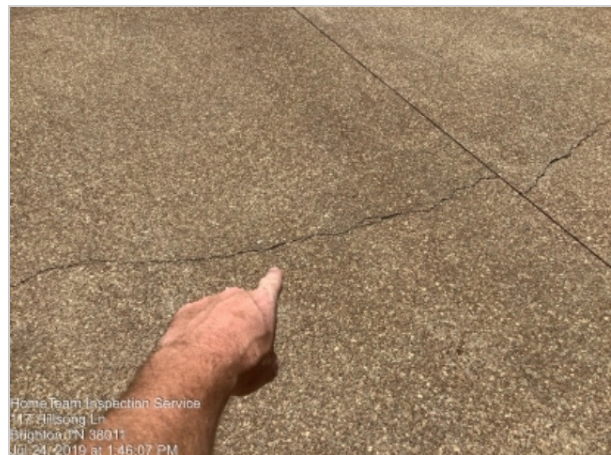
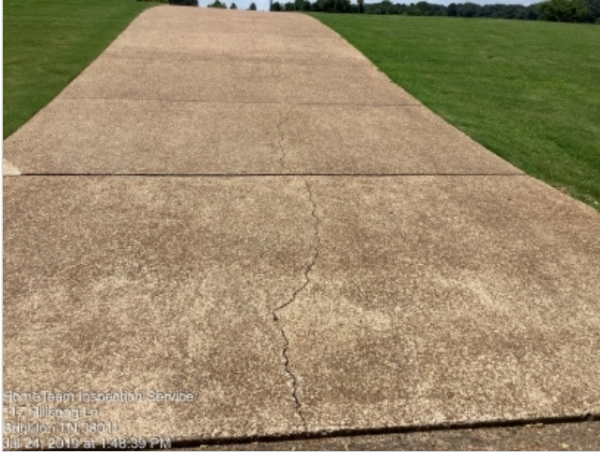
The driveway has several cracks. The cracks should be sealed to prevent moisture intrusion and further deterioration.

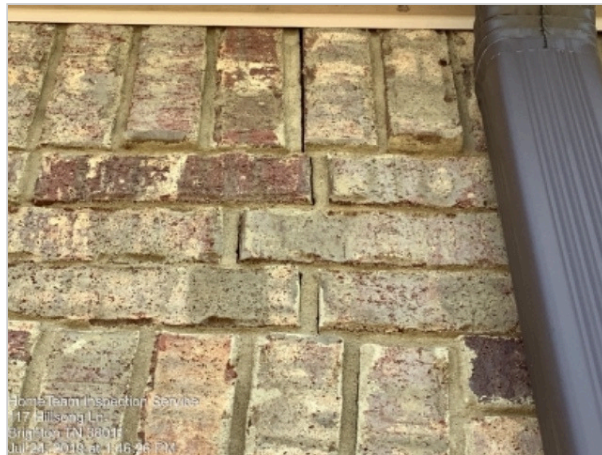
Photo 4

Cracks were present on the brick veneer of the structure. The cracks are common and do not usually have any structural significance. No structural concern on the brick veneer was noted. All cracks should be monitored for significant changes in characteristics. The cracks should be sealed to prevent water intrusion behind the brick. Location(s): the right side above garage door

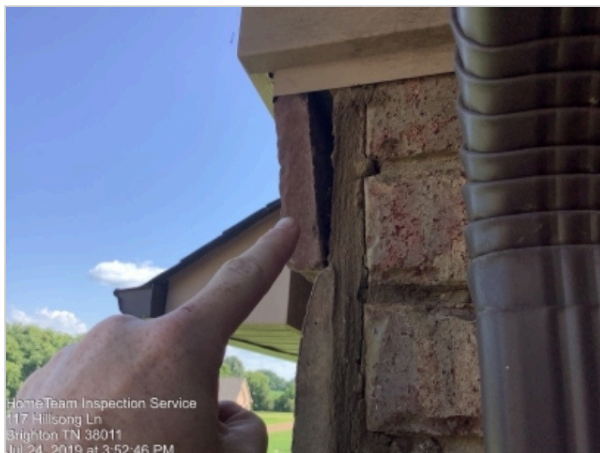
Photo 5

There was at least one loose stone on the front stone veneer. A qualified contractor should repair as necessary.

above front entry

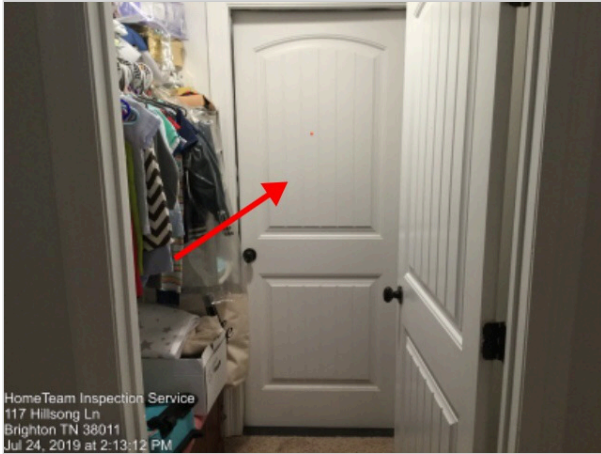
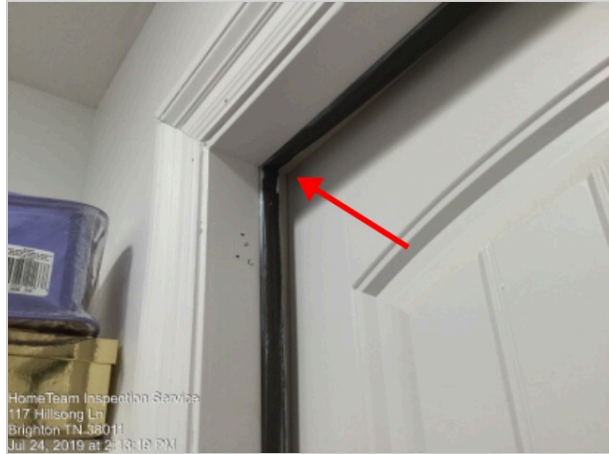
One door doesnot function properly.The door(s) require further evaluation and repair as necessary by a qualified contractor. Location(s): upstairs attic access

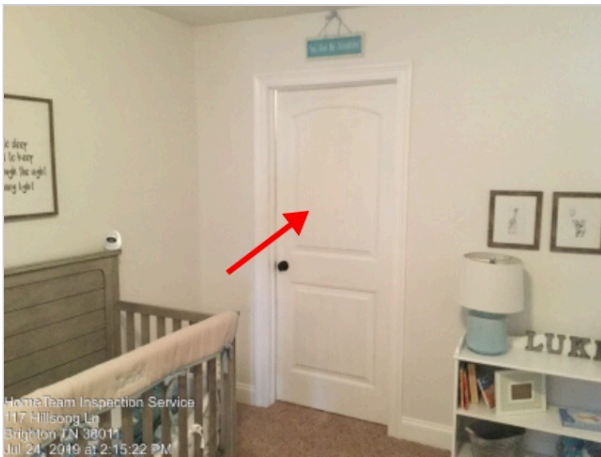
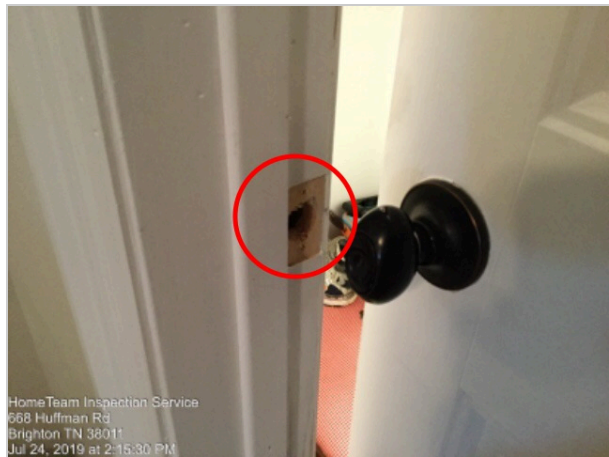
A door does not latch.The door, frame, and/or latching mechanism should be adjusted to allow for proper operation of the door. Location(s): upstairs front left bedroom closet

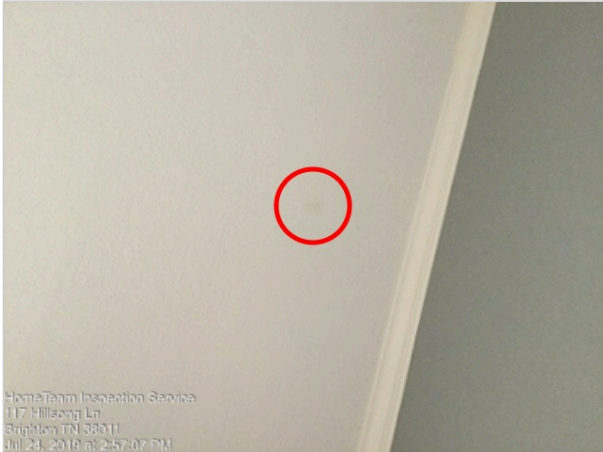
living room

Water stains were present on the ceiling of the structure.The cause of the stains was not identified by the inspector. The areas were dry at the time of the inspection and should be monitored for any future moisture. This is an indication of past or periodic water entry, leaks, or condensation. It is not possible for the inspector to identify hidden damage. The conditions that lead to the stains may not be present at the time of inspection. HomeTeam recommends a licensed general contractor for further evaluation to determine the cause, if there is any damage, and any repairs needed. Location(s): living room, kitchen, upstairs middle right bedroom

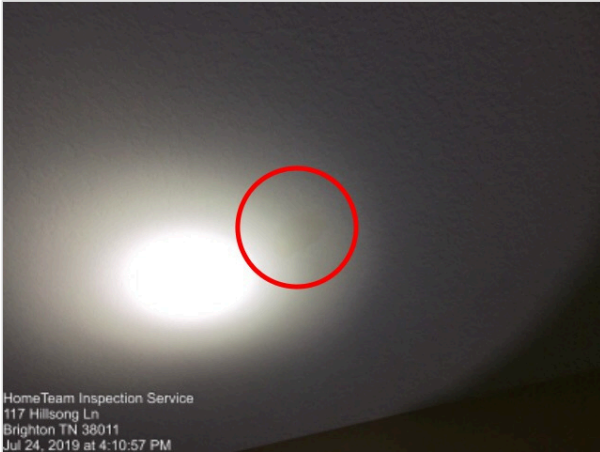
Water stains were present on the ceiling in the upstairs front left bedroom and the downstairs front left bedroom. Moisture was present at these locations at the time of inspection. HomeTeam recommends that a qualified contractor further evaluate and repair as necessary.

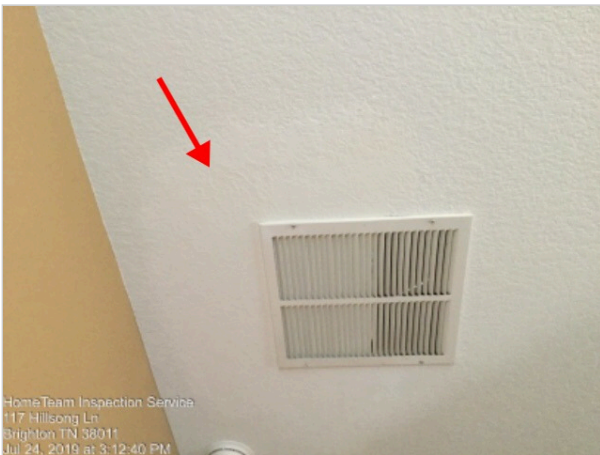
front left bedroom

NOTE: Previous repairs are evident in the structure's ceiling. The presence of repairs does not indicate any current or ongoing issue. However, HomeTeam is not able to see behind areas of repair and is unable to determine if the cause of the previous damage has been corrected. Monitor and correct as needed. Location(s): front left bedroom, kitchen

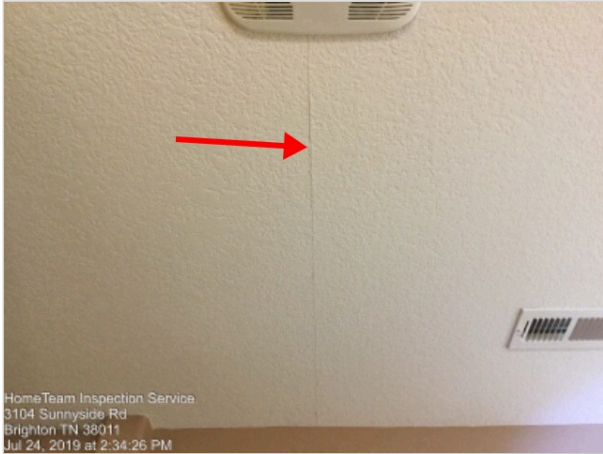
master bath

Small cracks were observed on the ceiling. There is no structural concern in these areas. It is recommended that a qualified professional be hired to repair the cracks if desired. Monitor the area(s) for any changes. If changes are observed, consult with a qualified contractor for further evaluation and possible repair.

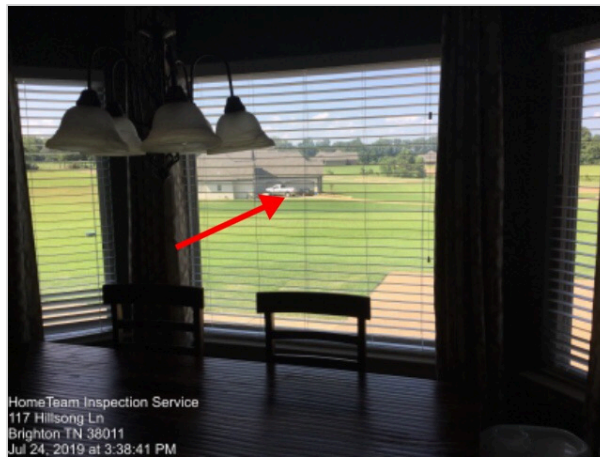
One of the windows in the structure was identified as having a broken thermal seal. A window with a defective thermal seal will show a slow but gradual "fogging" effect, and the insulation value of the window is marginally reduced. Changing conditions such as temperature, humidity, lighting as well as external water spots and soiling can limit the ability to visually review windows for broken seals. Therefore, conditions indicating a broken or compromised seal may not be apparent or visible at the time of the inspection. HomeTeam recommends having the affected window(s) repaired or replaced and all windows further assessed by a qualified window specialist. Location(s): kitchen

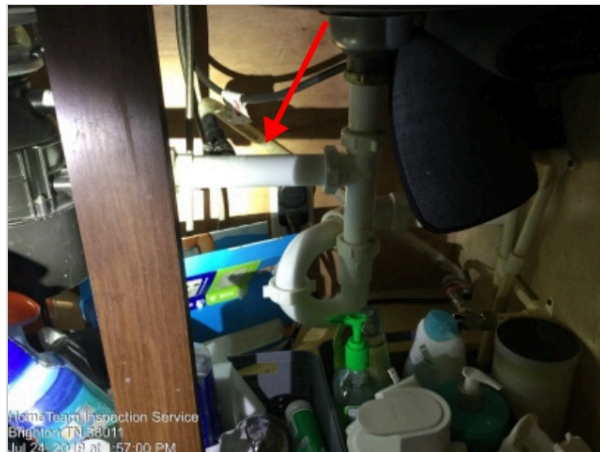
Photo 29

The dishwasher's drain hose is not equipped with an anti-siphon valve (air gap) and may not be configured in a way to prevent a back-flow of grey water into the dishwasher. Consult with the manufacturer to determine if this particular model requires an air gap or external high loop (some are integrated and are not visible). If so, HomeTeam recommends having an anti-siphon valve (air gap) installed or the drain hose looped higher than the attachment point of the drain hose (high loop) to the disposal/plumbing drain to prevent grey water returning back into the dishwasher. A qualified person should repair as necessary.

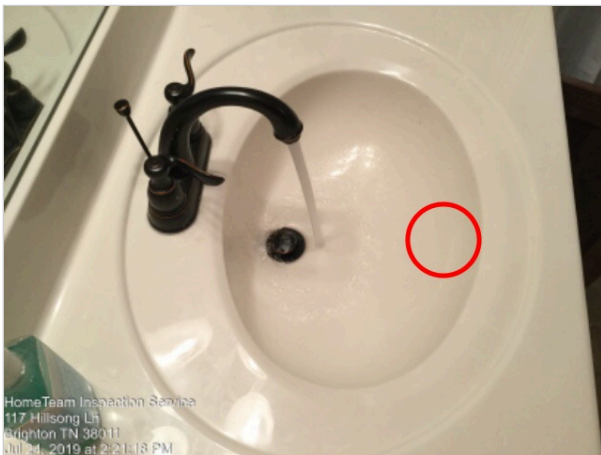
upstairs left sink

The upstairs bathroom sinks do not have an emergency overflow drain. This is more of an informational note rather than a defect. Without the overflow drain in place, there is potential for water to overflow if left unattended with the stopper in place. If this is a concern, consult with a qualified contractor for options.

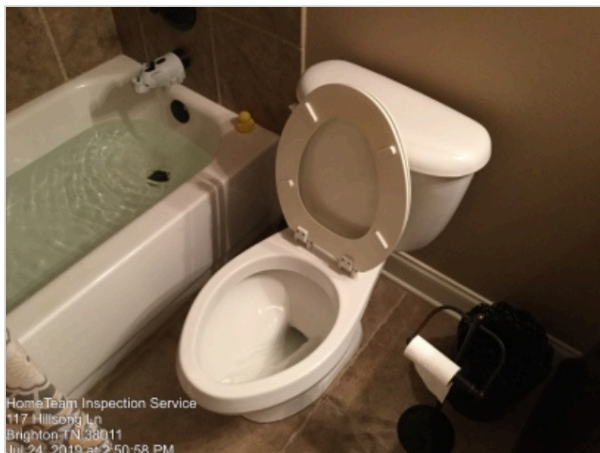
Photo 33

The toilet in the downstairs hall bath is loose. Failure to secure the toilet may lead to leakage around the wax ring. The toilet should be secured by a qualified contractor.

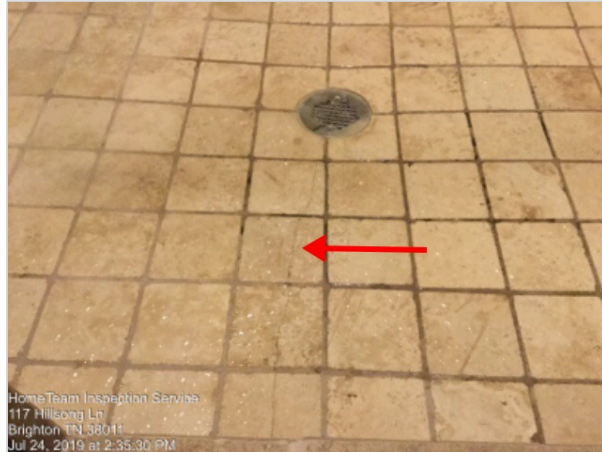
Photo 35

Several tiles on the shower floor were cracked. This appears to be mainly cosmetic but inspectors could not see the condition of the pan beneath the tile. If this is a concern, repair as necessary.

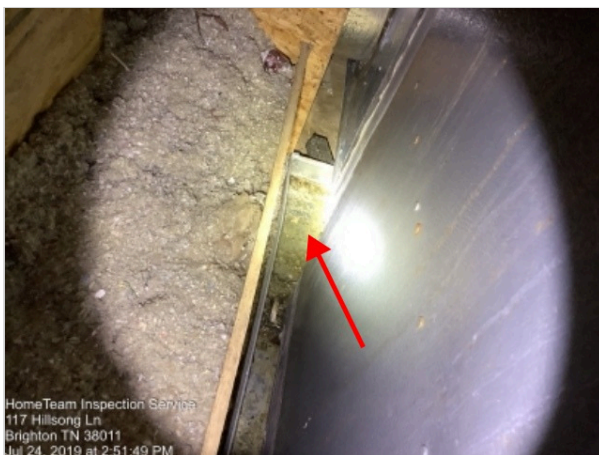
Photo 42

There is water in the catch pan beneath the furnace. This indicates there is a problem with the condensate drainage system. A licensed heating and air specialist should further evaluate and repair as necessary.

small amount of water in pan

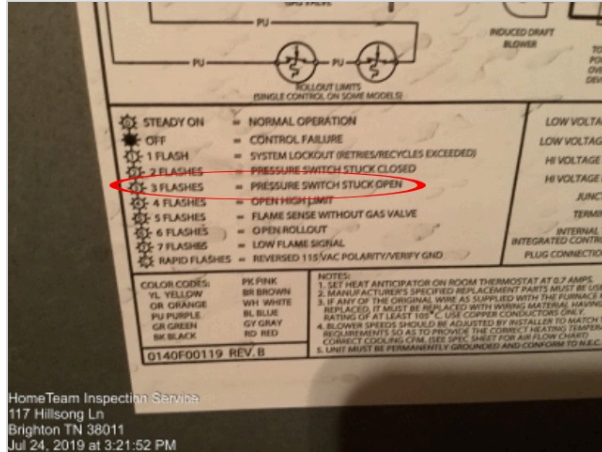
Photo 43

Because of its condition and performance at the time of the inspection, the downstairs furnace requires servicing by a professional HVAC technician. The furnace did not ignite when the thermostat called for heat. At that time, the technician will test refrigerant levels, service the equipment to improve its performance, and perform other tests beyond the scope of the home inspection to assess and identify any additional areas that may require attention.

furnace showing 3 flashes and there was water in pan
