# HomeTeam<sup>®</sup>

### HOME INSPECTION REPORT

The HomeTeam Inspection Service made a visual inspection of 123 Main Street, Anytown, USA 55555. Enclosed please find a written, narrative report of our findings in accordance with the terms of our Inspection Agreement.

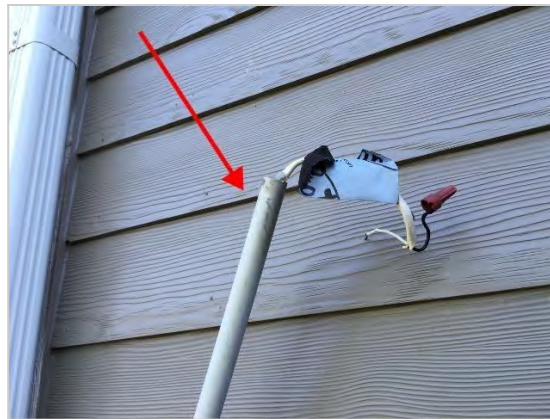
Photo 2

**Exposed or un-terminated live wires were observed on the exterior.** The wires should either be disconnected at the source or properly terminated in an approved, covered electrical box. Consult with a qualified electrician for repair and further assessment.
