HomeTeam[®]

HOME INSPECTION REPORT

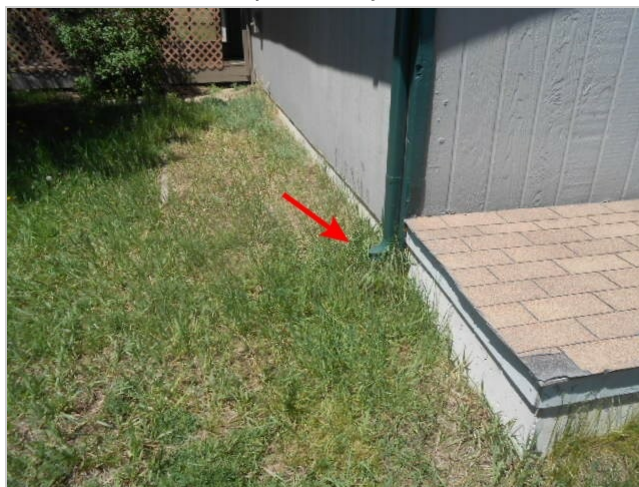
One of the downspouts on the left, rear of the home was missing the extension. This condition can allow for rain water to accumulate along the home and the possibility of water in the crawlspace if not repaired.

- One of the downspouts on the left, rear of the home was missing the extension. This condition can allow

for rain water to accumulate along the home and the possibility of water in the crawlspace if not repaired.

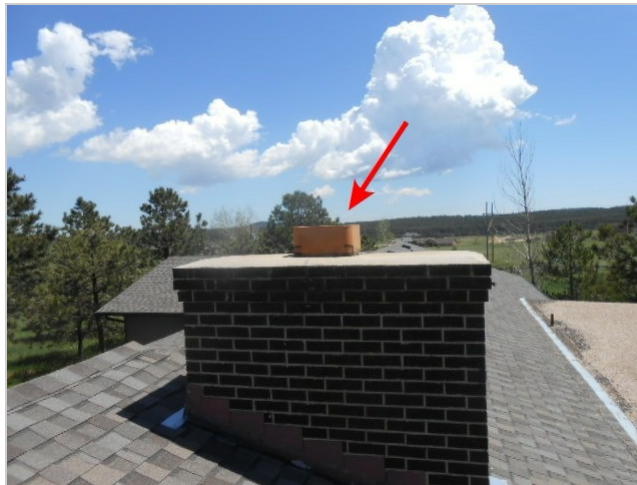
There was no rain hat on the chimney. This device is recommended to be installed by the seller (prior to closing) to prevent animals or rain water from entering the chimney and fireplace flue and causing damage to the home or to the metal flue damper inside the chimney.

- There was no rain hat on the chimney. This device is recommended to be installed by the seller (prior to closing) to prevent rain water from entering the chimney and fireplace flue and causing water damage to the home or to the metal flue damper inside the chimney.
