**RE: 555 Sample Dr.
Sample, OH 45069
Inspection #: 001-000000-0000**

File Number: **001-000000-0000**
Address of Inspection: **555 Sample Dr.**

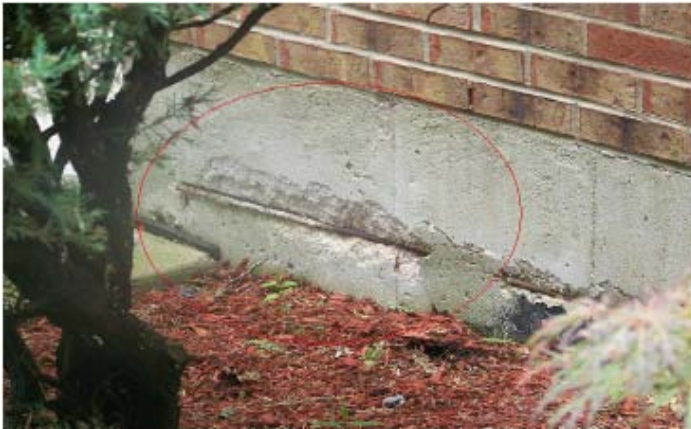
NOTE: The right side of home has an area on the concrete foundation that should be sealed.

There was normal settlement cracks observed on the foundation. These cracks did not appear to have any structural significance at the time of the inspection. There were no major visual defects observed on the visible portions of the foundation.
