HOME INSPECTION REPORT

**123 Sample Drive
Anytown, TX 55555**

PROPERTY INSPECTION REPORT

Prepared For:	Bill Sample	
	(Name of Client)	
Concerning:	123 Sample Drive, Anytown, TX, 55555	
	(Address or Other Identification of Inspected Property)	
By:	Inspector 1 Inspector 2	9-29-2017
	(Name and License Number of Inspector)	(Date)
	(Name, License Number of Sponsoring Inspector)

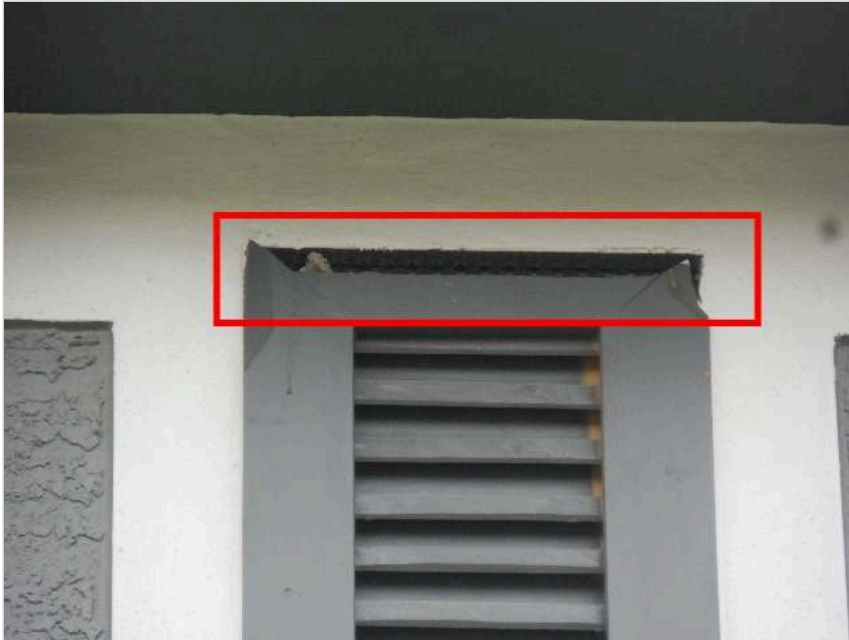
Deficiencies:
 Trim was damaged at the top of the front facing gable vent. Recommend repairing and sealing.

Part of trim damaged/missing at front gable vent.

- Trim was damaged at the top of the front facing gable vent. Recommend repairing and sealing.
- The sub-panel cover in the utility room was causing some of the breakers to trip when the panel door was closed (door hitting breaker handles). Recommend adjustment.

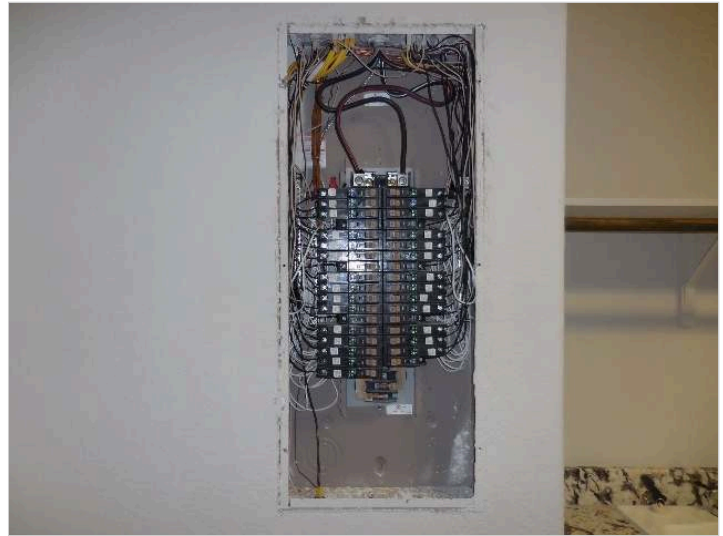
The sub-panel cover in the utility room was causing some of the breakers to trip when the panel door was closed (door hitting breaker handles). Recommend adjustment.

View of sub panel in utility room.

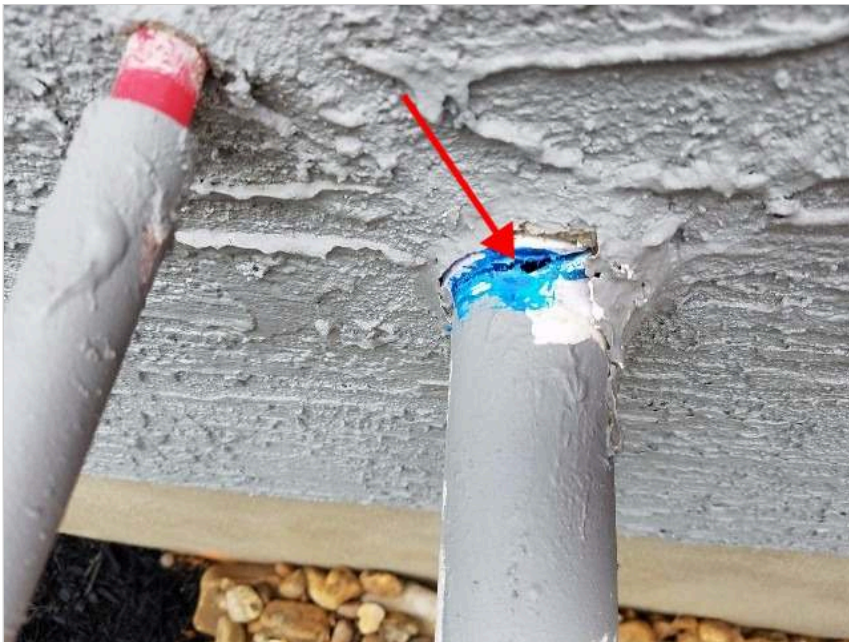
The drain line installed for an exterior back sink was broken at the wall and ineffectively glued back into place. Recommend properly repairing drain line.

Back exterior drain line broken.

- The upper right bathroom toilet fill/float valve has a small leak (water ran continuously). Recommend replacement or repair.
- The drain line installed for an exterior back sink was broken at the wall and ineffectively glued back into place. Recommend properly repairing drain line.

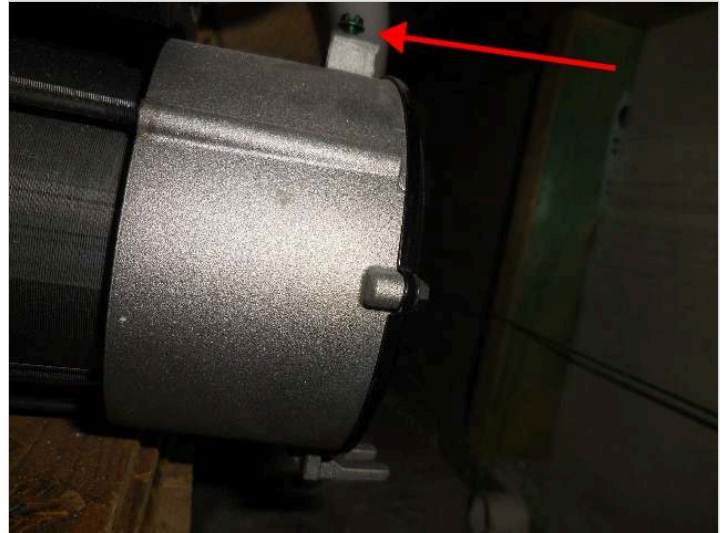
The spa tub pump was not properly bonded/grounded (or unable to determine).

Spa tub motor not bonded.
