HOME INSPECTION REPORT

The HomeTeam Inspection Service made a visual inspection of 123 Main Street, Anytown, USA 55555. Enclosed please find a written, narrative report of our findings in accordance with the terms of our Inspection Agreement.

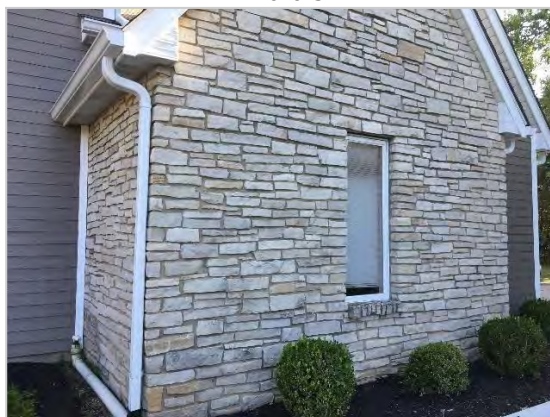
Photo 3

NOTE: The structure has a manufactured stone veneer (MSV) cladding. Structures with MSV can develop moisture intrusion problems even when properly constructed according to industry standards. The problem can develop because of moisture buildup behind the veneer that is unable to drain, and this moisture can cause significant structural damage that is not visible during a non-destructive test. Specific areas of concern include areas around the windows that may have been subjected to prolonged water exposure. Other areas of likely penetration are around chimneys, decks, and any other penetration points. Water intrusion is more likely at these points. In all cases, HomeTeam recommends having MSV-clad structures professionally inspected by an MSV-qualified technician prior to purchase and again each year. Typically, this type of test involves drilling several holes and inserting moisture meters to determine if any moisture is present behind the veneer.

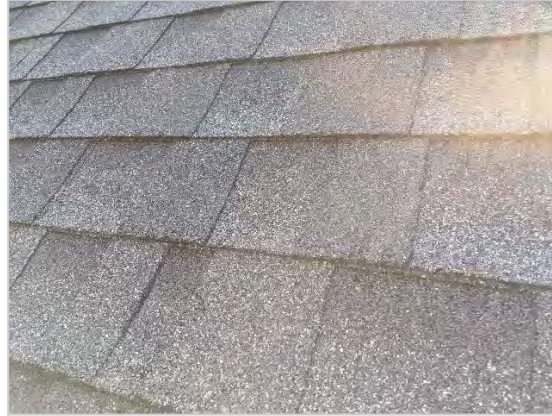
Photo 5

The roof shingles exhibited no curling and light surface wear. Several areas were tested for lifted edges, and lifted edges were not observed. Nail pops were not observed. Evidence of a hail event was not observed.

These conditions indicate the roof shingles were near the middle of their useful life.
