HomeTeam[®]

HOME INSPECTION REPORT

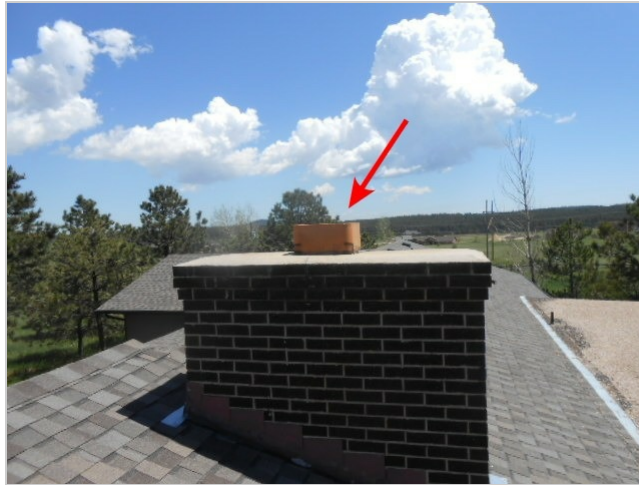
There was no rain hat on the chimney. This device is recommended to be installed by the seller (prior to closing) to prevent animals or rain water from entering the chimney and fireplace flue and causing damage to the home or to the metal flue damper inside the chimney.

- There was no rain hat on the chimney. This device is recommended to be installed by the seller (prior to closing) to prevent rain water from entering the chimney and fireplace flue and causing water damage to the home or to the metal flue damper inside the chimney.

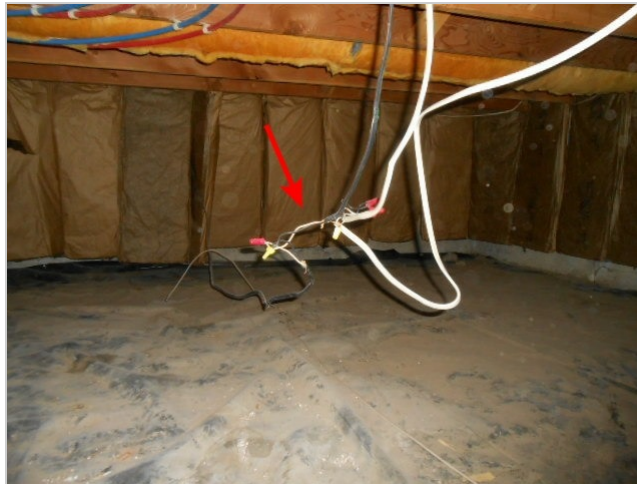
There were a few open splices noted throughout the crawlspace at the time of inspection. Open splices consist of wires joined together outside of a junction box or loose wiring. This is a safety concern which should be corrected by a qualified electrician prior to closing.

Open spliced wiring in the crawlspace.
