HOME INSPECTION REPORT

The HomeTeam Inspection Service made a visual inspection of 123 Main Street, Anytown, USA 55555. Enclosed please find a written, narrative report of our findings in accordance with the terms of our Inspection Agreement.

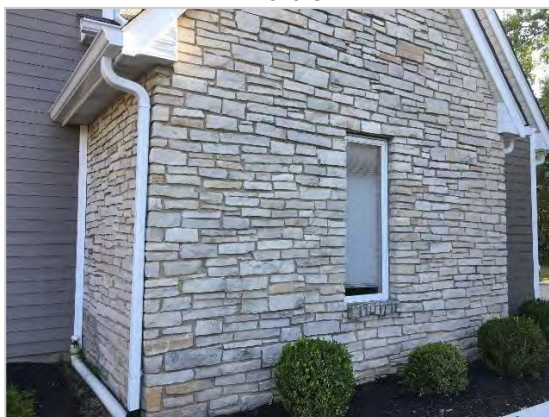
Photo 3

NOTE: The structure has a manufactured stone veneer (MSV) cladding. Structures with MSV can develop moisture intrusion problems even when properly constructed according to industry standards. The problem can develop because of moisture buildup behind the veneer that is unable to drain, and this moisture can cause significant structural damage that is not visible during a non-destructive test. Specific areas of concern include areas around the windows that may have been subjected to prolonged water exposure. Other areas of likely penetration are around chimneys, decks, and any other penetration points. Water intrusion is more likely at these points. In all cases, HomeTeam recommends having MSV-clad structures professionally inspected by an MSV-qualified technician prior to purchase and again each year. Typically, this type of test involves drilling several holes and inserting moisture meters to determine if any moisture is present behind the veneer.
