HOME INSPECTION REPORT

Address of Inspection: **1111 Sample Dr**

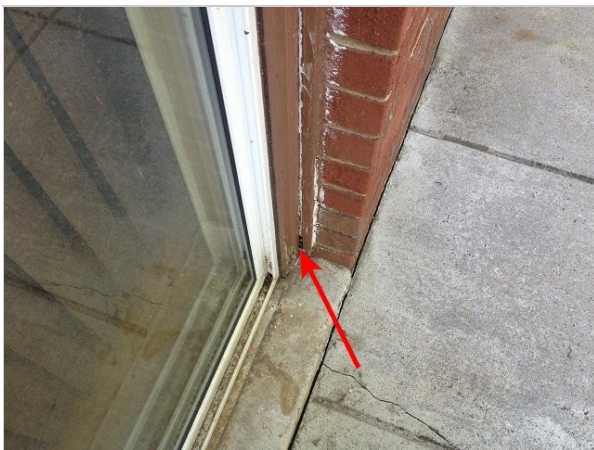
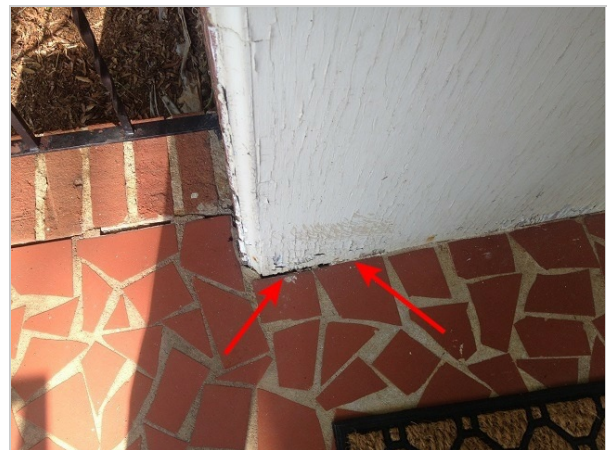
1. Wood rot and/or decay damage found on the paneling, casing and/ or sill around the doors/windows in the following location/s of the property: (A) casing around the rear patio door; (B) left panel on the front porch. Conducive to allowing water infiltration to the wall sheathing, floor structure and wall framing. Needs further evaluation and repair by a licensed general contractor.

- Wood rot and/or decay damage found on the paneling, casing and/ or sill around the doors/windows in the following location/s of the property: (A) casing around the rear patio door; (B) left panel on the front porch. Conducive to allowing water infiltration to the wall sheathing, floor structure and wall framing. Needs further evaluation and repair by a licensed general contractor.

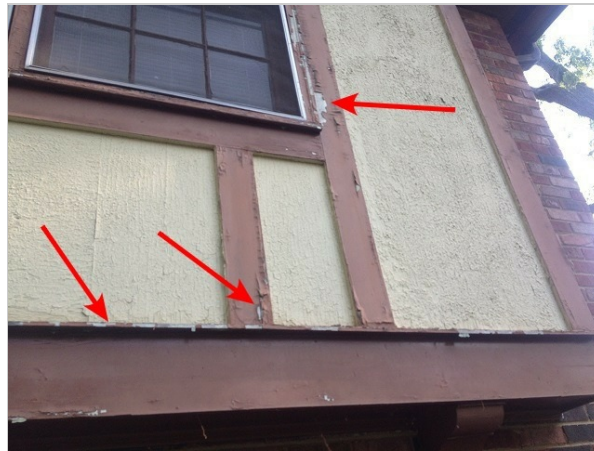
Figure 3

- The paint was peeling of exterior surface at the multiple locations-conducive for wood deterioration. Needs proper repair by a painting contractor.

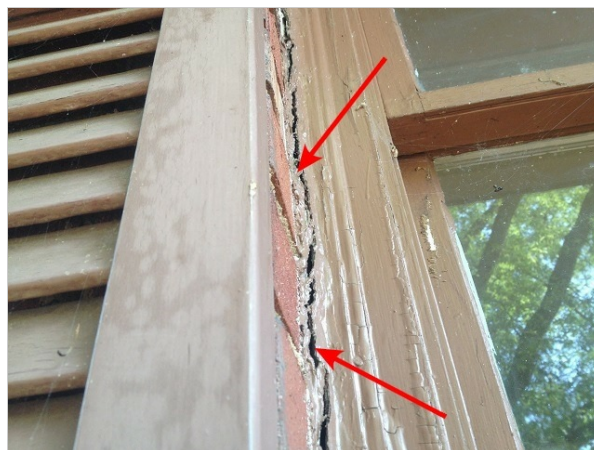
Figure 4

- Caulk is missing and/or deteriorated between the window jambs and brick walls - seen around front left window. Recommend caulking around windows to prevent ingress of water and increase the heating and cooling coast of the home.

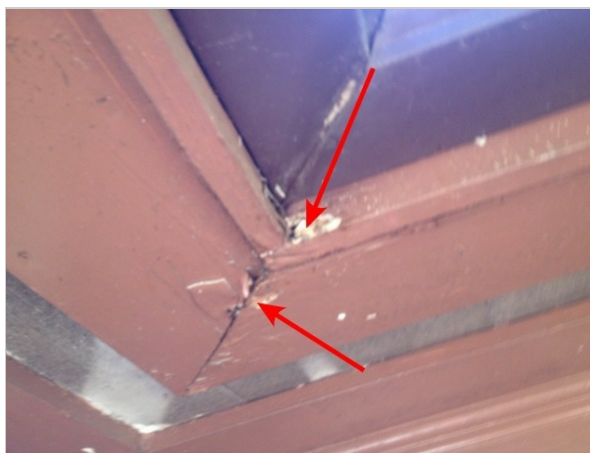
Figure 5

- Wood rot and/or decay damage found on the roof fascia/soffit boards in the following locations of the property:
(A) over the rear porch-conducive to allowing moisture damage the roof structure. Recommend a Licensed General Contractor evaluate further and repair/replace where necessary.

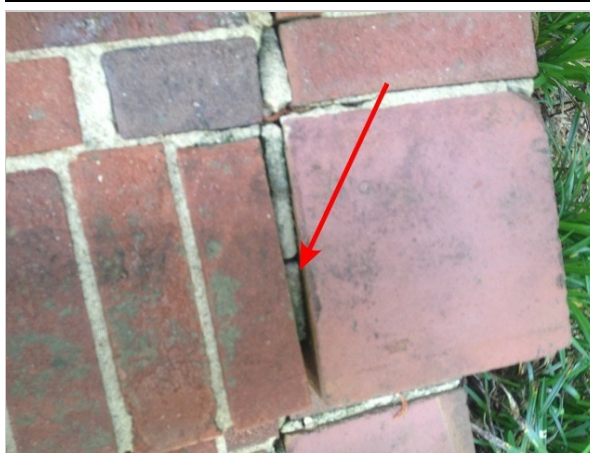
Figure 6

- Deteriorated/loose mortar between the brick/s at the rear porch entrance steps. This can become a potential tripping hazard. Recommend repair/replace deteriorated/loose mortar between brick/s where necessary.

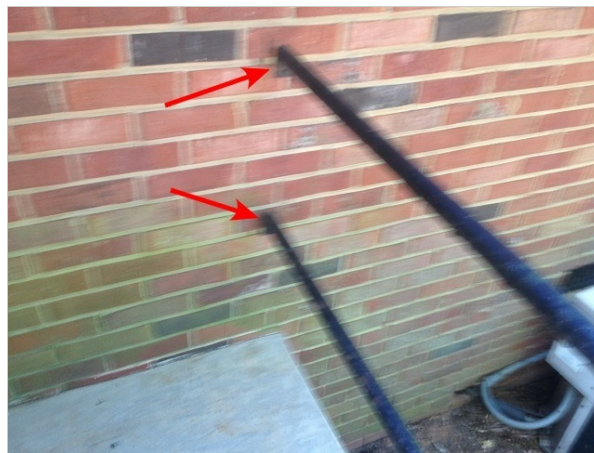
Figure 7

- The handrail on the rear porch / steps is not secure at the wall. This can become a potential tripping hazard. Recommend repair/resecure handrail where necessary.

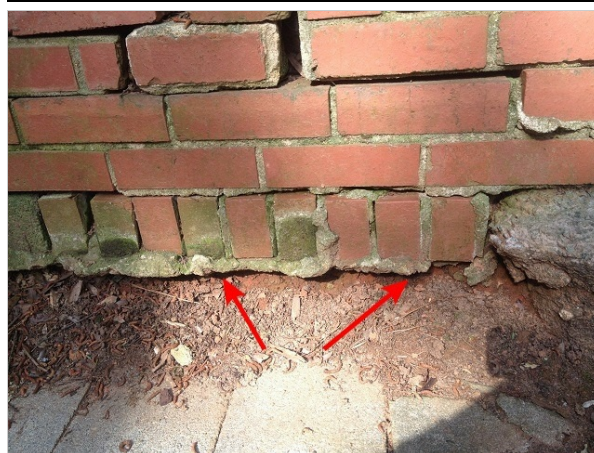
Figure 8

- The ground was washed out under the retaining wall on the left side of the rear patio. Considered as a safety hazard due to potential wall movement. Needs repair by a general contractor.

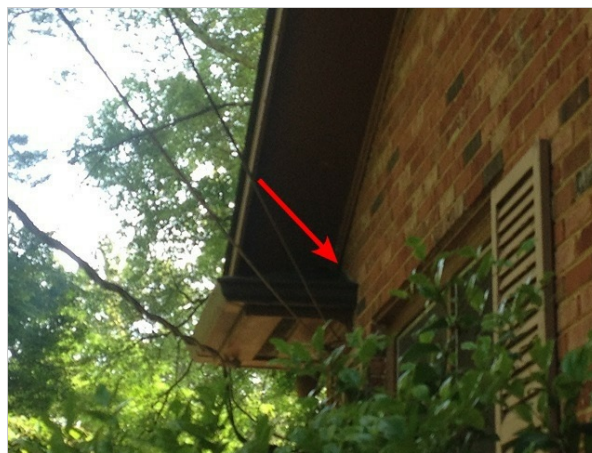
Figure 9

- There is no flashing where a portion of the roof abutts the house, observed in the following location: (A) around cornice roof on the left side of the house. Moisture intrusion into the property in this location would be possible, if left as is. Recommend a licensed Roofing Contractor evaluate and install flashing where missing or

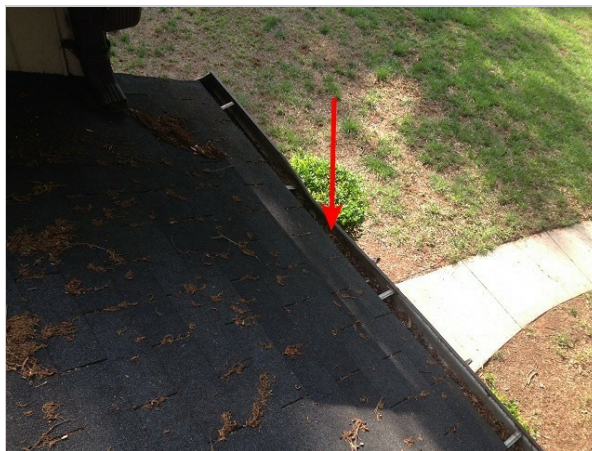
Figure 10

- The gutters on the house need to be serviced, such as cleaning, re-securing them, sealing seams, etc. Improperly functioning gutters can cause foundation problems.

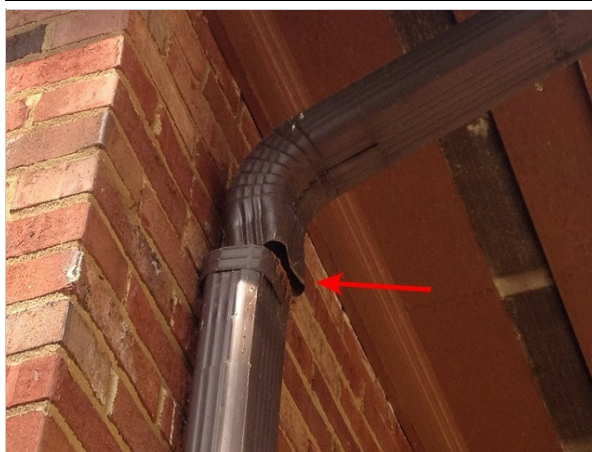
Figure 11

- One or more downspouts are loose or detached. This can result in water accumulating around the structure's foundation, or in basements and crawl spaces if they exist. Accumulated water is a conducive condition to wood destroying insects and organisms, and may also cause the foundation to settle and possibly fail over time. Recommend making repairs as necessary so downspouts are securely anchored and functional.

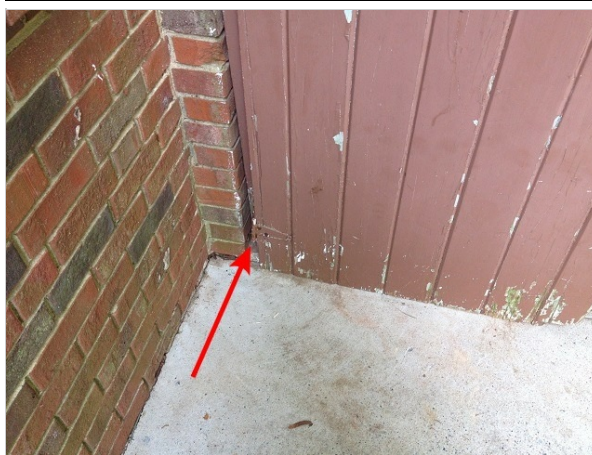
Figure 12

- Crawlspace access door was found to be loose and unsecured. Recommend resecure access door to prevent ingress of vermin and birds.

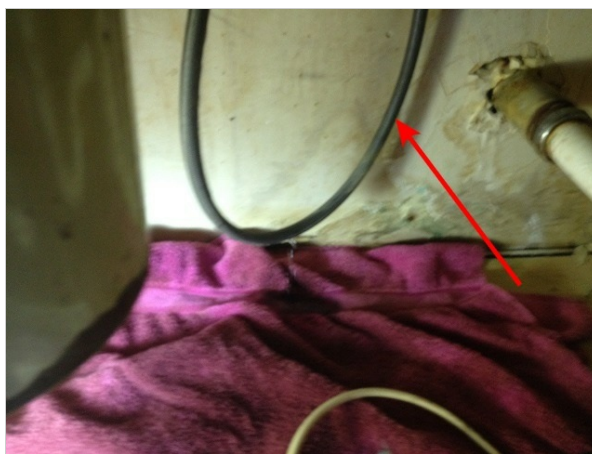
Figure 13

- The kitchen faucet was leaking under the sink. Needs repair by a licensed plumbing contractor.

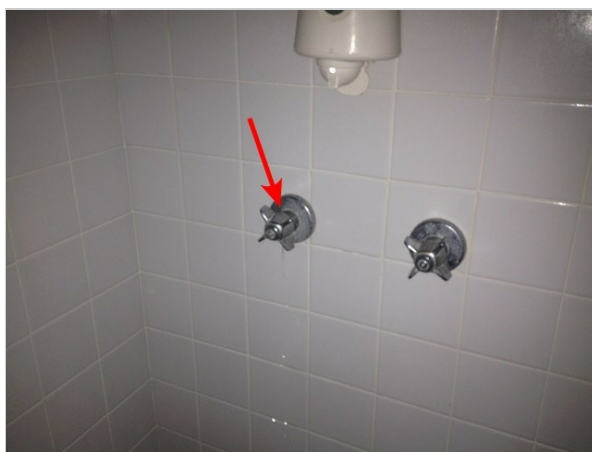
Figure 14

- The shower faucet in the master bathroom leaks around the stem while in use. Needs repair by a licensed plumbing contractor.

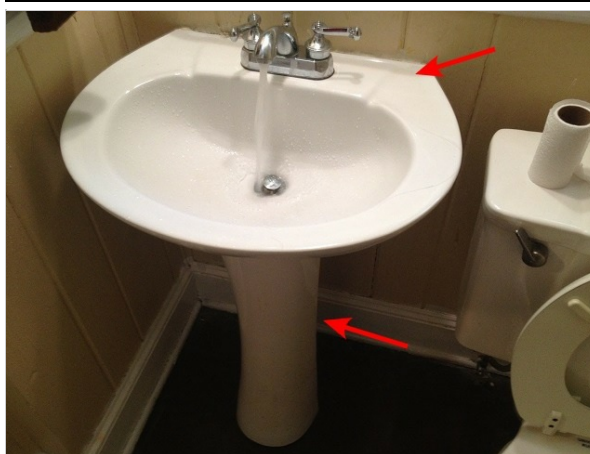
Figure 15

- The sink and pedestal were loose at the wall in the bathroom on the lower level. Needs repair by a licensed

plumbing contractor.

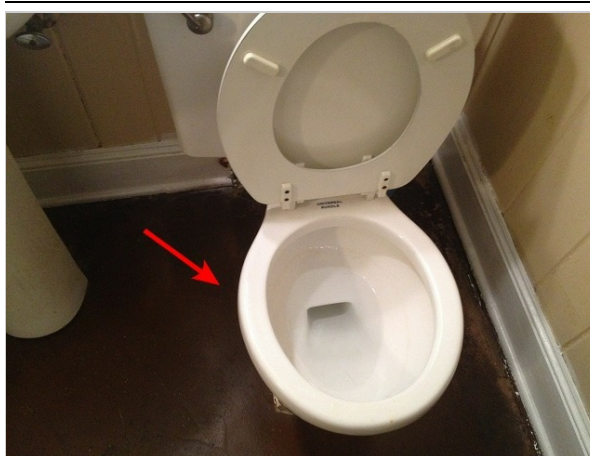
Figure 16

- Toilet found loose at the base and needs reanchoring - found in the following location:(A) in the lower bathroom. Any toilet that shows evidence of leaks or is loose and easy to move, should be remounted with a new wax ring seal to prevent potential leaks and water damage to the floor system and structure below. Visible evidence of floor stain marks and/or rot damage below the toilet may only become noticeable when the wax ring seal is replaced. Recommend repair/replace as required so toilet is securely fastened to the floor.

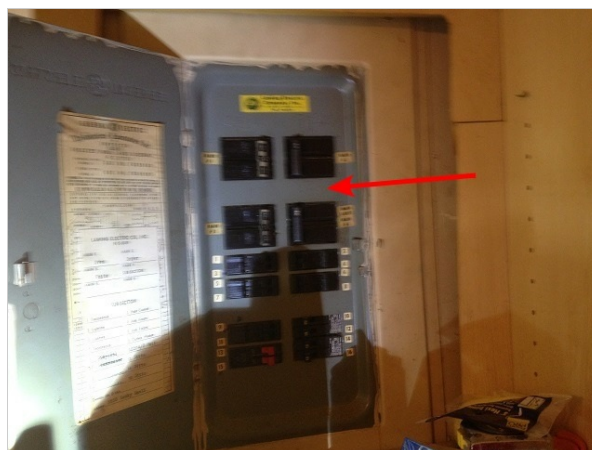
Figure 17

- The main panel was built in inside the cabinet and was not accessible for inspection. Recommended to have panel accessible and have the licensed electrical contractor to evaluate the panel.

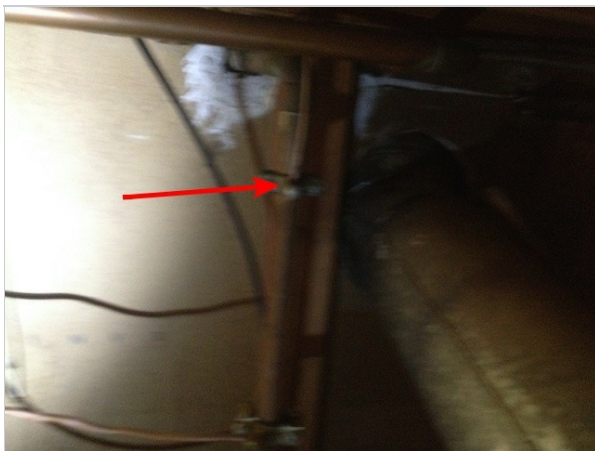
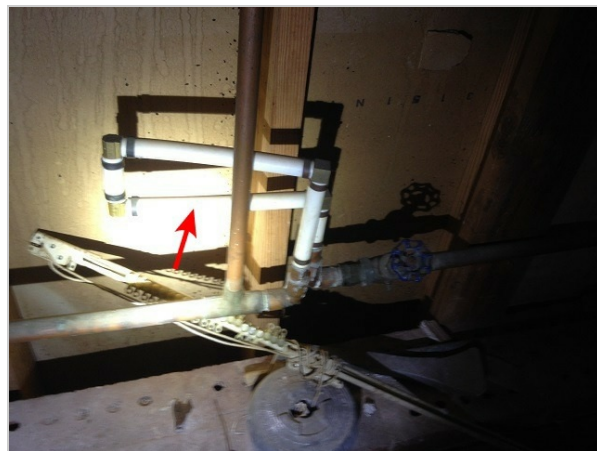
- The panel ground to a water pipe has been nullified by a plastic water main. Either an auxiliary ground should be established, or the panel should be regrounded. Needs repair by a licensed electrical contractor.

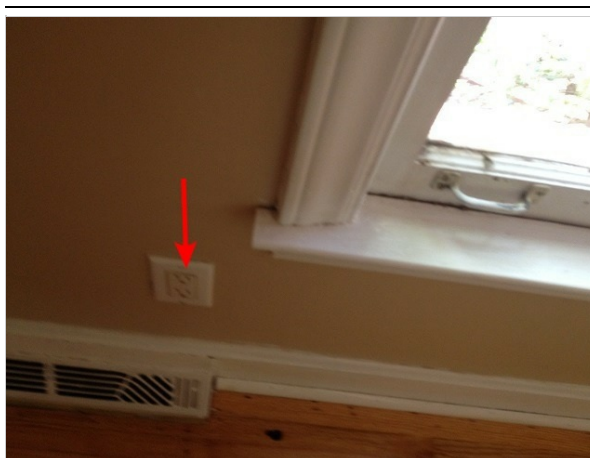
Figure 20

- Representative number of the wall receptacles in the house were were not grounded (open-ground), and do not meet the safety standards of modern wiring. Needs further evaluation and repair by a licensed electrical contractor.

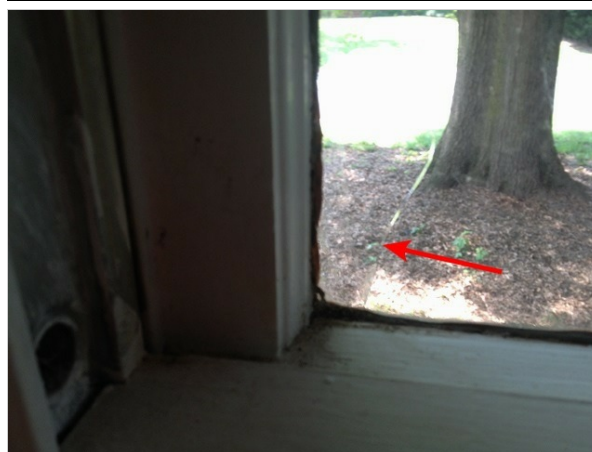
Figure 21

- One glass pane in the front family room had a broken or cracked glass pane that should be repaired or replaced.

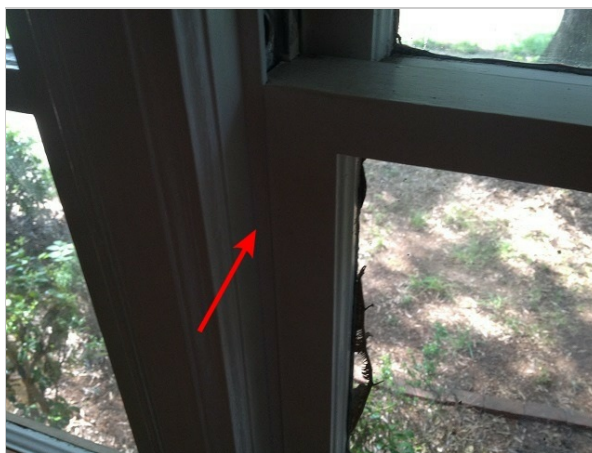
Figure 22

- A representative number of the windows were painted shut and could not be operated to verify operation or check for defects. The window(s) need maintenance to free them for opening and further inspection.

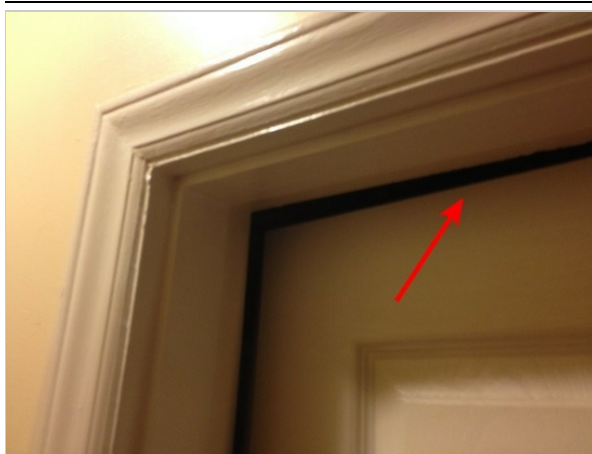
Figure 23

- The bedroom doors on the lower level and rear left bedroom bind in the jamb casing and is difficult to operate, and needs to be serviced to work smoothly.

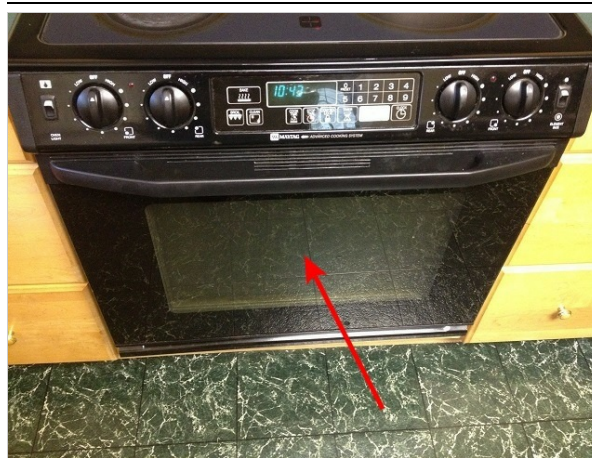
Figure 24

- The bottom heating element in the oven was not functioning. Needs repair by an appliances specialist.

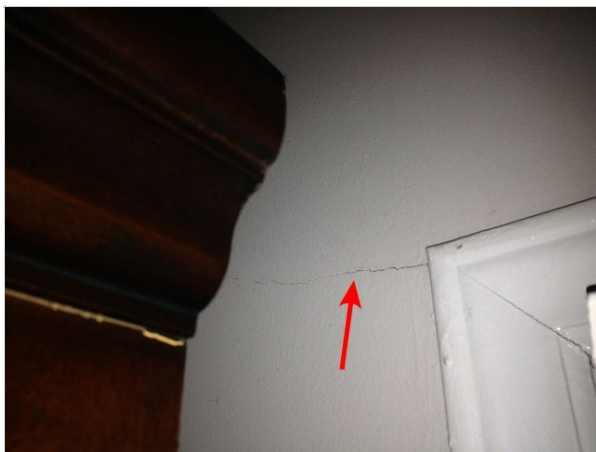
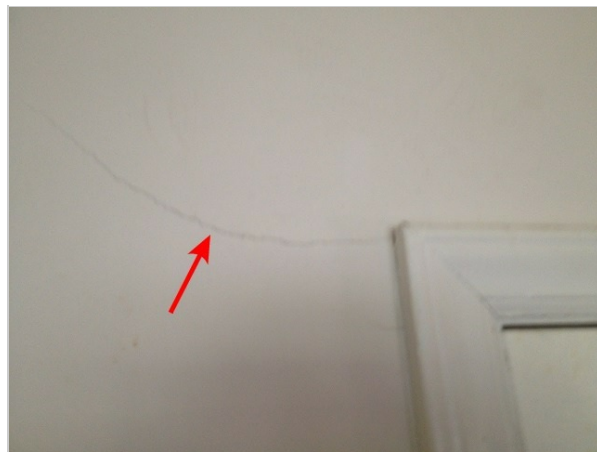
- Diagonal crack was noted on the wall located in master bedroom and rear left bedroom. This evidence suggests movement of the floor system. Additional movement will cause the crack to enlarge. A Licensed General Contractor should be consulted to determine the cause of the movement and if corrective measures are

needed.

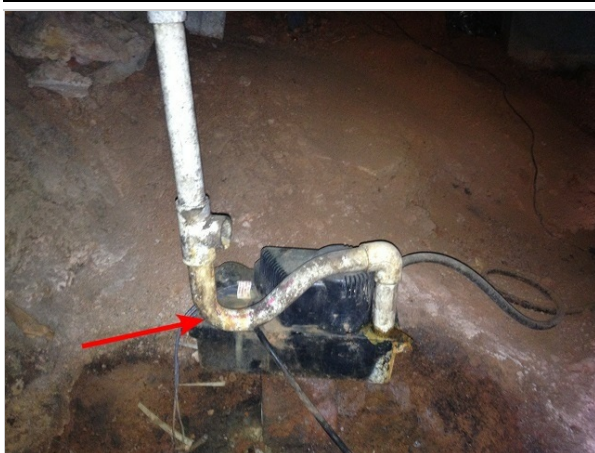
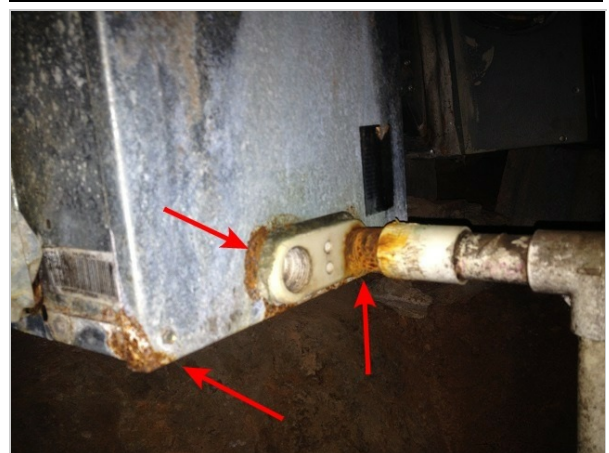
- The condensation water drain system was not functioning. The water was leaking around evaporator coil compartment-conductive for coil deterioration. Needs further evaluation and repair or service by a licensed HVAC contractor.

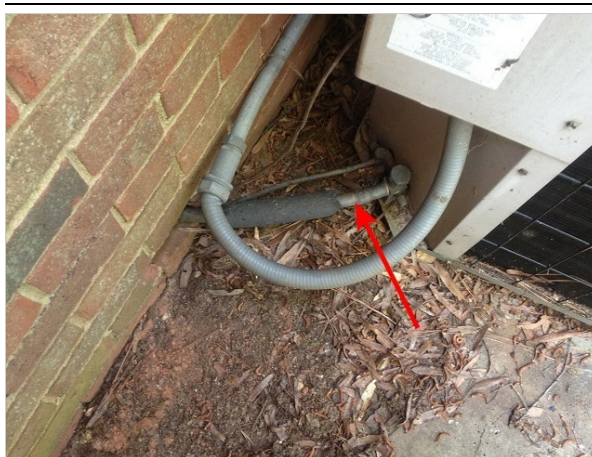
Figure 29

- Insulation for the outside condensing unit's refrigerant lines is damaged, deteriorated and/or missing in one or more areas. This may result in reduced efficiency and increased energy costs. Recommend replace insulation as necessary.

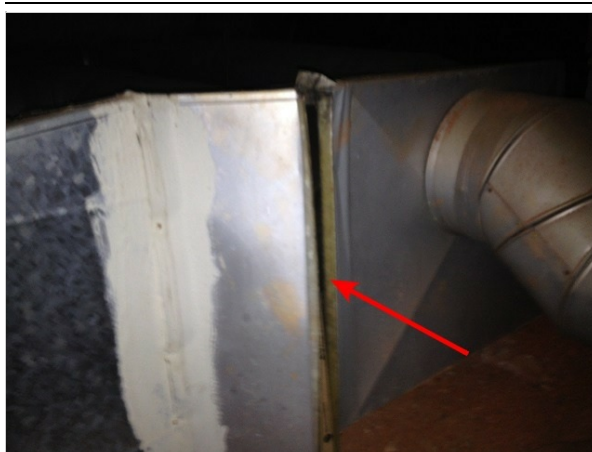
Figure 30

- The cover was missing on the filter compartment-conductive for dust penetration inside of the air handler. Needs repair by a licensed HVAC contractor.
