HomeTeam[®]
INSPECTION SERVICE

123 Sample Drive

Inspection #: 0000

HOME INSPECTION REPORT

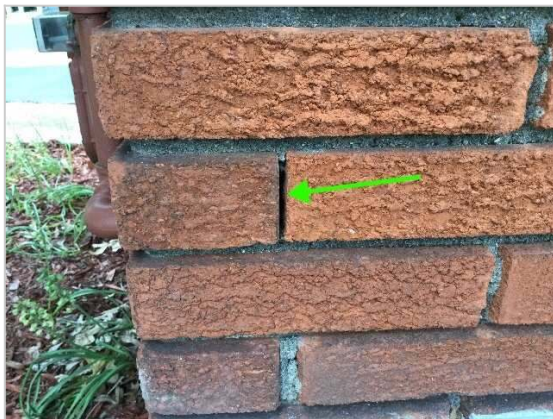
Missing mortar was noted on the brickwork on the brick window sills and a few areas of the home of the home. There were no loose bricks noted. Small amounts of missing mortar are usually inconsequential. Extensive amounts of missing mortar can permit water intrusion. Consult with a qualified masonry contractor for repair estimates.

Missing mortar on home example.

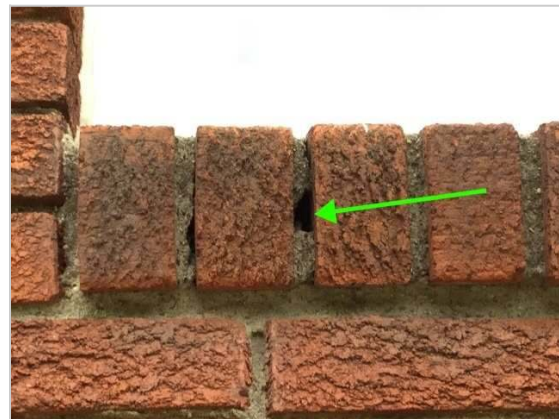
Missing mortar on sill example.

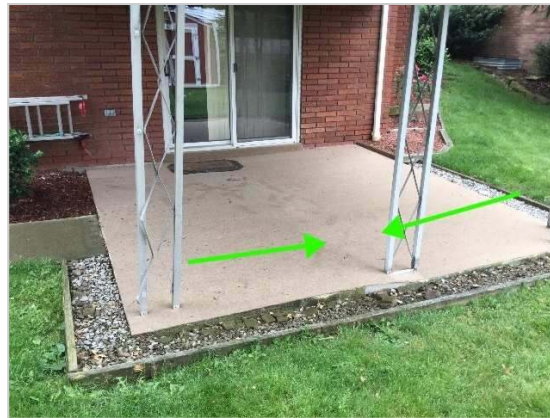
Settlement was noted on the back patio slab. The settlement does not appear to be active. Settlement of concrete slabs is common and is usually not a problem. If the settlement causes the concrete slab to pitch toward the foundation of the home, it is possible that water will drain into the basement. In this case the slab was not pitched toward the foundation. It is not possible for us to positively determine if active settlement is occurring during a home inspection. The area should be monitored for evidence of new or continued settlement. Consult with a qualified contractor for further evaluation if required.

Patio slab settlement.

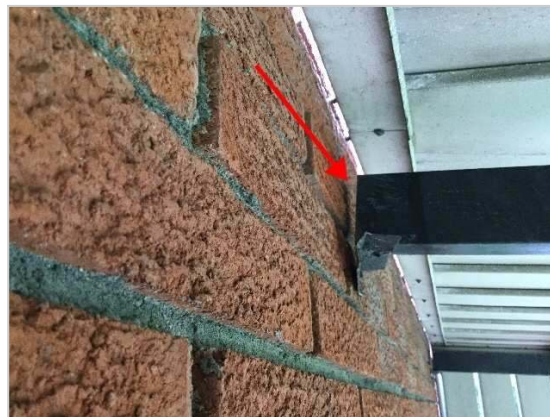
The patio awning roof was not securely attached the home. consult with a qualified contractor for evaluation and repair.

Awning supports not securely anchored to home.

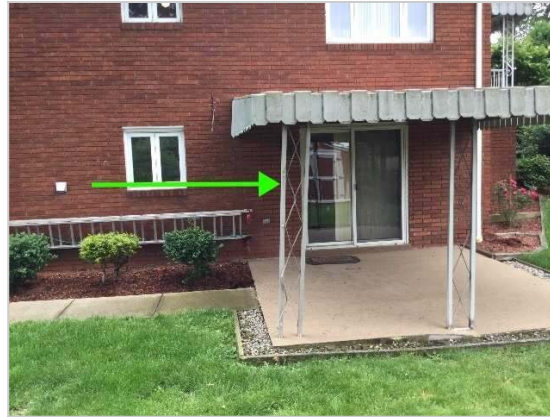
The right rear vertical support post on the patio cover is not plumb. The post is an important structural component and should be repaired. Consult with a qualified contractor for recommendations.

Post leaning.

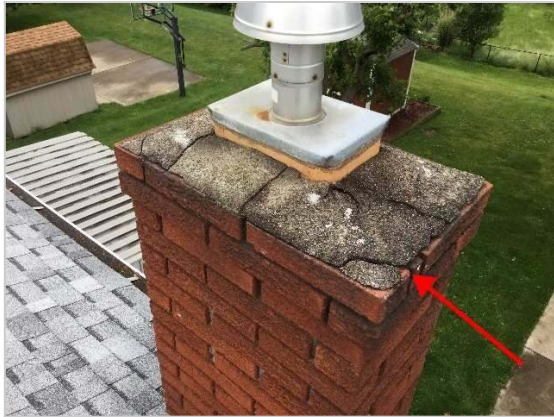
There was cracks on the top caps in the chimney's brickwork and repairs should be made to prevent further deterioration. Consult with a qualified masonry contractor for repair.

Mortar cap cracks - rear chimney.

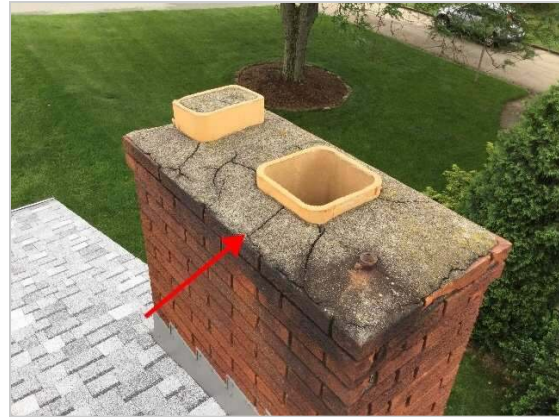
Mortar cap cracks - left chimney.

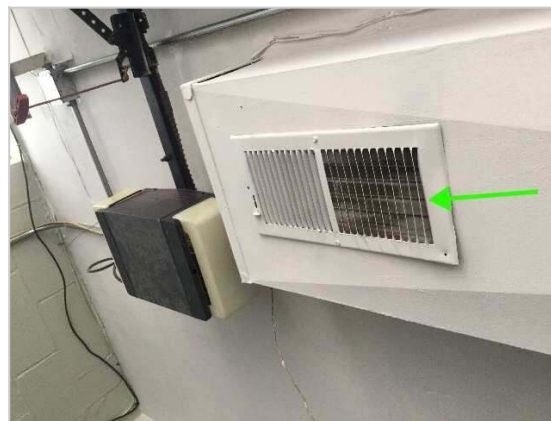
An open heating duct was noted in the garage. There should be no open air ducts in the garage. Fumes containing carbon monoxide from the exhaust of a car can enter the heating and air conditioning ducts and become a health hazard. The duct should be removed and the opening sealed.

Open air ducts in garage.

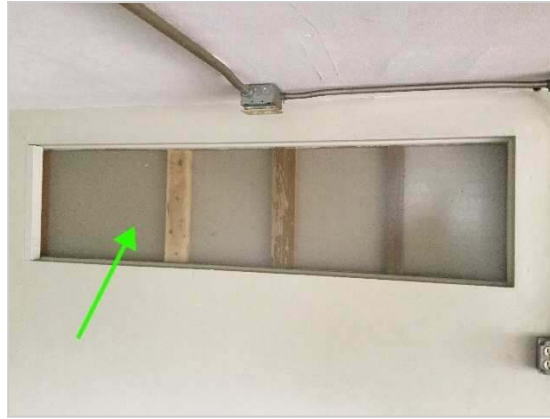
The finish on the garage ceiling and any partition walls between the garage and basement or living space is designed to provide a barrier between the garage and living space in the event of a fire. One or more openings were noted in the partition wall. Repairs should be made to the wall to maintain the integrity of this important safety feature.

Non fire rated material in partition wall.

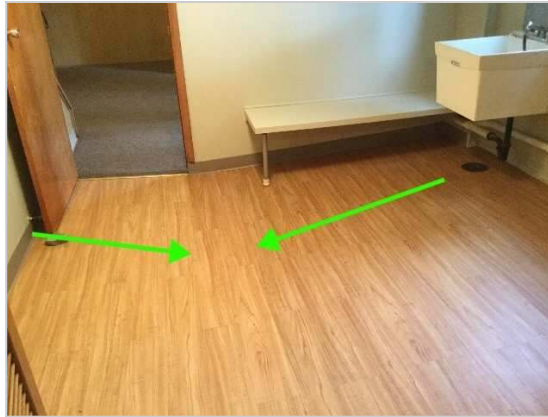
Settlement was noted on the basement floor slab. The settlement does not appear to be active. Settlement of concrete slabs is common and is usually not a problem, as there is no connection between the floor and structure of the home. It is not possible for us to positively determine if active settlement is occurring during a home inspection. The area should be monitored for evidence of new or continued settlement. Consult with a qualified contractor for further evaluation if required. Certain instances of settlement can damage floor or drain plumbing. Plumbing issues below floor level are not visible for inspection and therefore cannot be evaluated. Consult with a qualified plumber to have a sewer camera inspection performed if desired.

Slab settlement.

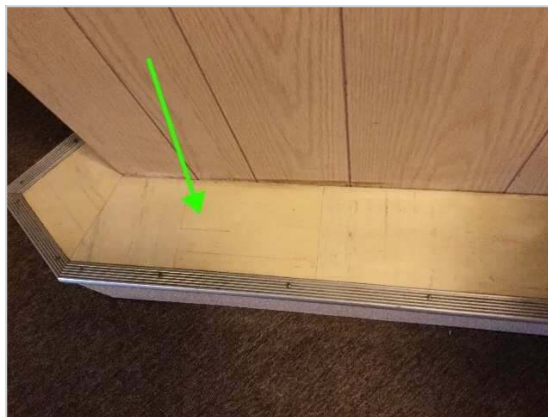
The floor tile in the basement measures 9-inches by 9-inches. Almost all 9X9 floor tiles contain asbestos. The visible tile was not deteriorating or decaying at the time of the inspection. It is advisable to avoid disturbing the substance prior to any testing. The only way to confirm the contents of the material is to have a sample tested by a qualified laboratory. If the substance is of any concern, a qualified asbestos testing firm should be contacted.

Possible asbestos tile.

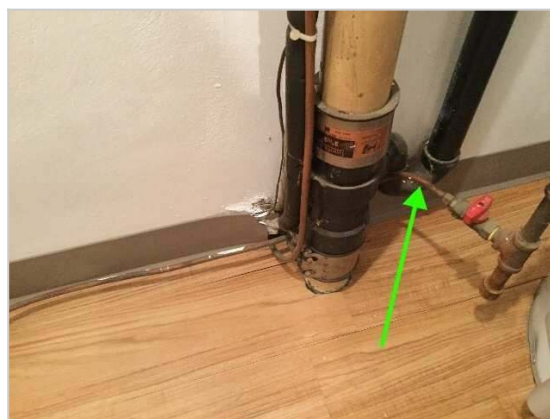
Some of the gas appliances in the home are plumbed with soft copper tubing. The tubing was observed on the gas line (s) feeding the dryer. This may or may not be an issue based on the local jurisdiction. Some areas permit the use of soft copper tubing while others do not. Consult with a qualified plumber for further evaluation and recommendations.

Soft copper tubing.

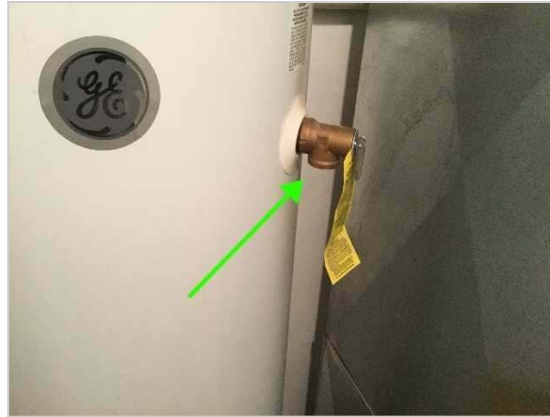
There was no drip leg installed on the T&P valve of the water heater. The drip leg directs water from the T&P valve toward the floor. A drip leg terminating within six-inches of the floor should be installed.

Missing drip leg.
