HOME INSPECTION REPORT

The HomeTeam Inspection Service made a visual inspection of 123 Main Street, Anytown, USA 55555. Enclosed please find a written, narrative report of our findings in accordance with the terms of our Inspection Agreement.

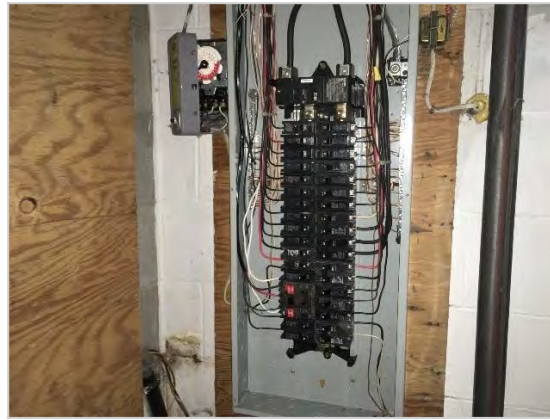
Photo 9

The service wire appeared to be 120/240 volt and 200 amp and entered a Siemens service panel, located on the rear basement wall. The main service disconnect was 200-amp rated and was located in the main panel. The branch circuits within the panel were copper. These branch circuits and the circuit breaker to which they were attached appeared to be appropriately matched. The internal components of the service panel, i.e. main lugs, bus bars, etc were in good condition.

The visible house wiring consisted primarily of the NM (non-metallic) type and appeared to be in good condition.
