HomeTeam[®]

HOME INSPECTION REPORT

The HomeTeam Inspection Service made a visual inspection of 123 Main Street, Anytown, USA 55555. Enclosed please find a written, narrative report of our findings in accordance with the terms of our Inspection Agreement.

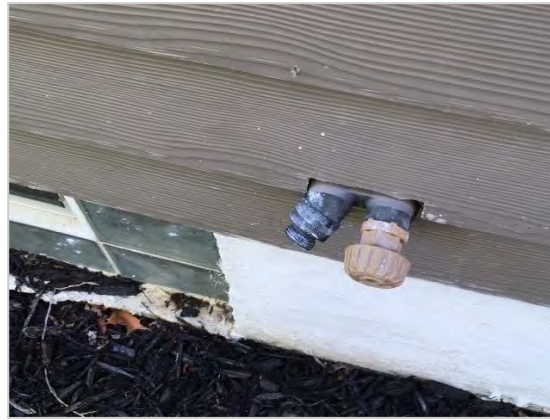
Photo 1

NOTE: Exterior hose bibs did not function when tested. During winter months and times of colder temperatures, homeowners often turn off hose bibs from the interior to prevent pipes from freezing and bursting. Due to the possibility of uncontrollable leaks at the faucet handle if activated, HomeTeam does not activate shutoff valves. Once temperatures remain safely above freezing the client should check the hose bibs for proper operation.

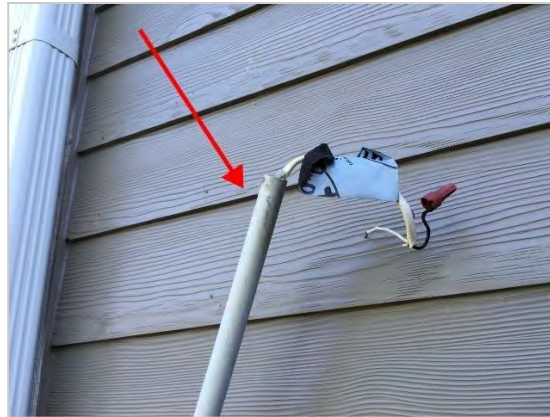
Photo 2

Exposed or un-terminated live wires were observed on the exterior. The wires should either be disconnected at the source or properly terminated in an approved, covered electrical box. Consult with a qualified electrician for repair and further assessment.

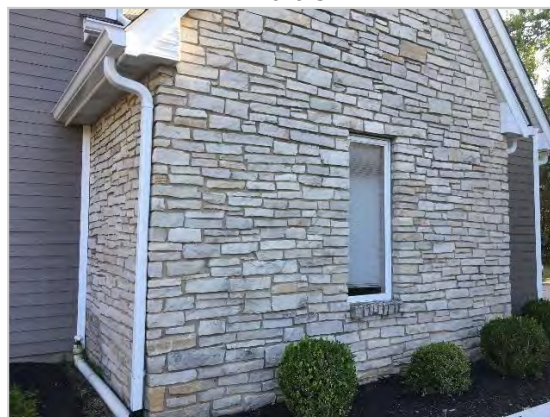
Photo 3

NOTE: The structure has a manufactured stone veneer (MSV) cladding. Structures with MSV can develop moisture intrusion problems even when properly constructed according to industry standards. The problem can develop because of moisture buildup behind the veneer that is unable to drain, and this moisture can cause significant structural damage that is not visible during a non-destructive test. Specific areas of concern include areas around the windows that may have been subjected to prolonged water exposure. Other areas of likely penetration are around chimneys, decks, and any other penetration points. Water intrusion is more likely at these points. In all cases, HomeTeam recommends having MSV-clad structures professionally inspected by an MSV-qualified technician prior to purchase and again each year. Typically, this type of test involves drilling several holes and inserting moisture meters to determine if any moisture is present behind the veneer.
