HOME INSPECTION REPORT

Saturday,
December
8, 2018

**Bill
Sample
123
Sample Rd
Anytown
WA,
55555**

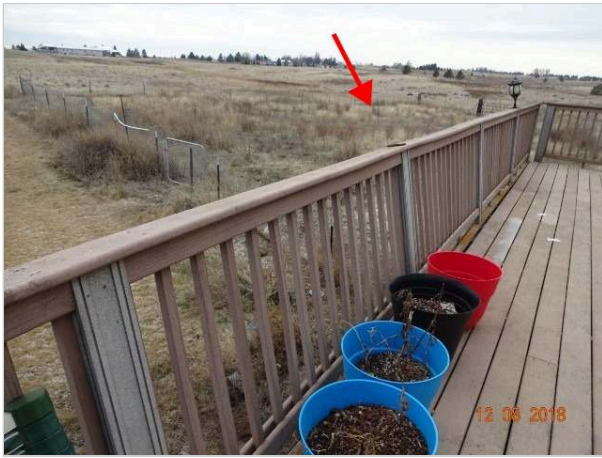
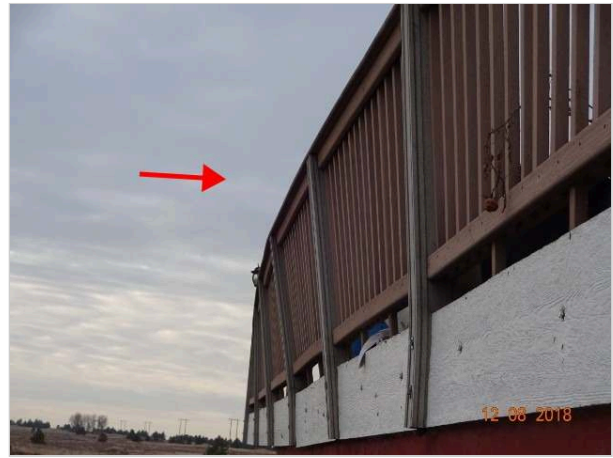
- The left side handrail around the deck was leaning forward, away from the deck. The handrail was mostly secured, and should be repaired. Contact a qualified contractor for further evaluation and repairs.

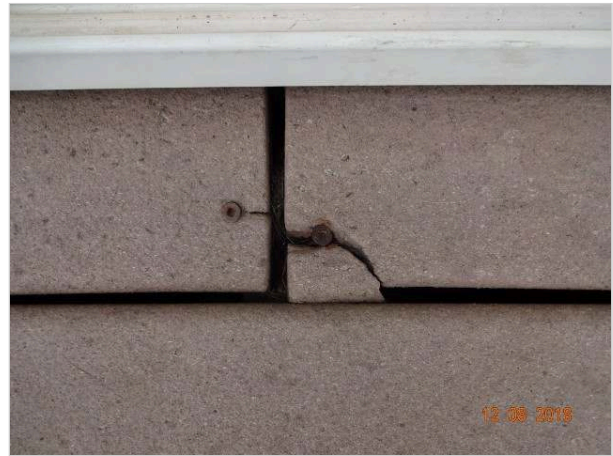
- There were minor damaged and cracked boards noted around the right and rear sides deck. Repairs should be made as desired.

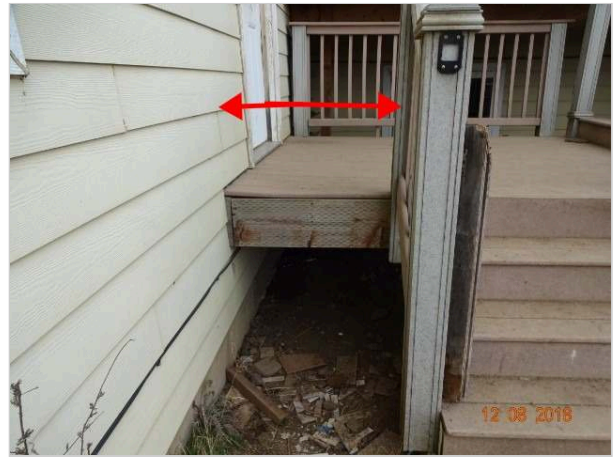
- There was no handrail/ guard rail installed on the left side of the deck stairs. Local codes may require the installation of handrails in locations where three or more steps are present, and or anywhere there is a height of 30 inches or more off grade. Although it may not be required, it is recommended that railing be installed.

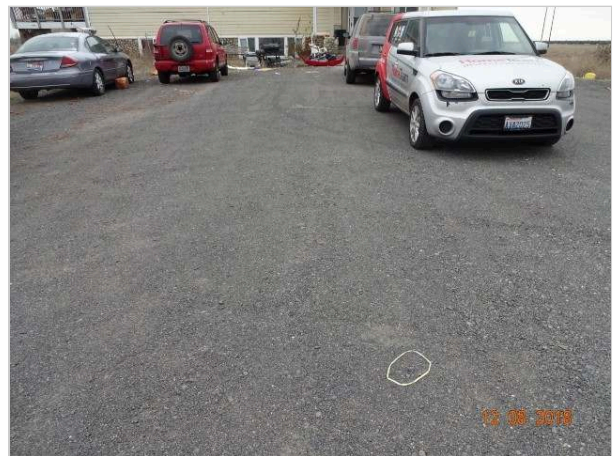
- There were uneven areas and potholes noted on the front and rear sides of the gravel driveway. These conditions can be a trip hazard and could potentially cause damage to a vehicle. It is recommended that these areas be repaired using a suitable or similar surfacing material to "feather" the out-of-level conditions to make a smooth transition. Contact a qualified contractor for further recommendations and repairs.

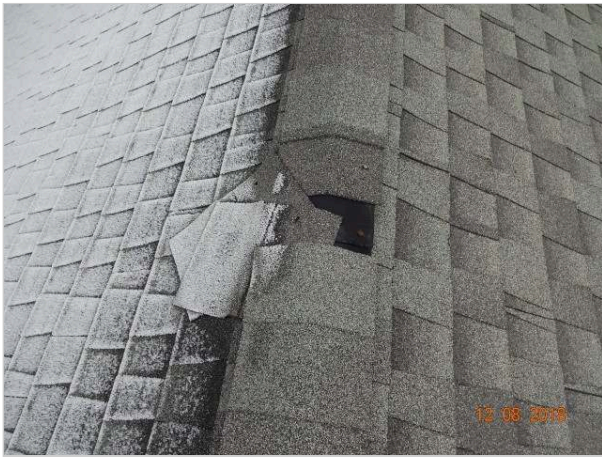
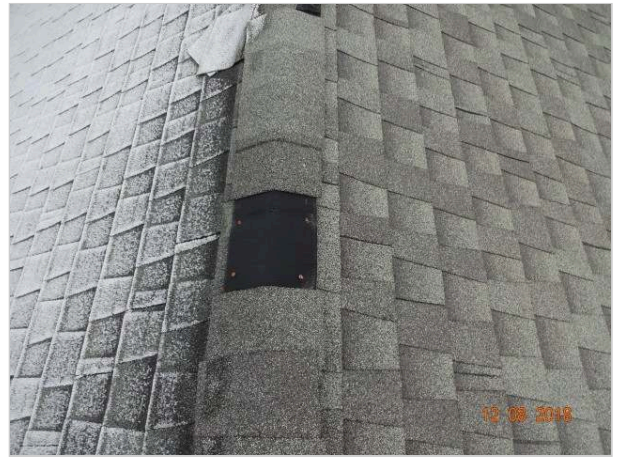
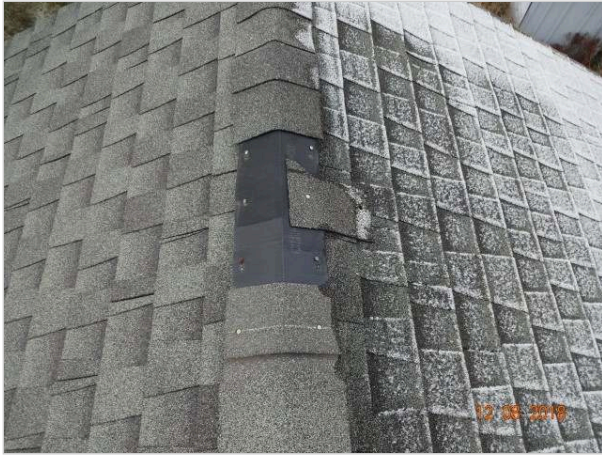
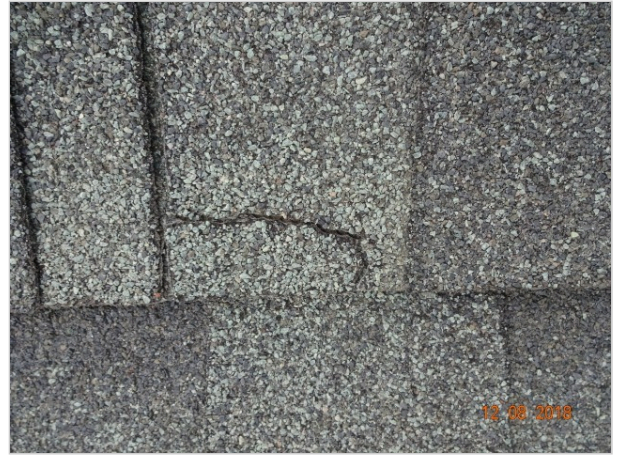
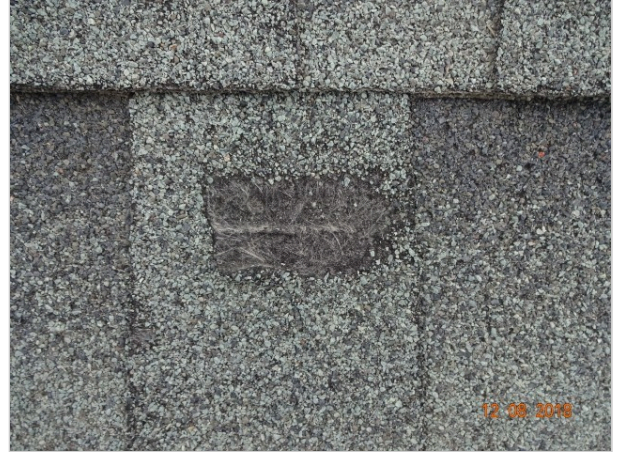
- There were torn, missing and damaged shingles observed on the roof that should be repaired to help prevent water intrusion into the attic space. Contact a qualified contractor for repairs.

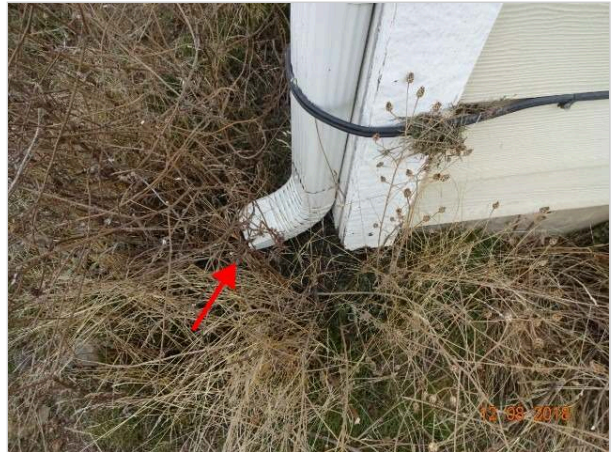
- All of the downspout (s) were draining at or too close to the base of the foundation. All roof drainage should be directed at least six feet from the base of the foundation.

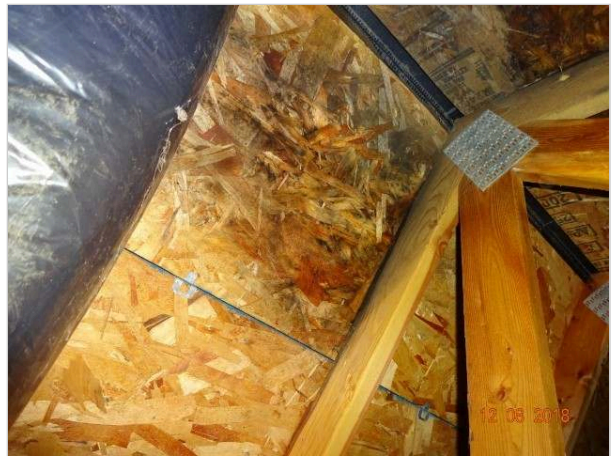
- Water marked or damaged roof decking was noted in the attic. The marks appear to be the result of previous leaks. Repairs to the affected areas are not required. No immediate action is necessary. It is recommended that the attic be monitored for further leaks and be repaired as needed.

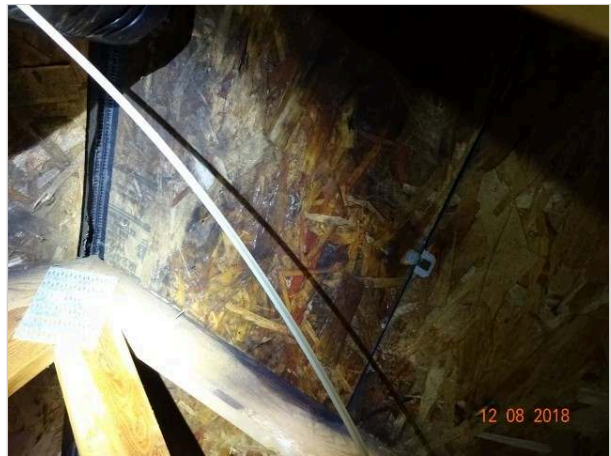
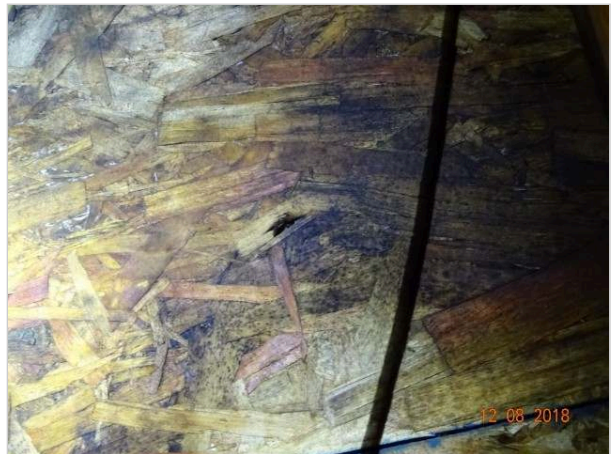
- A substance with the characteristics of mold is visible in the attic. Since the attic is not a part of the living space, the condition may not have any affect on those that are sensitive to mold. The presence of certain mold and mold spores in housing can result in mild to severe health effects in humans and can deteriorate the structure of the dwelling resulting in structural damage. Health effects include, but are not limited to: asthma, allergy symptoms, watery eyes, sneezing, wheezing, difficulty breathing, sinus congestion, blurry vision, sore throat, dry cough, aches and pains, skin irritation, bleeding of the lungs, headaches, memory loss and fever. As humans vary greatly in their chemical make-up, so does the individual's reaction to mold exposure. For some people, a small number of mold spores can cause ill effects. In others it may take many more. The EPA (<http://www.epa.gov/mold/moldresources.html>) advises consumers that areas less than ten square feet of coverage can usually be controlled using readily available household products. In the event the substance cannot be controlled, a certified mold testing and remediation firm should be contacted for a recommended course of action.

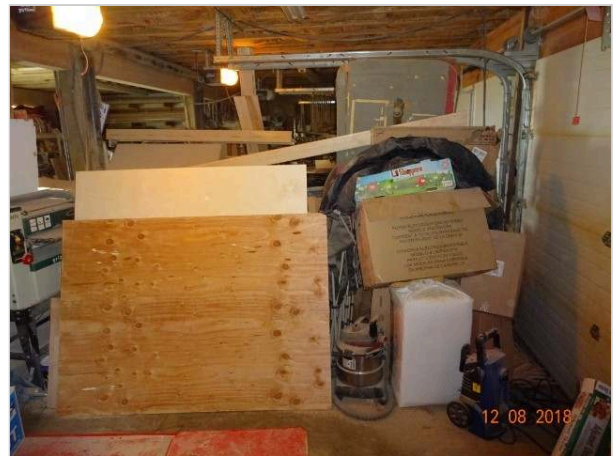
- NOTE: There was limited visibility and or limited access in one or more areas in the garage. The limited visibility was due to the garage being cluttered with some stored items and/or shelves at the time of inspection, therefore several areas were unable to be inspected.

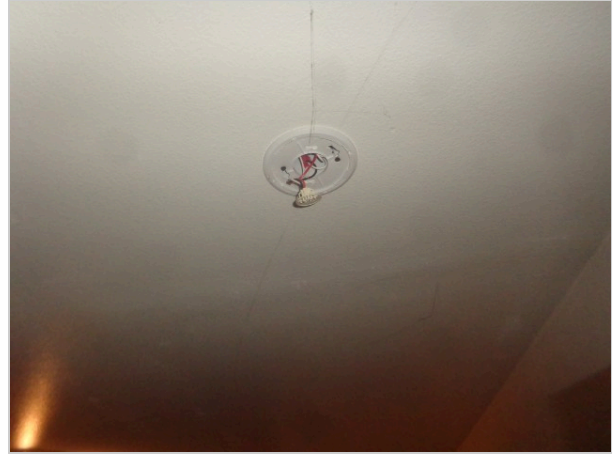
- There were missing smoke detectors found in many areas of the home. Smoke detectors are required in WA State. It is recommended that smoke detectors be in each bedroom for safety reasons.

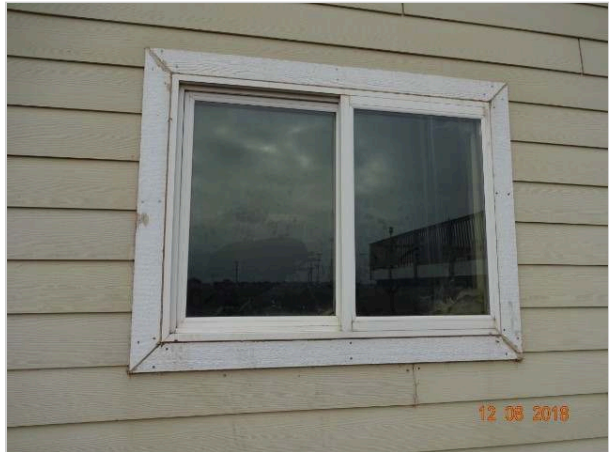
- Cracked glass was noted on the basement window(s). For safety and security all cracked and broken glass should be replaced.

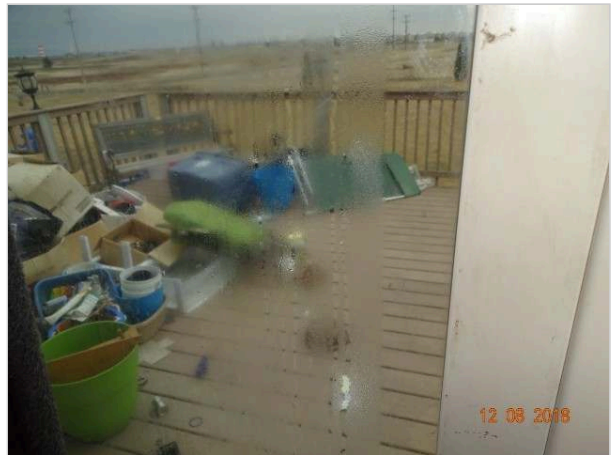
- The front and left screen doors were torn and damaged at the time of inspection. It is recommended that repairs be made.

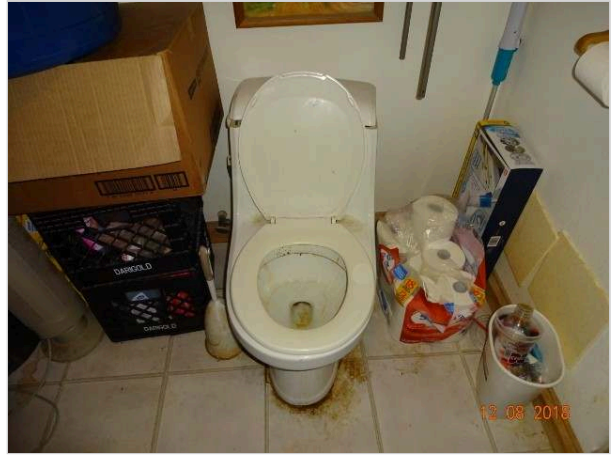
- Water marks with minor surface damage was noted on the main level bathroom floor. The water marks appeared to be the result of previous leaks. Consult with a qualified contractor for evaluation and repairs as required.

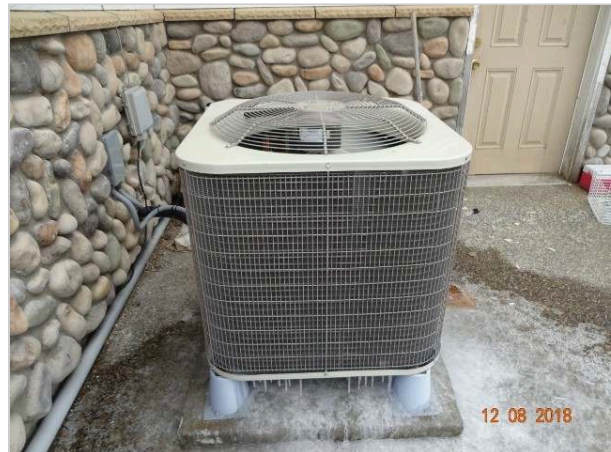
- The heat pump unit appeared to be have leaked prior to the time of inspection. Due to the cold temperature, the water has frozen over and the unit was surrounded by ice. If the unit continues to function in this state, severe damage to the unit could occur. It is highly recommend that a licensed HVAC contractor be contacted for further evaluation and repair recommendations before further use.
