HOME INSPECTION REPORT

The HomeTeam Inspection Service made a visual inspection of 123 Anywhere St., City, ST 12345. Enclosed please find a written, narrative report of our findings in accordance with the terms of our Inspection Agreement.

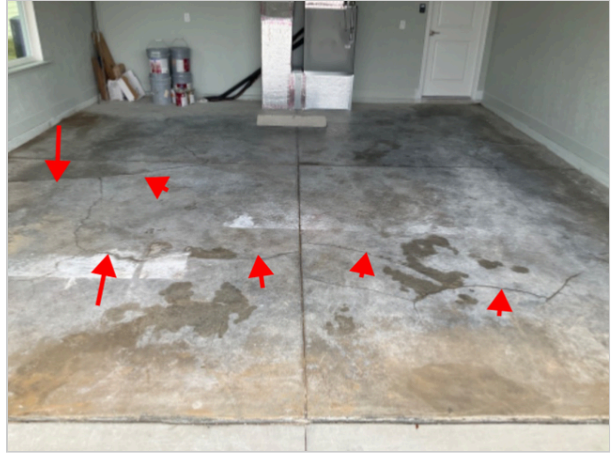
Photo 19

The garage floor had minor spider cracks observed. These cracks did not appear to be a structural issue. These cracks should be sealed and monitored.

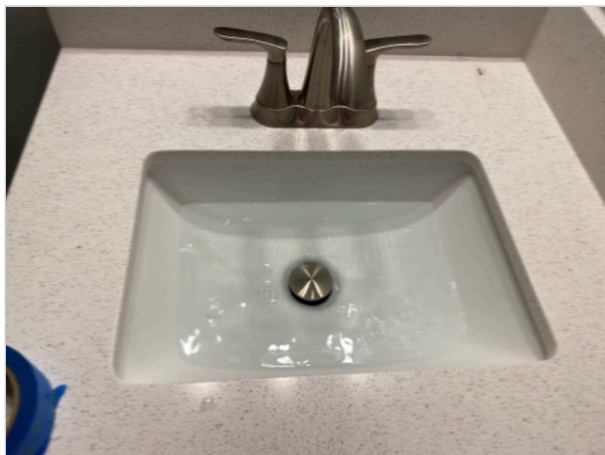
Photo 45

Hall bath sink drains slowly.

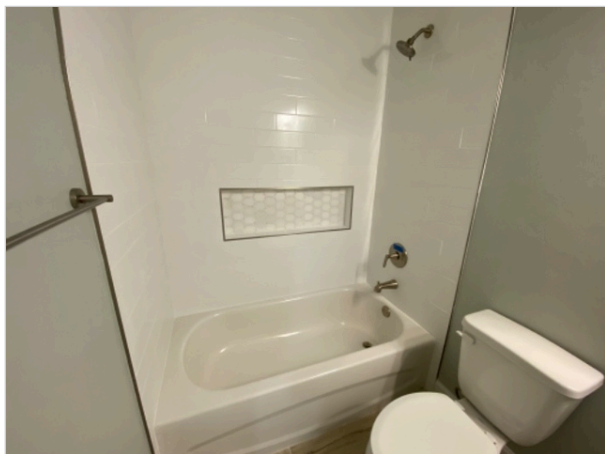
Photo 47

The shower controls in both guest bathrooms had the hot/cold reversed, which is a possible scald issue and should be corrected.

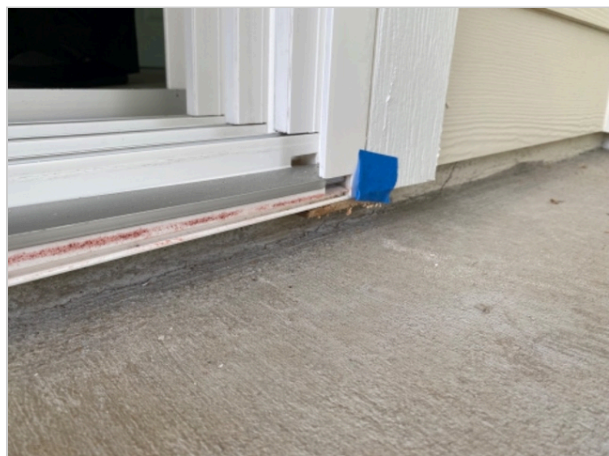
Photo 58

The rear sliding door threshold extends over the edge and is not supported properly. Recommend a qualified contractor to repair as needed.

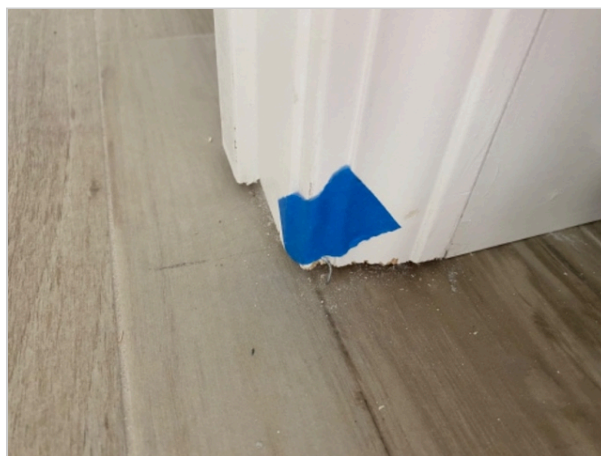
Photo 60

An exposed nail was observed at the guest bedroom/ jack & jill bathroom door frame that should be removed

and has been marked with blue tape to help the builder and contractors identify said issues.

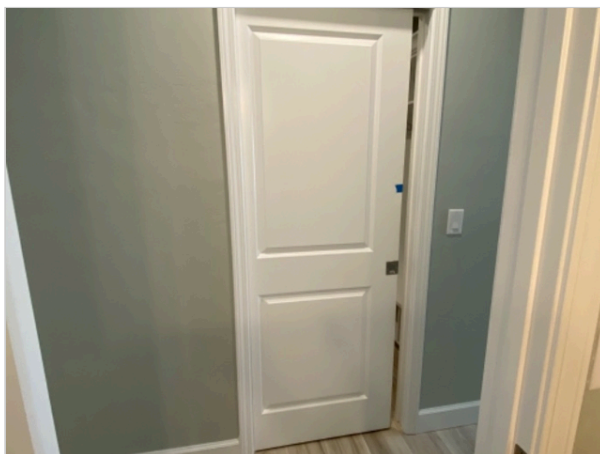
Photo 61

The pocket door for the laundry room is difficult to open and should be adjusted.
