HOME INSPECTION REPORT

The HomeTeam Inspection Service made a visual inspection of 123 Anywhere St., City, ST 12345. Enclosed please find a written, narrative report of our findings in accordance with the terms of our Inspection Agreement.

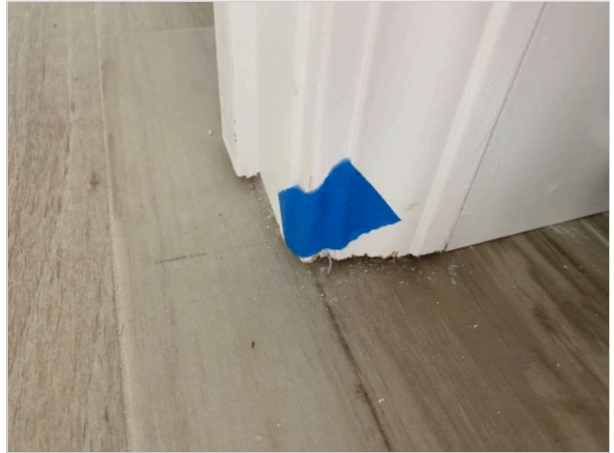
Photo 60

An exposed nail was observed at the guest bedroom/ jack & jill bathroom door frame that should be removed
