Monday, July 22, 2019

RE: 123 Sample Drive Anytown, FL 12345

HOME INSPECTION REPORT

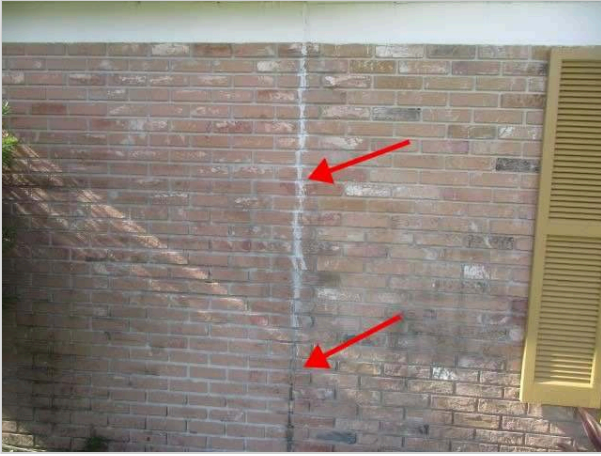
A SETTLEMENT CRACK WAS OBSERVED ON THE LEFT SIDE OF THE HOME.

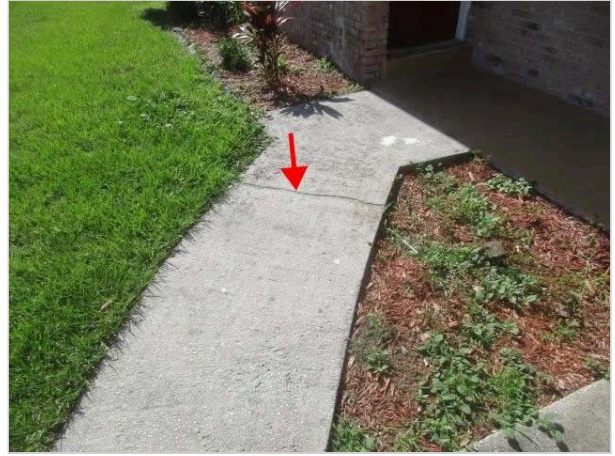
There was a concrete walkway leading to the concrete entry way in the front of the home. There were no material defects observed in the visible portions of the walkway and the entry way BUT, NORMAL SETTLEMENT WAS OBSERVED.

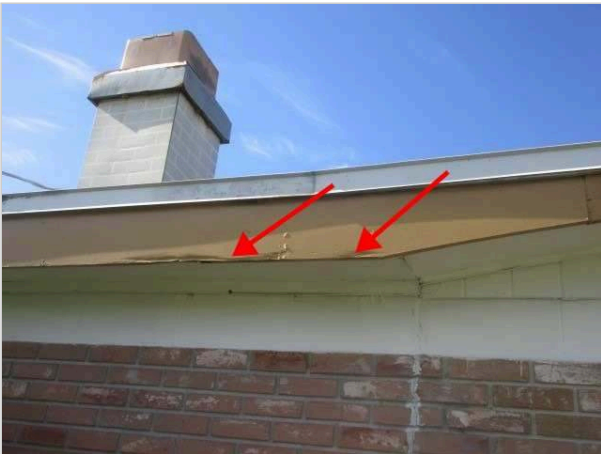
DETERIORATED FASCIA

THE FASCIA TRIM WAS DETERIORATED IN A NUMBER OF AREAS AROUND THE HOME

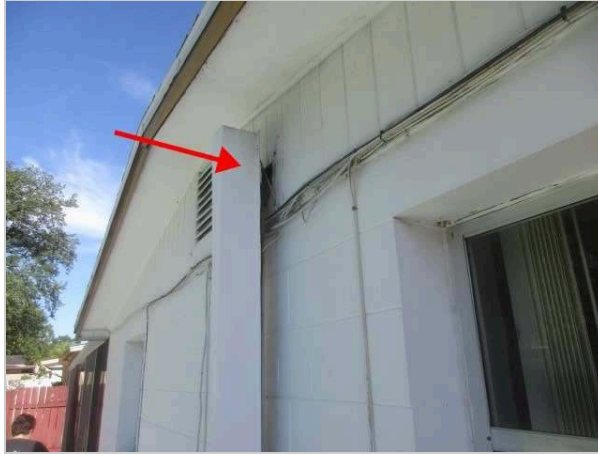
NOT SECURED

THE AC LINE CHASE WAS NOT SECURED.

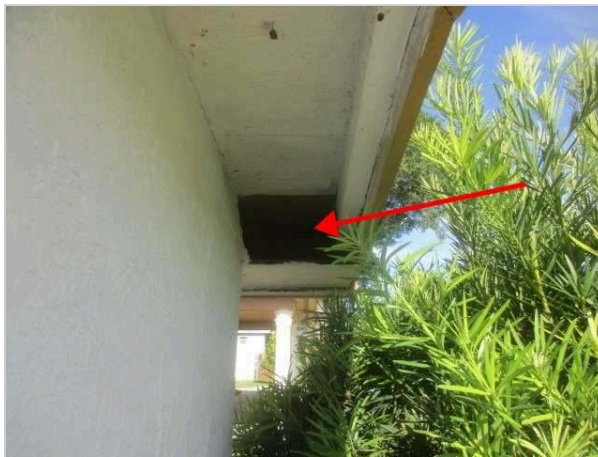
SEAL GAP

A GAP WAS OBSERVED IN THE SOFFIT AT THE FRONT RIGHT CORNER OF THE HOME.

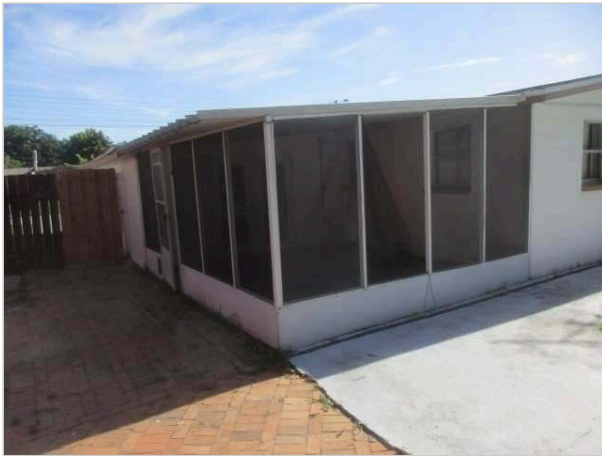
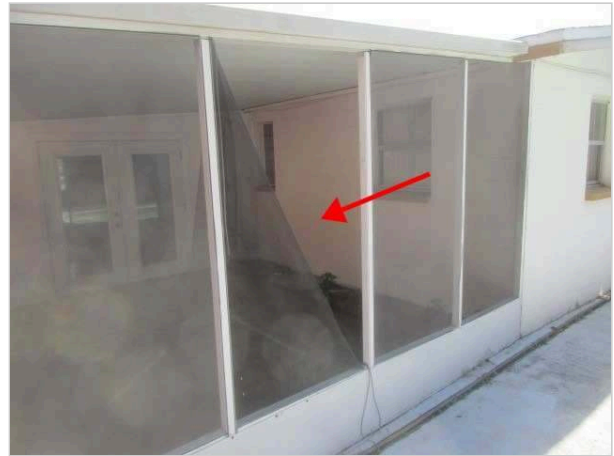
There was a screened enclosure around the patio. There were no material defects observed in the visible portions of the patio cover or its supports BUT, RIPS WERE OBSERVED.

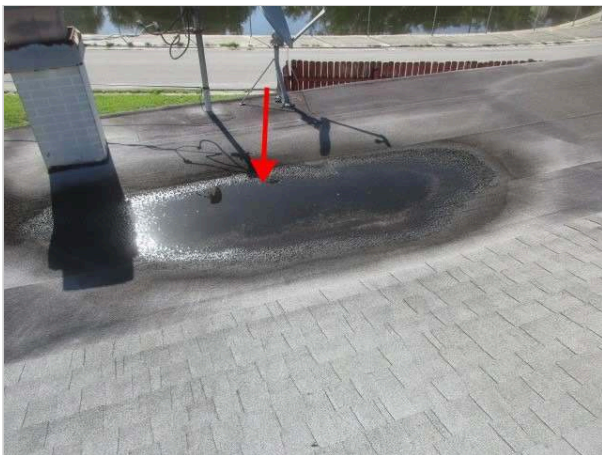
WATER PONDING ALONG WITH ALLIGATOR CRACKING WAS OBSERVED ON THE FLAT ROOF ON THE LEFT SIDE OF THE HOME. THE REAR SECTION WAS NOT SEALED.

THE ROOFING SYSTEM SHOULD BE FURTHER EVALUATED BY A QUALIFIED ROOFING CONTRACTOR TO DETERMINE THE EXTENT AND COST OF REPAIR/REPLACEMENT. A RECEIPT SHOULD BE LEFT FOR YOUR RECORDS AND PROTECTION.

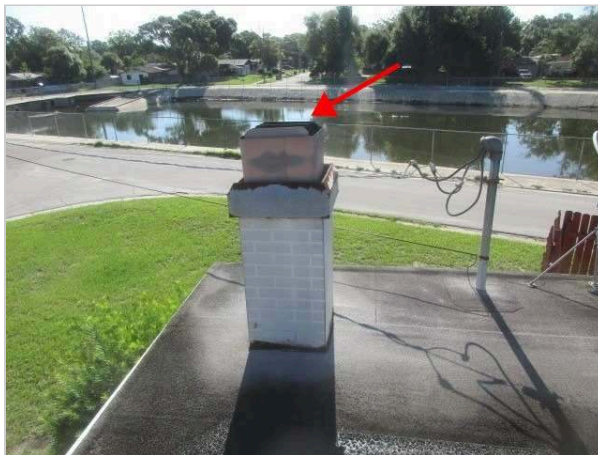
MISSING CAP

CHIMNEY: There was no rain cap on the chimney. This device will help to prevent rainwater from entering the flue and causing water damage.

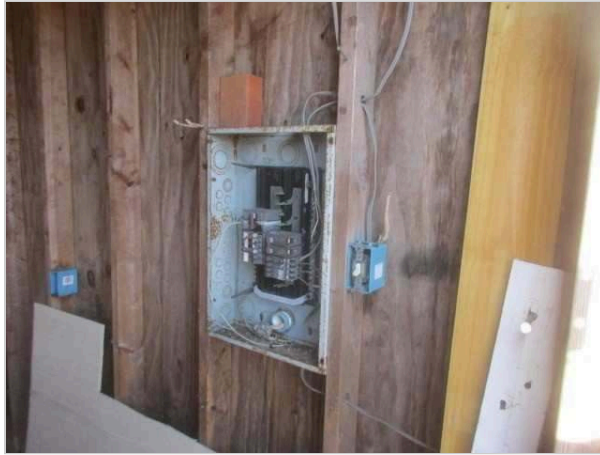
NOTE: WHAT APPEARED TO BE AN ABANDONED SERVICE PANEL WAS OBSERVED IN THE EXTERIOR SHED. A

VISUAL INSPECTION COULD NOT DETERMINE IF POWER HAD BEEN COMPLETELY DISCONNECTED.

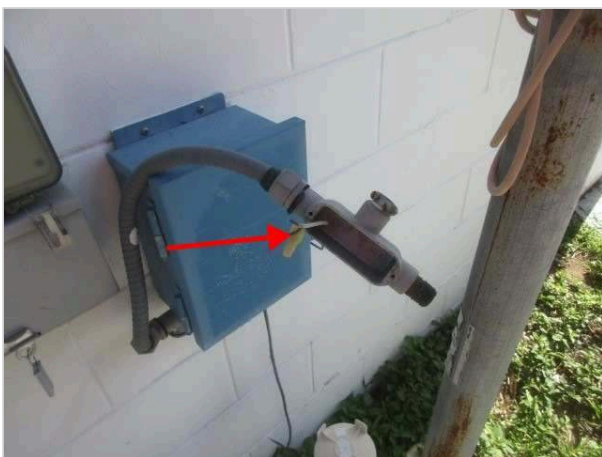
EXPOSED WIRES AT POOL EQUIPMENT

EXPOSED WIRES WERE OBSERVED IN A NUMBER OF AREAS AROUND THE HOME. THE WIRES SHOULD BE PLACED IN CONDUITS OR JUNCTION BOXES.

FURTHER EVALUATION TO DETERMINE THE EXTENT AND COST OF REPAIR SHOULD BE PERFORMED BY A QUALIFIED LICENSED ELECTRICIAN. A RECEIPT SHOULD BE LEFT FOR YOUR RECORDS AND PROTECTION.

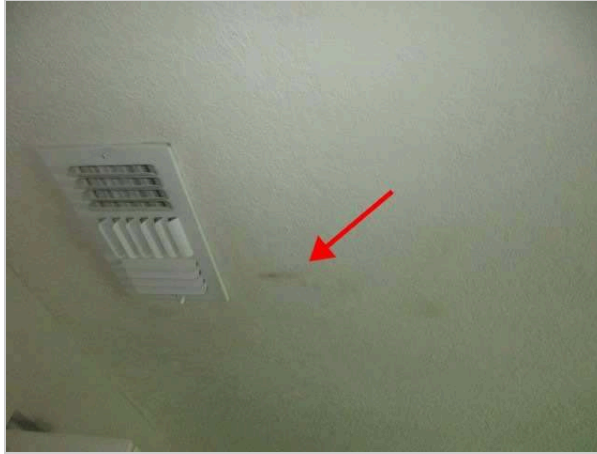
MOISTURE STAINS (DRY).

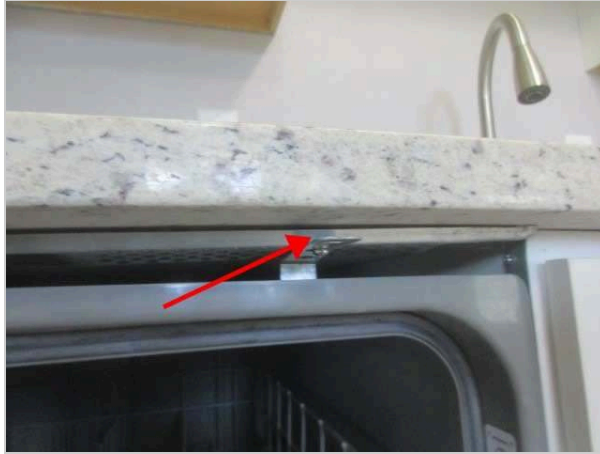
THE DISHWASHER WAS NOT SECURED TO THE COUNTER.

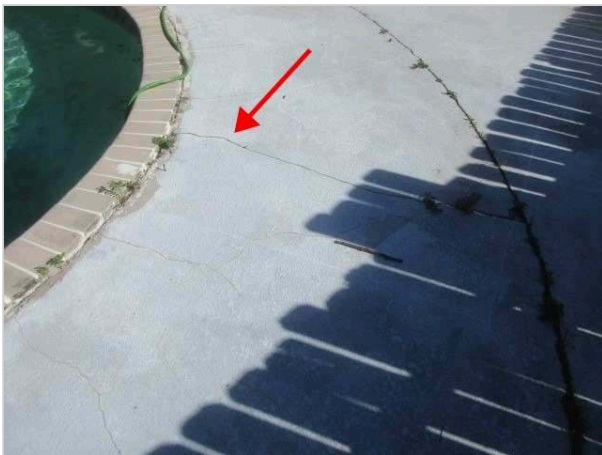
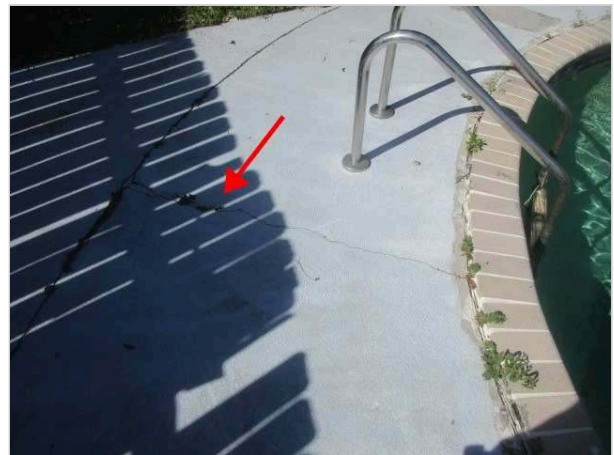
SETTLEMENT CRACKS

The in-ground pool was constructed of gunite. The deck surrounding the pool was constructed of kool Deck. There were some cracks (which should be monitored) in the pool decking. There were no material defects observed in the visible portions of the pool .

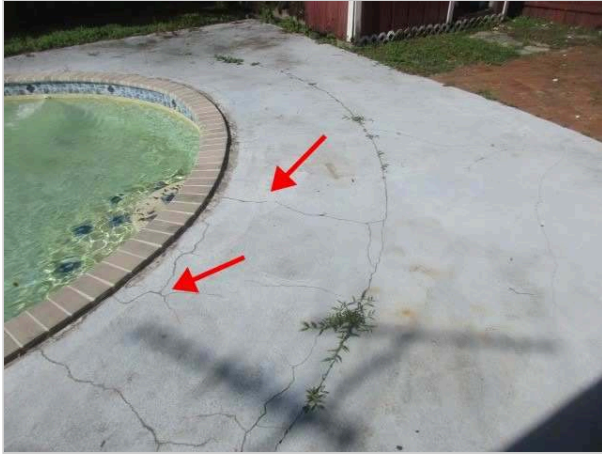
NOTE: There was a water hose in the pool (there was no water running in the hose) at the time of the inspection. This could be an indication that the pool may be losing water somewhere in the pool shell and/or in the plumbing between the pool and the pool equipment. It could not be determined if any leaks were occurring at the time of the inspection. If this concerns you, the pool should be further evaluated by a qualified licensed pool contractor.

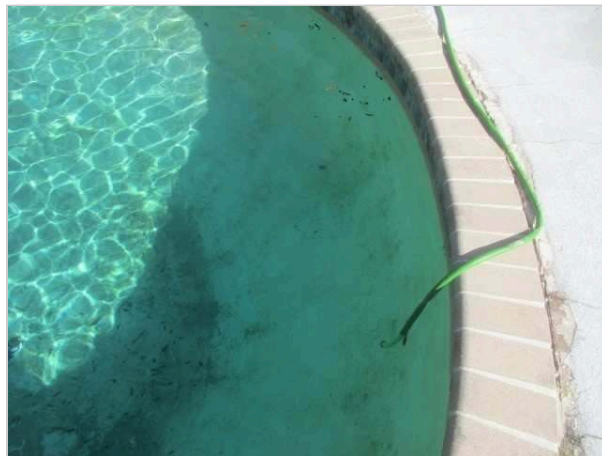
There was pitting, wear and staining in the pool surfaces. This indicates that the marcite pool surface is **AT THE END OF ITS LIFE AND WILL REQUIRE RESURFACING. Further evaluation and consultation will be required by a pool contractor.**

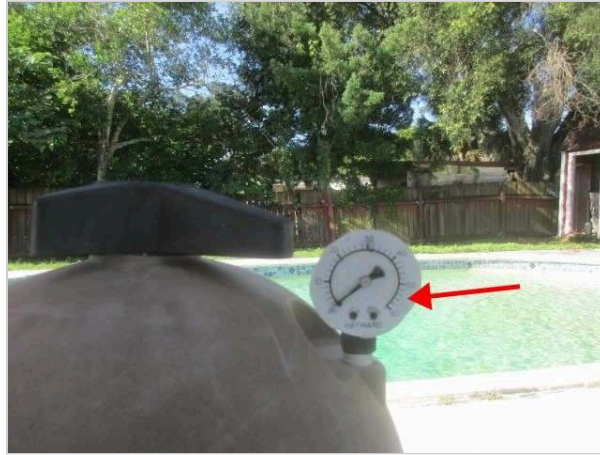
NOT FUNCTIONAL

THE PRESSURE GAUGE FOR THE POOL FILTER WAS NOT FUNCTIONAL.
