HOME INSPECTION REPORT

**123 Sample Drive
Anytown, TX 55555**

PROPERTY INSPECTION REPORT

Prepared For:	Bill Sample	
	(Name of Client)	
Concerning:	123 Sample Drive, Anytown, TX, 55555	
	(Address or Other Identification of Inspected Property)	
By:	Inspector 1 Inspector 2	9-29-2017
	(Name and License Number of Inspector)	(Date)
	(Name, License Number of Sponsoring Inspector)

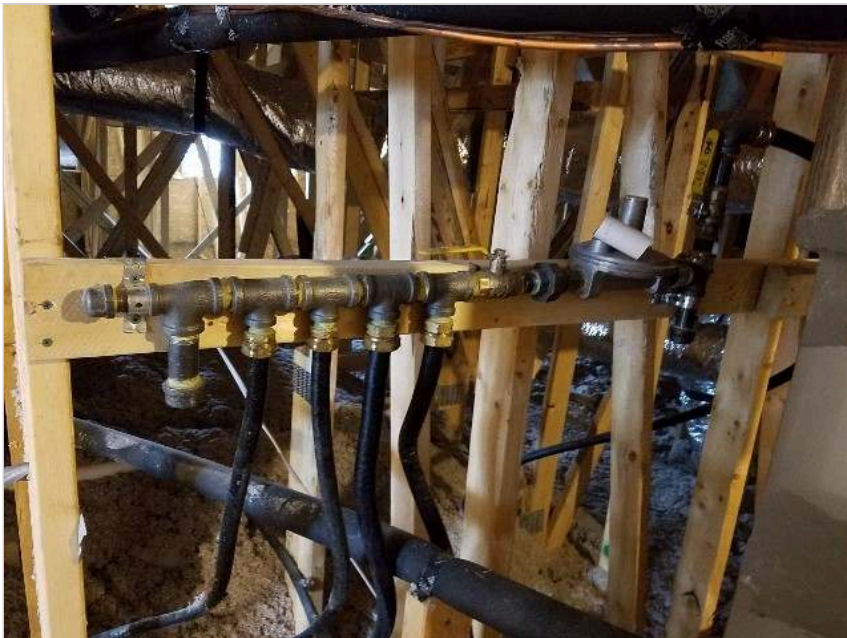
Corrugated Stainless Steel Tubing (CSST) was used in the gas supply system and we were unable to verify proper adherence to the manufacturer's bonding instructions. Bonding to the gas supply system was observed at the gas supply line next to the gas meter. (New Homes with CSST) It is recommended that you consult with your builder and have them certify proper CSST bonding according to the specific manufacturers instructions. CSST Advisory Notes: The lack of suitable electrical bonding may increase the potential for lightning strikes to cause arcing at the CSST gas piping and may result in perforation of the piping, gas leaks, and fires. Proper adherence to the manufacturer's bonding instructions should lower the risk of electrical arcing and related damage. It is recommended that you retain a licensed electrician (or certified CSST specialist) for further evaluation of the installation and that corrective action be taken as needed.

CSST manifold in attic space.
