# HomeTeam<sup>®</sup>

### HOME INSPECTION REPORT

**Tom and Sue Brown**  
**123 Main Street**  
**Anywhere, NC 12345**

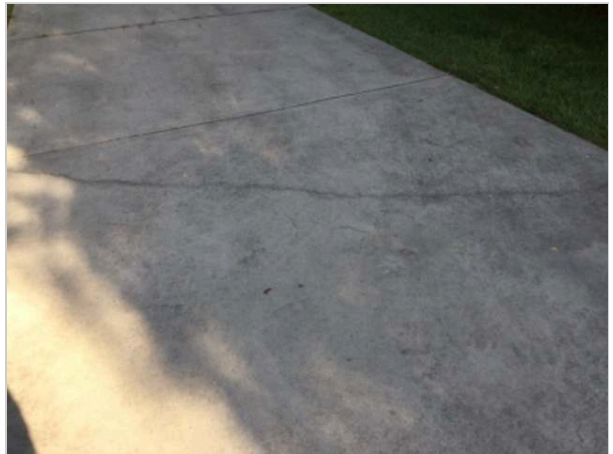
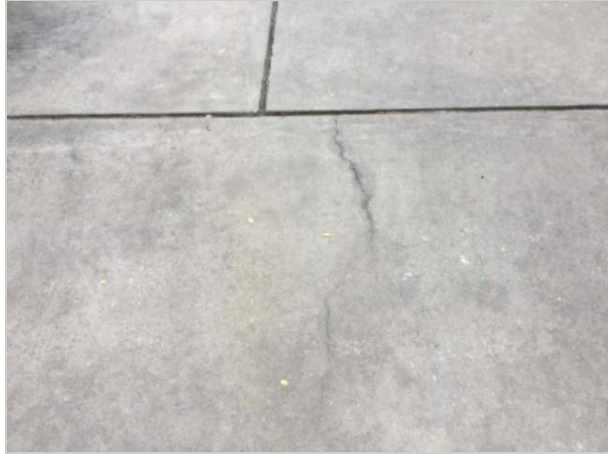
***The driveway has cracked and settled unevenly. This condition may deteriorate further and can be a tripping hazard. Have a qualified contractor evaluate and repair as required.***

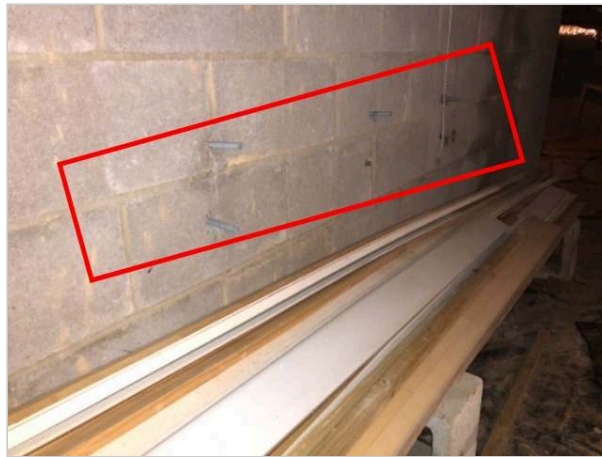
***At the lower deck, there are attachment bolts with no hardware. This may impact stability. Have a qualified contractor install and tighten all hardware as required.***

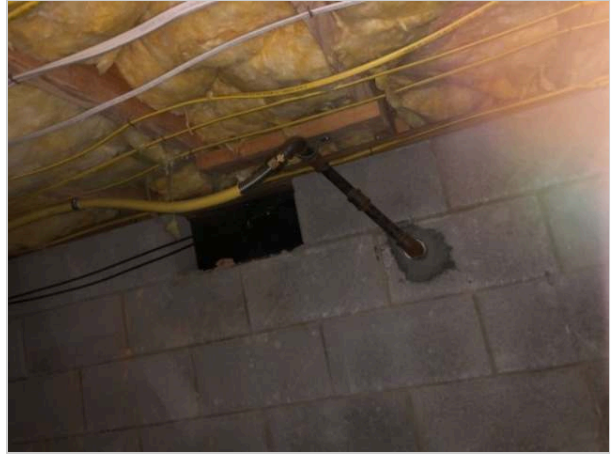
***The gas piping in this home includes corrugated stainless steel tubing (CSST). The gas piping was not bonded to the electrical grounding system of the home. Though not required when this home was constructed, it is a valid safety enhancement with CSST installed. Bonding the gas piping to the electrical system grounding adds protection to the gas line and equipment during an electrical storm. Have a qualified electrical contractor install bonding to the gas line of this home.***

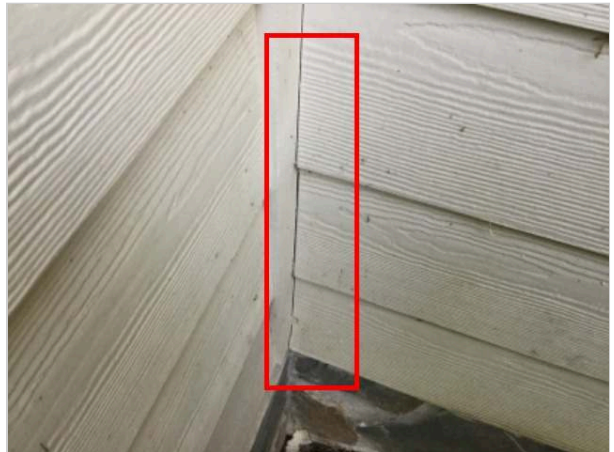
***The exterior caulking around the siding and trim is cracked or missing in numerous areas. Failed or missing caulk can allow moisture to infiltrate siding and structural components and lead to mold or rotted wood. Have a qualified contractor rework the caulking everywhere required.***

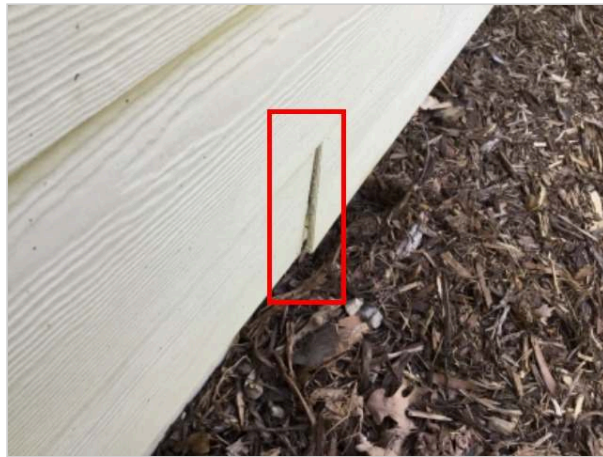
**Loose siding was noted on the right side of the home. If left, this condition can allow water infiltration behind the siding. Have a qualified contractor repair the siding.**

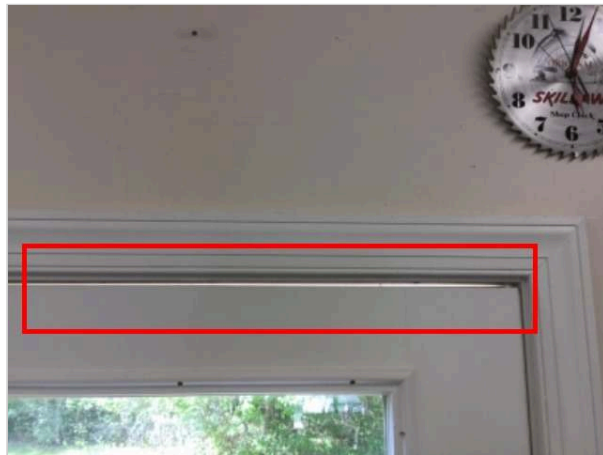
**At the garage rear door, daylight can be seen through the weather stripping. This will waste energy and allow pests access to the home. Have a qualified contractor repair as required.**

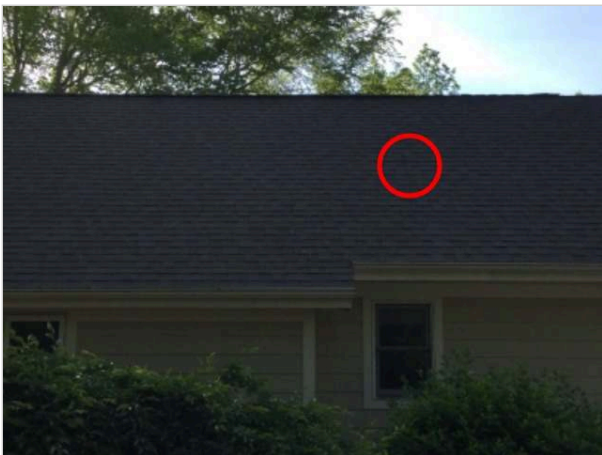
Front left

***On this roof, one shingle appeared to be in poor condition. Further, there was one curled shingle and one that appeared to be pushed up by a nail. Broken, loose curled and/or cracked shingles can allow the infiltration of water and lead to damaged structural components. Have a qualified contractor to evaluate and repair as required.***

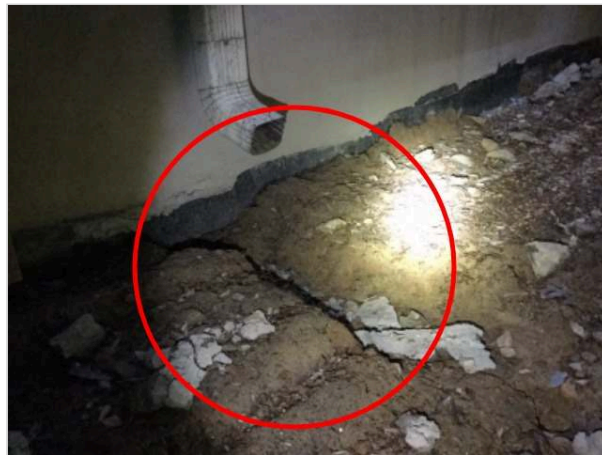
***At the rear, under the deck,, the gutter downspout flow is creating erosion in this part of the yard. If left, this erosion will worsen. Have a qualified contractor install a flexible drain pipe to move this water away from the foundation and to an area that will not erode.***

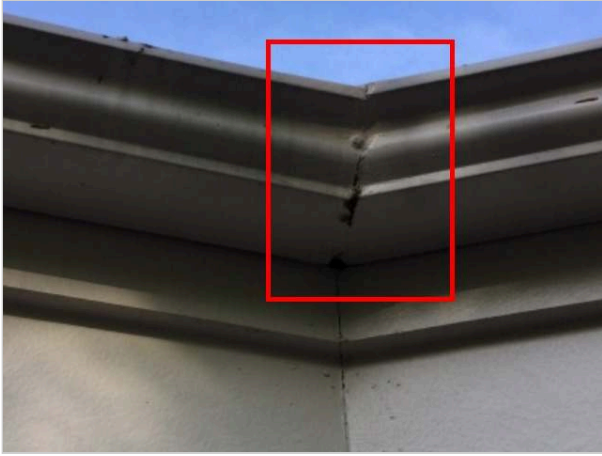
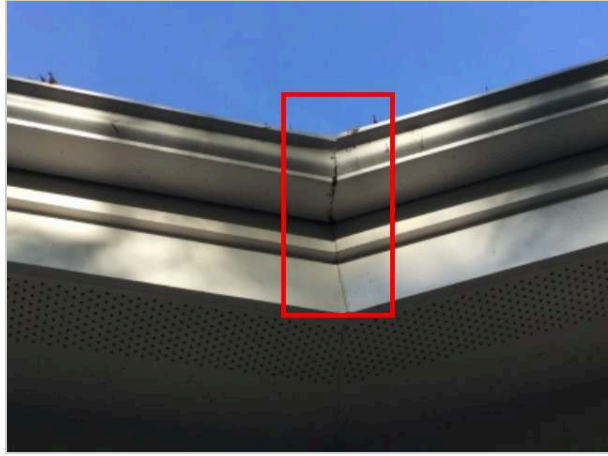
***At the the rear, over the deck, area, the gutter seams show corrosion. Today they were dry but this indicates leakage at the seams. Have a qualified contractor evaluate the gutters and repair as required.***

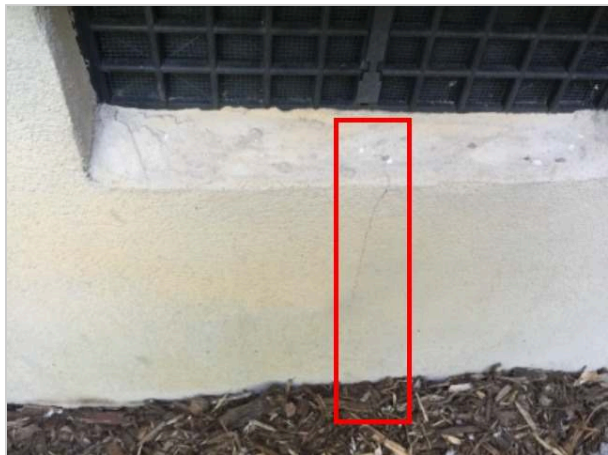
***On the foundation wall around the home, there are several places where the mortar parge coat exhibits shrinkage cracking. The foundation wall in the crawl space did exhibit damage but not at each of these. This parge coat is cosmetic but moisture entering the cracks and freezing may contribute to further damage. Have a qualified contractor seal or repair this parge coat as required.***

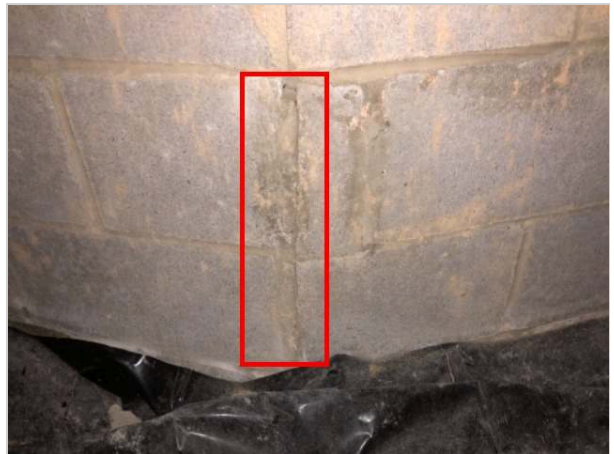
***On the rear of the home, the foundation is cracked. This crack is not open and there is no differential movement.. There was no apparent structural movement in the living space above. Have a qualified structural engineer evaluate and advise.***

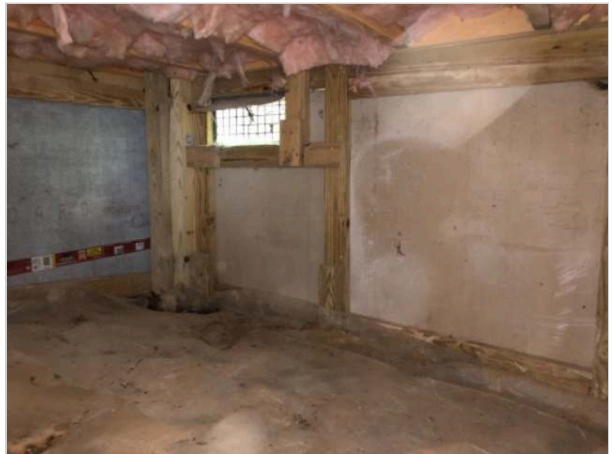
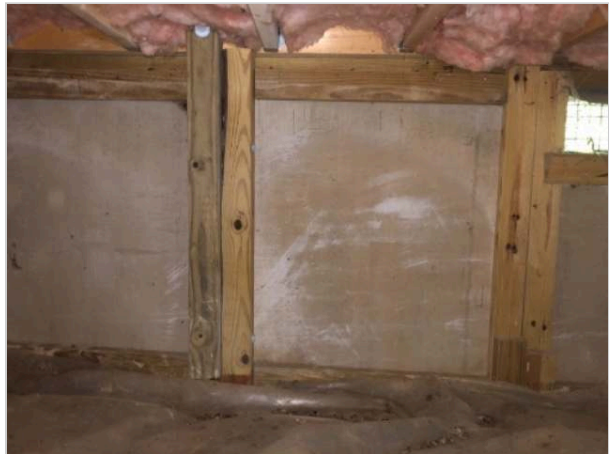
***At the left end of the home, it appears the walk-in closet was added on to the home. The foundation for this area is deck-like and the space closed with attached panels. This may not be structurally sufficient. Have a qualified structural engineer evaluate the foundation here and advise..***

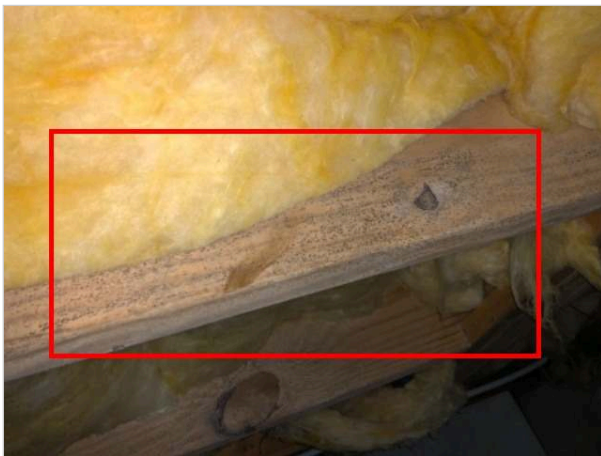
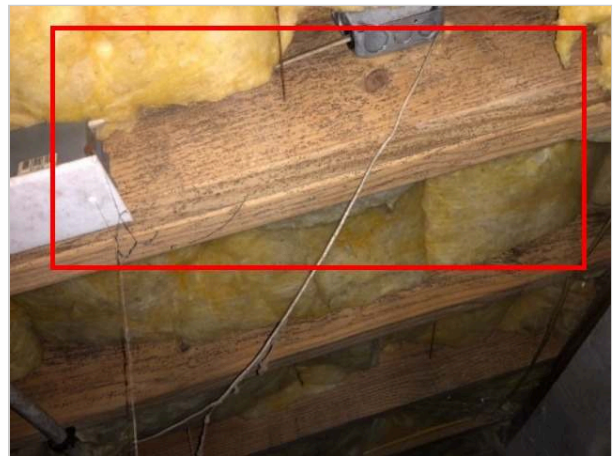
*In the crawl space, there is evidence of possible microbial growth on the floor structure. This is evidence of higher than normal moisture levels at some point. Higher moisture levels can lead to harmful mold and fungus and makes the wood more susceptible to wood destroying insects. Have a qualified contractor mitigate the conditions and perform any necessary repairs.*

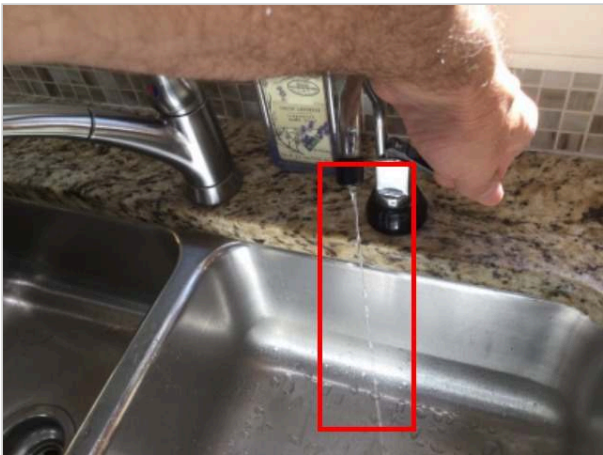
*At the kitchen sink, the filtered water dispenser operates as if the filter is clogged. that is, there is good flow for a couple of seconds and then the flow diminishes greatly. Have a qualified plumbing contractor evaluate and repair as required.*

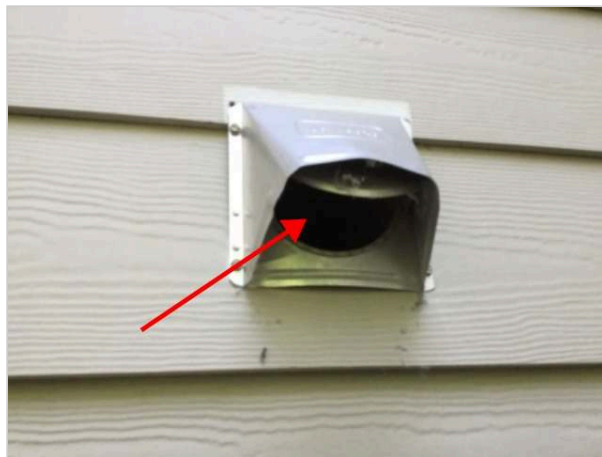
***The dryer vent outlet cover appears to be partially clogged. A clogged dryer vent can overheat and lead to fire. Have a qualified contractor replace the vent outlet cover and clean the vent hose.***
