HomeTeam[®]

HOME INSPECTION REPORT

The HomeTeam Inspection Service made a visual inspection of 123 Main Street, Anytown, USA 55555. Enclosed please find a written, narrative report of our findings in accordance with the terms of our Inspection Agreement.

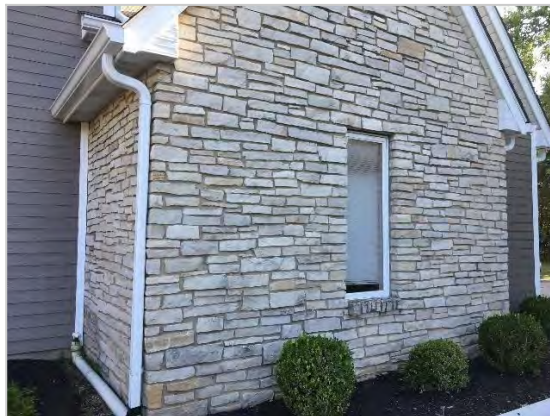
Photo 3

NOTE: The structure has a manufactured stone veneer (MSV) cladding. Structures with MSV can develop moisture intrusion problems even when properly constructed according to industry standards. The problem can develop because of moisture buildup behind the veneer that is unable to drain, and this moisture can cause significant structural damage that is not visible during a non-destructive test. Specific areas of concern include areas around the windows that may have been subjected to prolonged water exposure. Other areas of likely penetration are around chimneys, decks, and any other penetration points. Water intrusion is more likely at these points. In all cases, HomeTeam recommends having MSV-clad structures professionally inspected by an MSV-qualified technician prior to purchase and again each year. Typically, this type of test involves drilling several holes and inserting moisture meters to determine if any moisture is present behind the veneer.
