HOME INSPECTION REPORT

Wednesday, July 3, 2024

John Doe
123 Anywhere St.
City, ST 12345

The inspected property consisted of a two story wood-framed structure with brick, stucco, and wood siding that was occupied at the time of the inspection. There were no material defects on the visible portions of the siding.

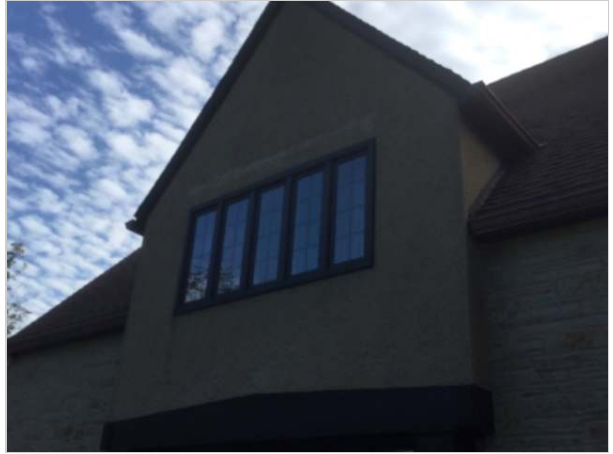
Section seven item (I) of the home inspection agreement specifically excludes the inspection of the exterior insulated finish system (EIFS). These systems are dependent on proper installation by certified contractors in strict accordance with the manufacturer's specifications. We cannot confirm that this installation conforms to all technical specifications. If there is any question on the condition of this finish system, you should consult with a contractor certified in EIFS

installation. All open voids should sealed. Previous repairs were noted.

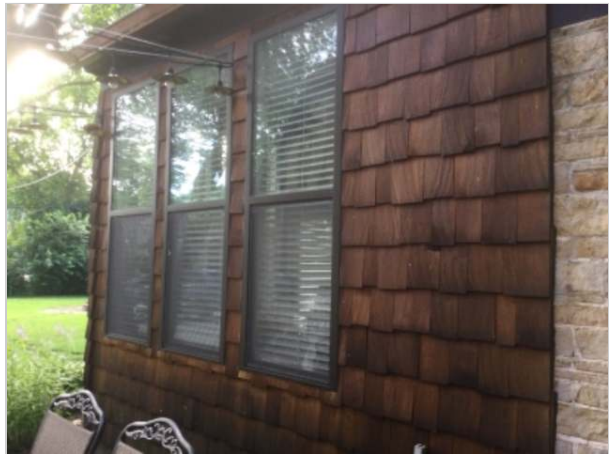
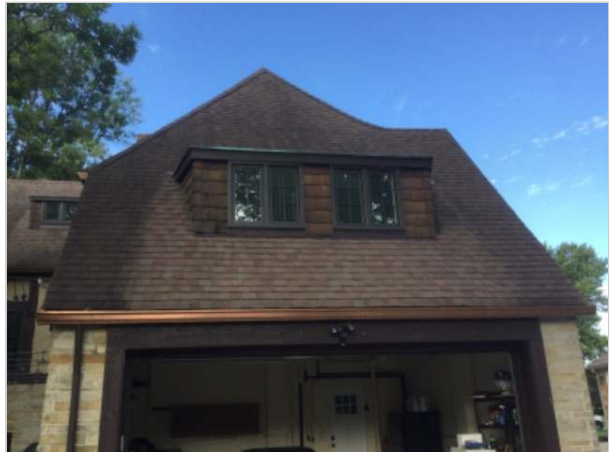
The cedar shack needs to be weather treated on a regular bases to help prevent wood damage.

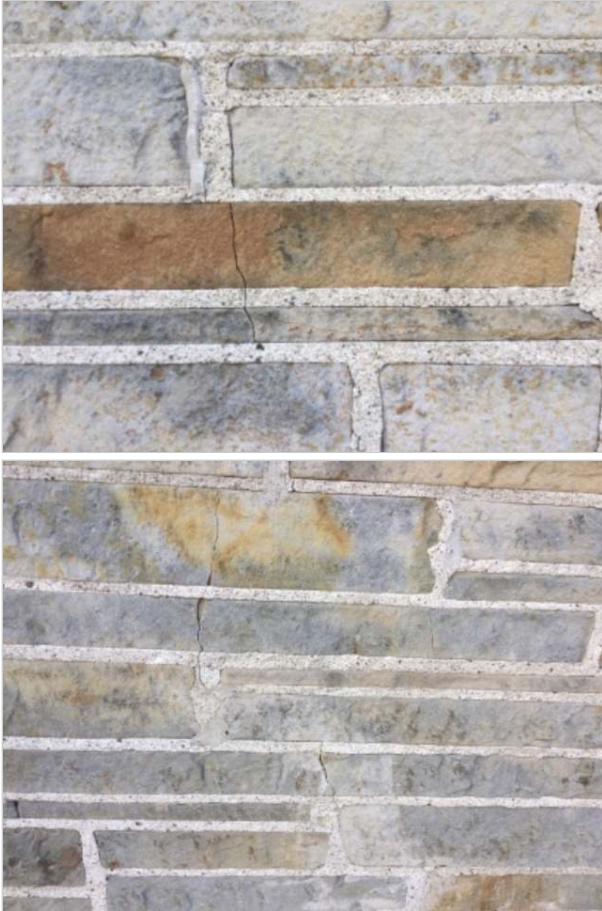
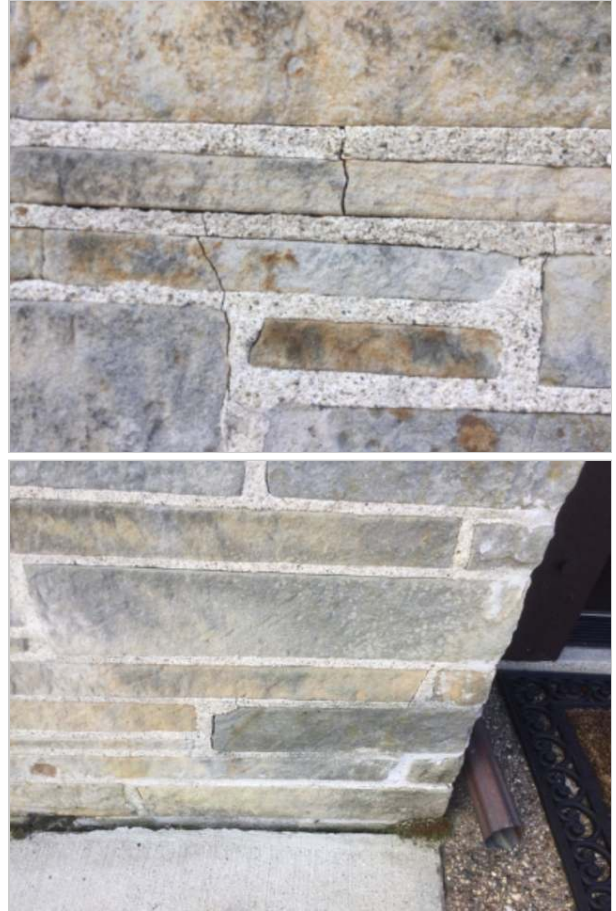
One or more cracks were noted on the brick veneer of the home. The cracks were located on the garage. The cracks appear to have been caused by settlement, are common and do not usually have any structural significance. No structural concern on the brick veneer was noted at the time of the inspection. All cracks should be monitored for significant changes in characteristics. Corrective action did not appear to be necessary. Consult with a qualified masonry contractor if the cracks change significantly or you desire another opinion on this condition.

All open mortar joints in the brickwork should be pointed and monitored.

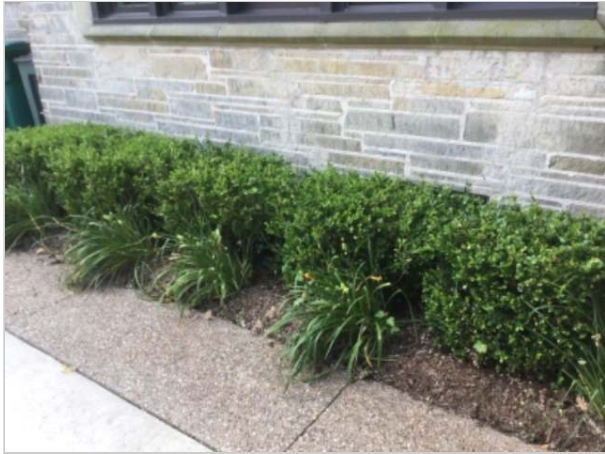
Plant growth was observed against the home at the time of the inspection. Recommend removing this growth away from the siding to prevent possible damage including insect infestation.

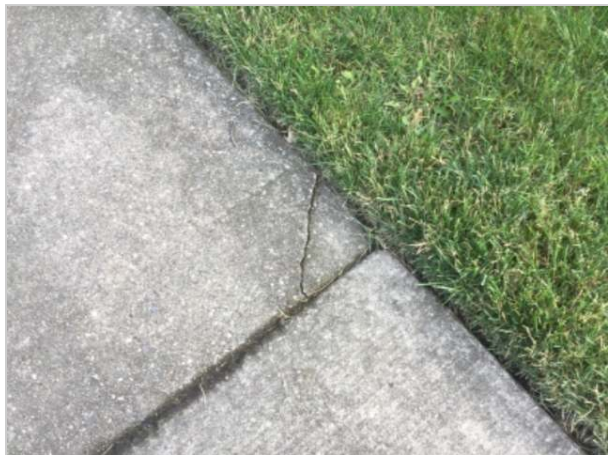
The walkway trip hazards need to be removed for safety.

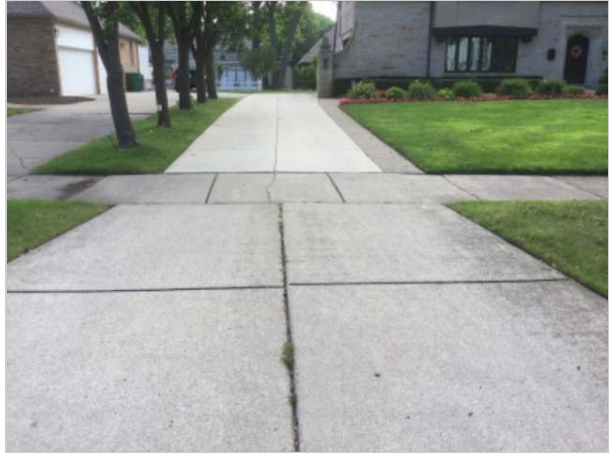
There was a concrete driveway on the left side of the home which led to the attached garage. There were minor cracks and trip hazards noted on the driveway. Surface defects in driveways develop and progress with age and are considered normal as long as they do not create a safety hazard. There were no material defects observed in the driveway.

Caulking or sealing of cracks and joints in the driveway will keep snow and ice from freezing in the open joints and prevent further damage.

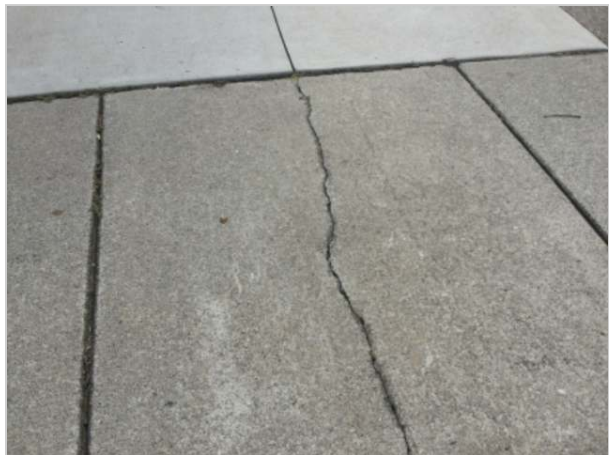
The driveway trip hazards need to be removed for safety.

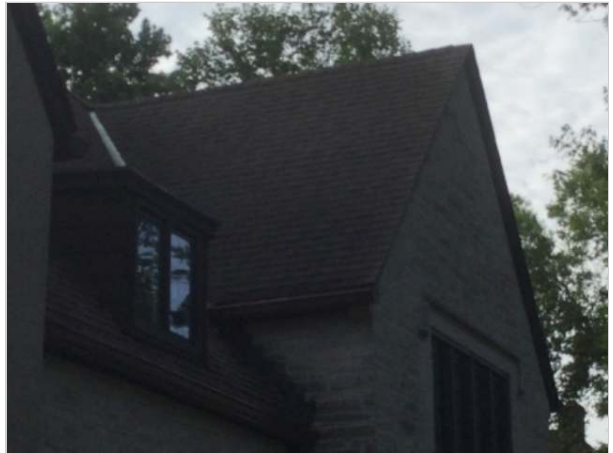
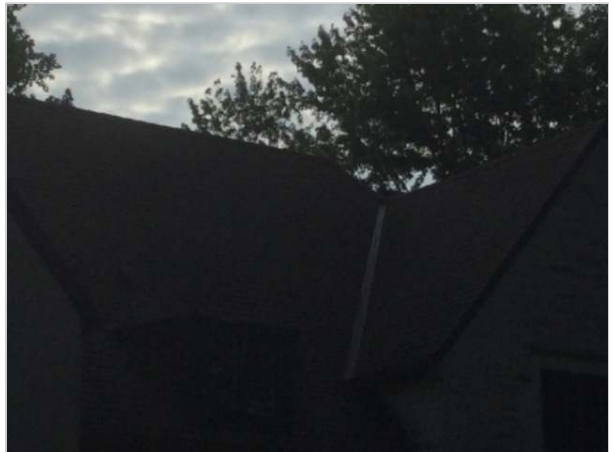
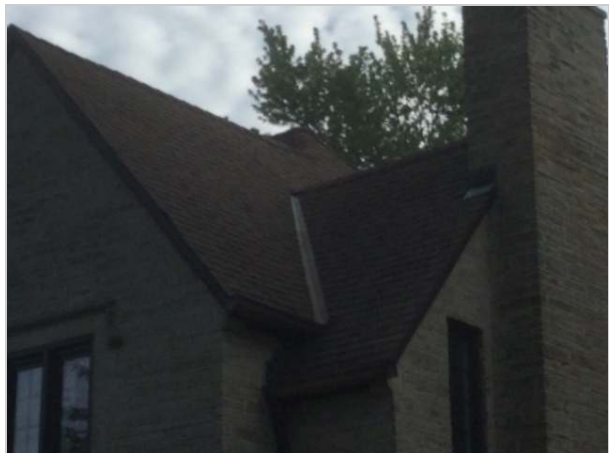
The age of the roof covering, as reported by the seller, was unknown. There were two layers of shingles on the roof at the time of the inspection. There was moderate curling and moderate surface wear observed on the roof shingles at the time of the inspection. These conditions indicate the roof shingles were in the late second half of their useful life.

Use a product called Wet & Forget to remove the moss and mildew buildup on the shingles

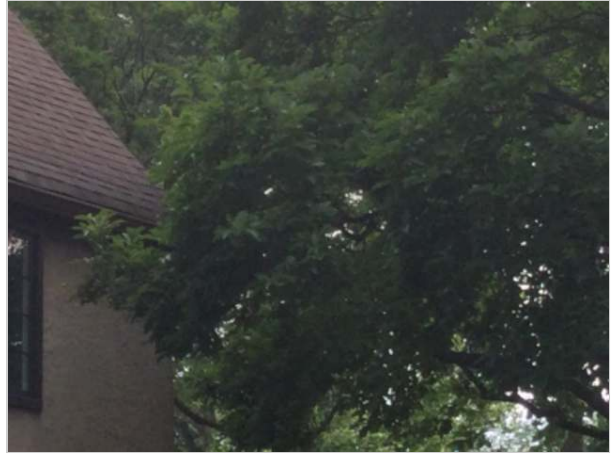
There were signs of moderate shingle wear at the time of the inspection. Fiberglass and the beginning signs of map cracking were noted. If this is a concern we recommend further evaluation by a licensed roofer.

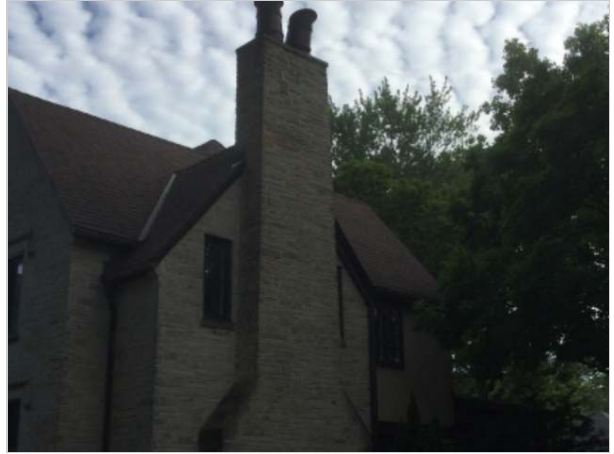
The damaged chimney should be repaired or replaced.

A chimney cap with a spark arrest needs to be installed on the chimney.

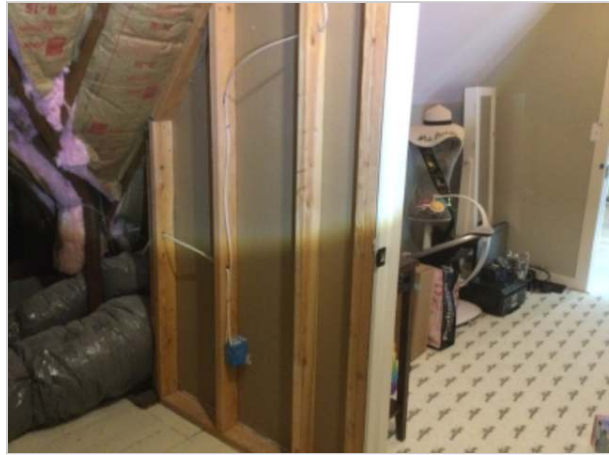
Evidence of rodent activity was noted in the attic at the time of the inspection. We couldn't determine if this was active. Monitor for possible future pest control needs.

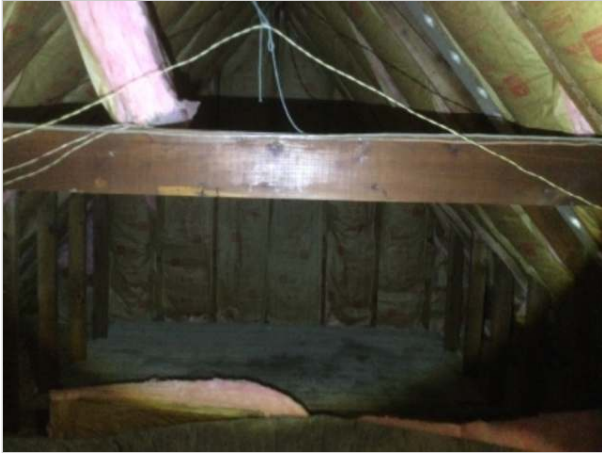
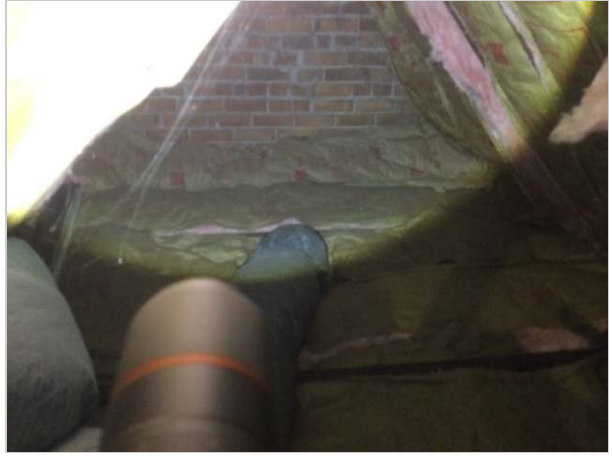
The attic did not appear to have adequate ventilation. There were no vents installed. Proper ventilation in the summer helps extend the life of asphalt / fiberglass roofing, as well as reducing radiated heat from the attic to the living space. Proper ventilation in the winter allows heat loss from the living area to exit the home, preventing the possibility of condensation forming in the attic, which could create mold conditions. Consult with a qualified roofer for further recommendations.

Insulation has been applied directly to the roof rafters in the attic storage areas. Insulation applied directly to the roof deprives the roof deck of proper ventilation and can cause the roof to overheat resulting in shortened roofing life. Additionally, condensation can form between the insulation causing damage to the roof deck. The insulation should be removed from the roof rafters. Walls adjacent to or below the attic spaces should be insulated.

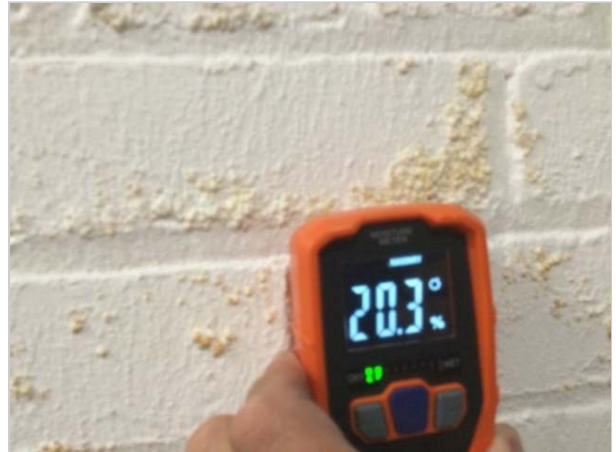
There was Efflorescence on portions of the basement walls. This indicates water is entering the foundation walls. By improving the grade, keeping the gutters clean and having six foot downspout extensions on can help with this condition.

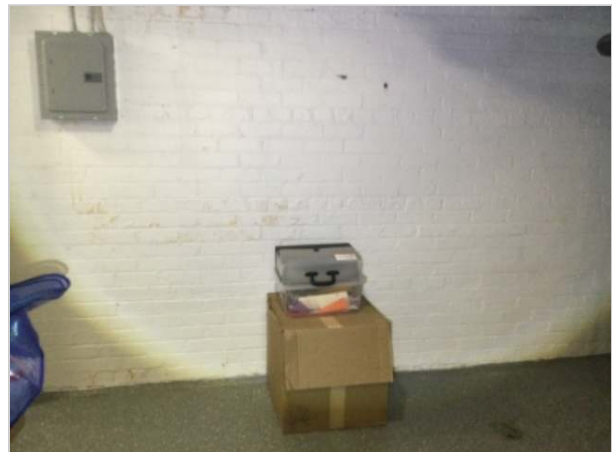
The block foundation has been painted. This may have hidden some deficiencies.

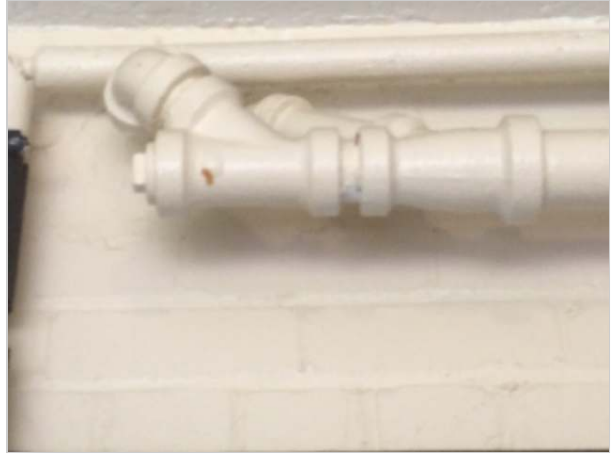
The main waste lines were corroded at the time of the inspection. Repairs may be necessary in the near future. If this is a concern, further evaluation should be conducted by a licensed plumber.

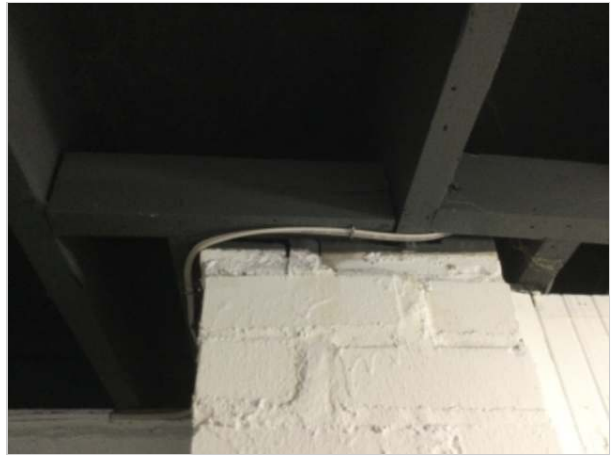
Evidence of amateur wiring was noted in the basement. Amateur wiring does not conform to standards methods and could be a safety concern. Consult with a qualified electrician for evaluation and repairs as required.

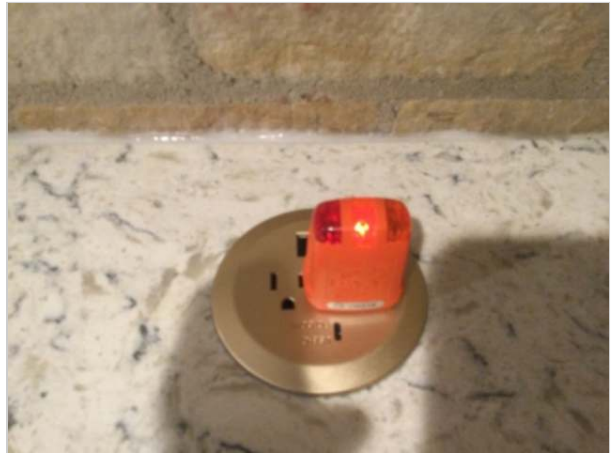
Kitchen

One or more three prong type outlets in the home tested as having an open ground. This means that the third prong, also known as the ground prong is not doing its job. This is usually caused by a missing ground connection at an electrical device in the circuit. This condition is usually easily correctable by an electrician. Open grounds in wet locations is considered a safety issue and should be corrected. Please note that we only test outlets that are visible and readily accessible at the time of the inspection.

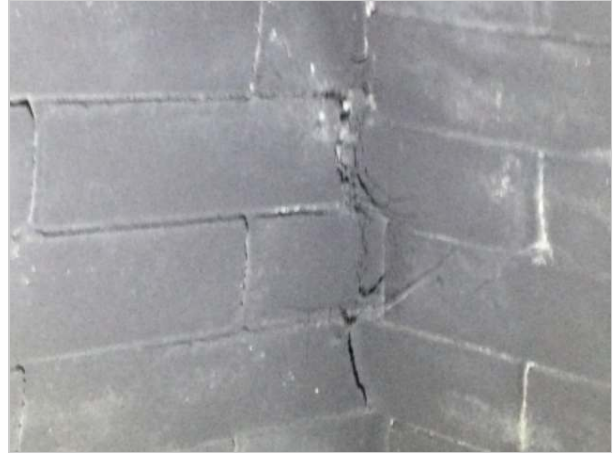
Cracks were noted in the firebox of the fireplace located in the basement. The bricks and mortar inside the firebox are designed to act as a heat and spark shield and should be free of any voids. Efflorescence was also noted. Consult with a qualified, reputable chimney and fireplace service for evaluation and repair.

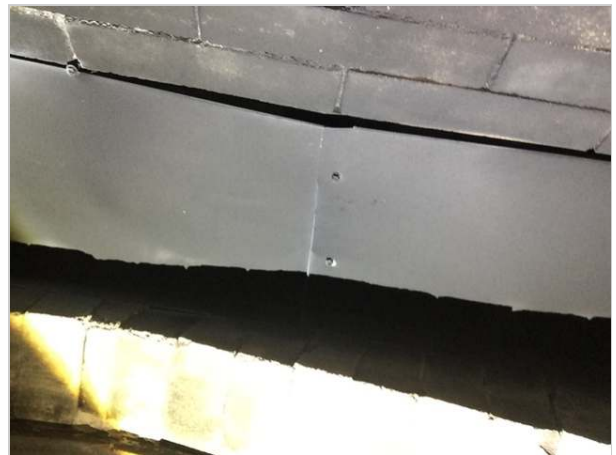
The owner states the fire place logs are vent less. We are unable to confirm that information. The flue is sealed with a metal cover. Recommend further evaluation by a fireplace specialist.

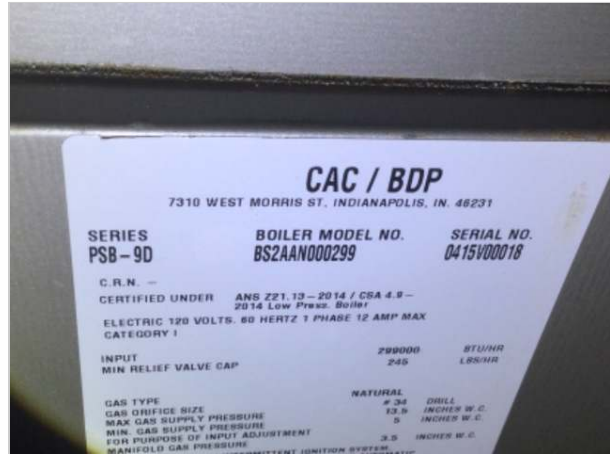
The heating system was found to be functional. The boiler does not appear to have been recently serviced. It is recommended that the furnace be cleaned and serviced by a qualified contractor upon taking ownership of the property. The furnace should be serviced annually to maintain safe and efficient operation.

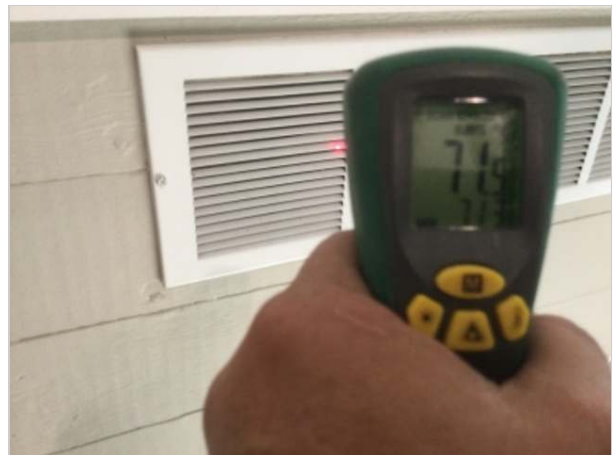
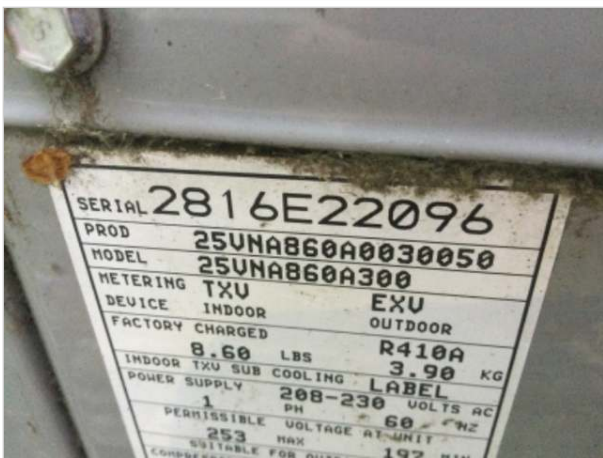
The A/C exterior condenser coil needs to be cleaned.

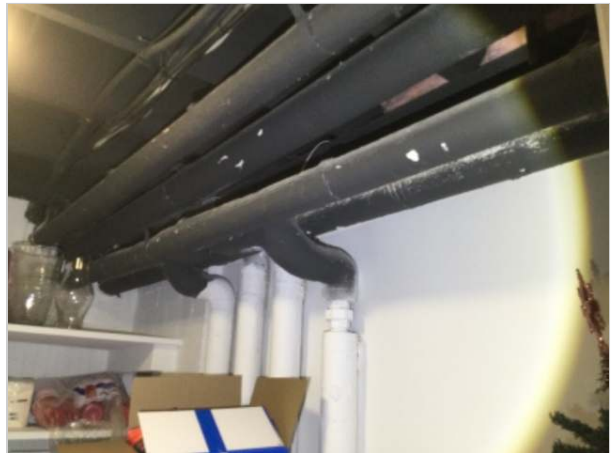
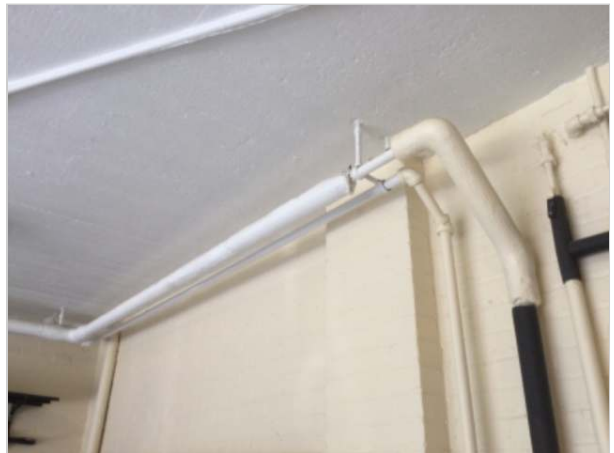
The boiler heating pipes in the basement were covered with a material that has the characteristics of asbestos. The material did appear to be damaged or deteriorating at the time of the inspection. It is advisable to avoid disturbing the substance prior to any testing. The only way to confirm the contents of the material is to have a sample tested by a qualified laboratory. If the substance is of any concern, a qualified asbestos testing firm should be contacted.
