**123 Sample Drive
Anchorage, AK 99504
Inspection #: 00000**

HOME INSPECTION REPORT

Inspection Date: November 14, 2016

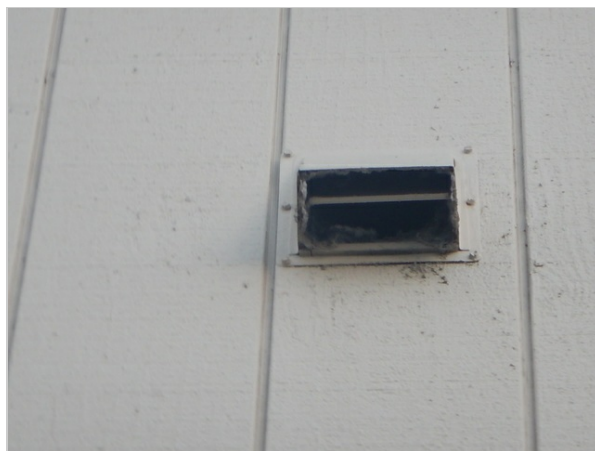
The exterior dryer vent has lint accumulation which does not allow the back draft preventer to close and is considered a fire hazard. Professionally clean the ducting from the dryer to the exterior.

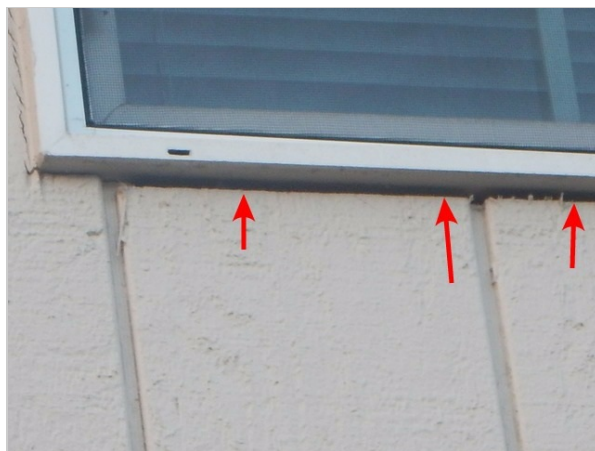
The master bedroom window is not sealed to the siding. Caulk the window to the siding to prevent possible moisture intrusion.

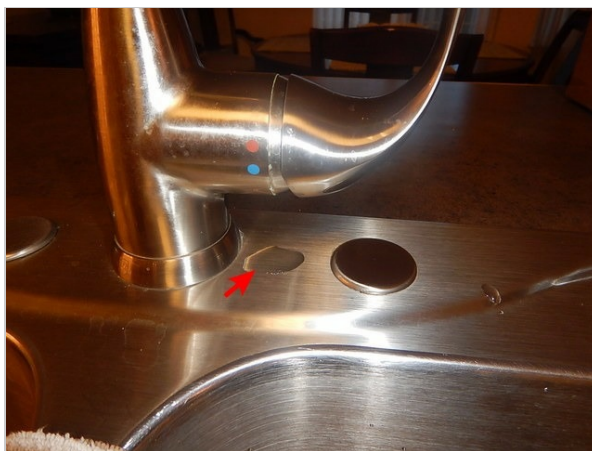
The sink faucet in the kitchen leaks at the stem. Repair or replace the faucet as needed to ensure a leak free operation.
