# HomeTeam<sup>®</sup>

### *HOME INSPECTION REPORT*

*This summary provides a quick overview of the results of the inspection performed on 8/3/2015 at 123 Sample Drive, Homosassa, FL 34446:.*

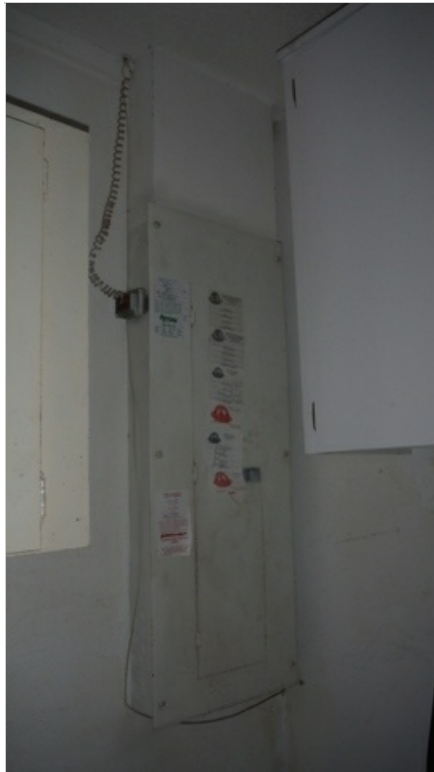
**The electric panel is surrounded by cabinets and is not immediately accessible. This could create an unsafe condition in the event of an emergency.**

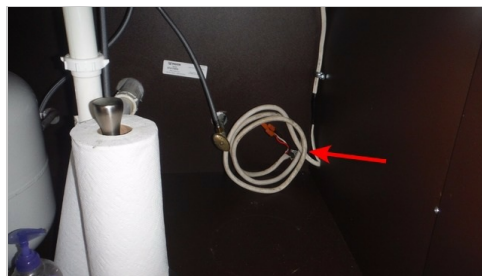
CAPPED WIRE UNDER PATIO SINK

**There was a capped wire under the patio sink that was capped and appeared to not have power.**

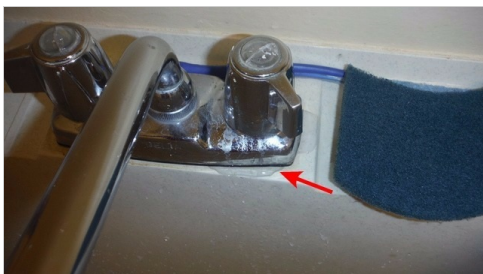
LEAKS

**The cold water knob on the laundry room sink leaks when turned on. Recommend replacing seals and tightening.**

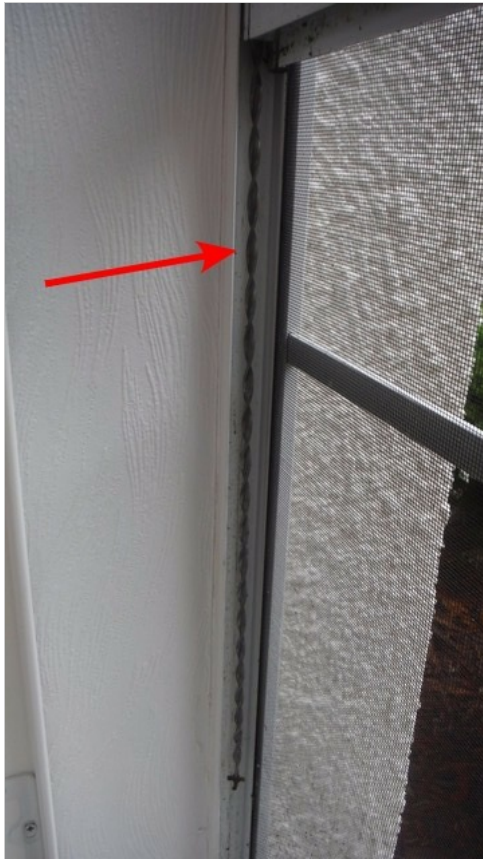
**SPRUNG SPRING**

**The front office window had a sprung spring on the left side.**

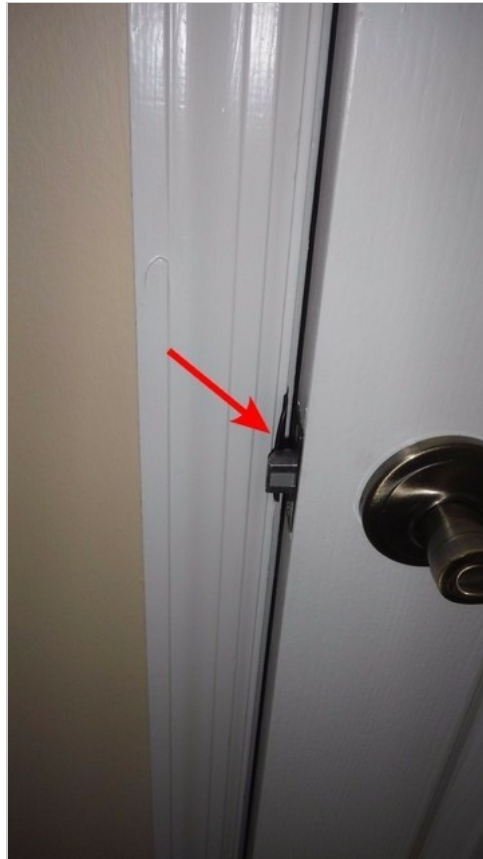
**WOULD NOT LATCH CLOSED**

**The two left side bedroom doors would not latch when closed. Recommend adjusting the catch latch.**

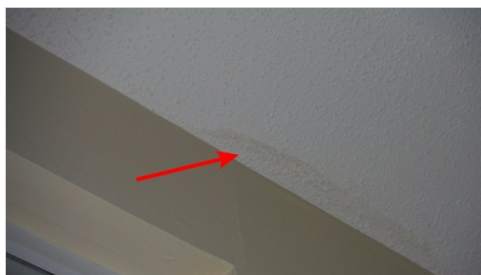
**WATER MARK**

**There was a small water mark in the living room above the sliding glass door. It appears to be possibly coming from the vent pipe directly above. Recommend sealing the vent pipe and if the mark appears to get bigger contact a qualified licensed roofing contractor to further evaluate.**

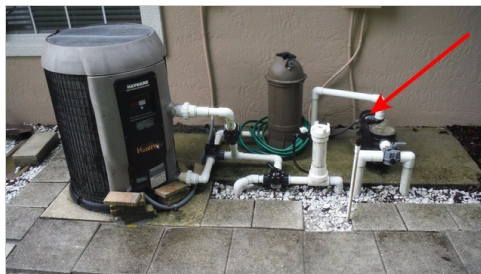
Pump

**The pool pump was louder than normal. This could indicate failing bearings.**
