### *HOME INSPECTION REPORT*

The inspected property consisted of a ranch wood-framed structure with plywood siding / cladding that was occupied at the time of the inspection. Minor, exterior type caulking and maintenance, painting are common on most homes and may be present but may or may not be specifically identified in this report. The approximate temperature at the time of the inspection was 70-75 degrees Fahrenheit, and the weather was sunny and clear. The utilities were on at the time of the inspection. The buyer was present during the inspection. The home was situated on a lightly sloped lot. The general grade around the home appeared to be mostly adequate to direct rain water away from the foundation. The age of the home, as reported by the building permits was said to be 37 years old.

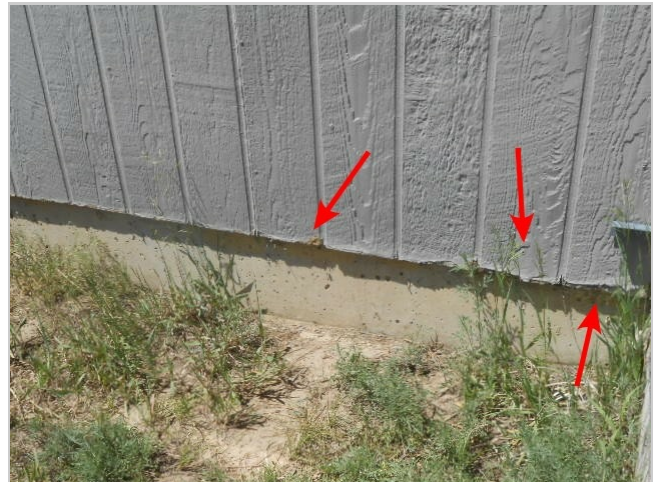
The siding and trim throughout the exterior of the home were in overall marginal condition. There were several areas throughout the exterior where the siding and trim was deteriorating and scraping, repairs, caulking and paint to match are needed. We recommend that a reputable contractor further evaluate the homes exterior and any recommendations for repairs and maintenance be completed prior to closing to prevent any further decay and to prevent possible water intrusion into the home or the homes structure.

- The siding and trim throughout the exterior of the home were in overall marginal condition. There were several areas throughout the exterior where the siding and trim was deteriorating and scraping, repairs, caulking and paint to match are needed. We recommend that a reputable contractor further evaluate the homes exterior and any recommendations for repairs and maintenance be completed prior to closing to prevent any further decay and to prevent possible water intrusion into the home or the homes structure.

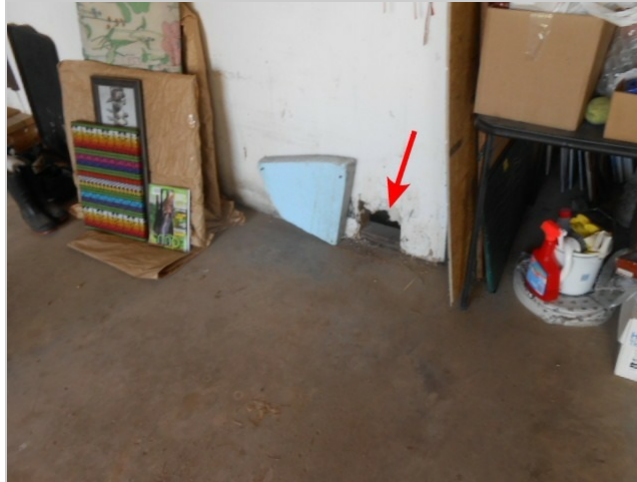
There was one firewall breach observed in the garage ( on the rear garage wall ) at the time of inspection. Firewall breaches are safety concerns which include holes or voids in the firewall separation between the

garage and home which should be sealed to prevent a garage fire from spreading easily into the home.

- There was one firewall breach observed in the garage ( on the rear garage wall ) at the time of inspection. Firewall breaches are safety concerns which include holes or voids in the firewall separation between the garage and home which should be sealed to prevent a garage fire from spreading easily into the home.
