### *HOME INSPECTION REPORT*

Address of Inspection: **123 Sample Drive, Louisville, KY**

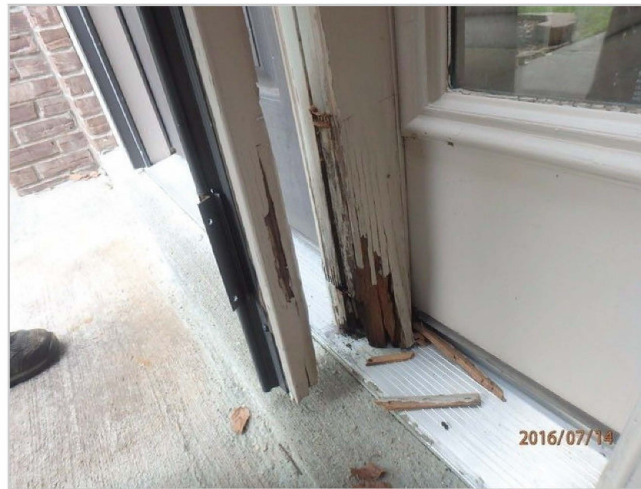
**Photo 1**

**Rotted wood was present on the front door** . The areas should be repaired and further evaluated at the time of repair.

example of rotted wood around the front door

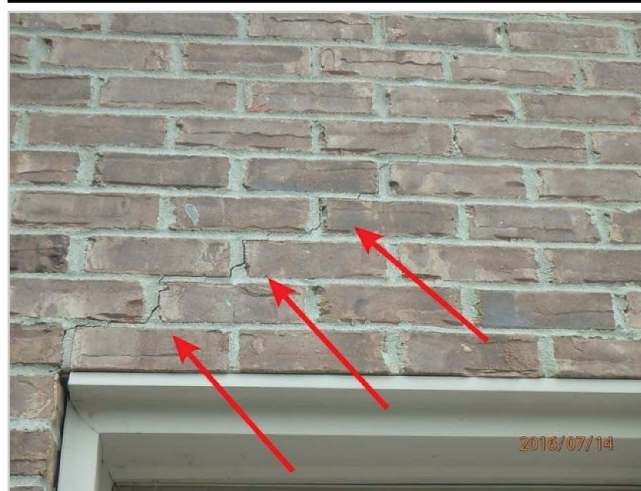
**Photo 2**

**Cracks were present on the brick veneer of the home.** The cracks were located on the front. The cracks are common and do not usually have any structural significance. No structural concern on the brick veneer was noted. All cracks should be monitored for significant changes in characteristics. The cracks should be sealed to prevent water intrusion behind the brick.

mortar crack

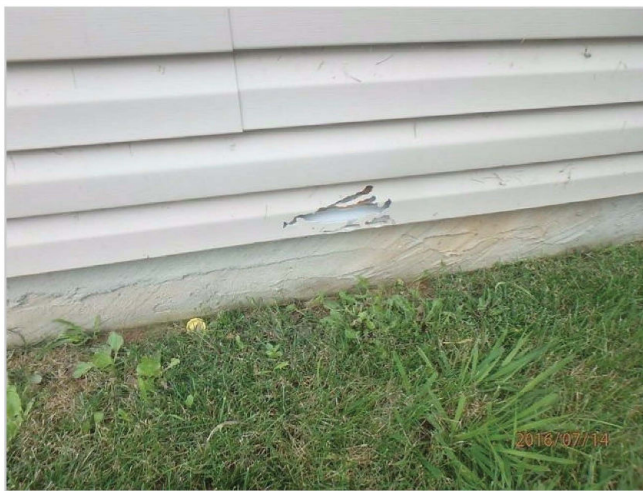
**Photo 3**

**Holes were noted on the right and back sides of the home's exterior.** This condition does not have any effect on the structural integrity of the building. The areas should be repaired to prevent water intrusion.

example of damaged siding

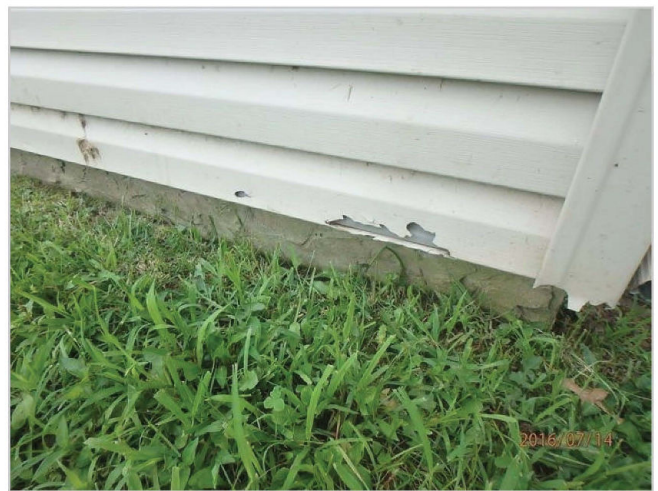
**Photo 4**

example of damaged siding

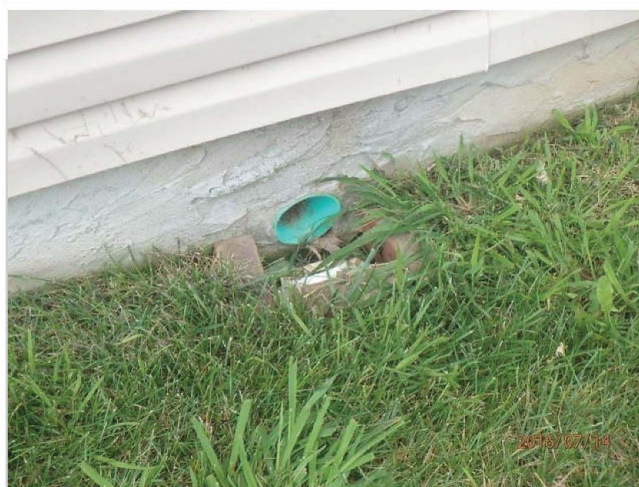
**Photo 5**

**The dryer vent cover is missing.** The vent cover should be repaired or replaced to prevent birds or other small animals from entering the home.

missing dryer vent cover

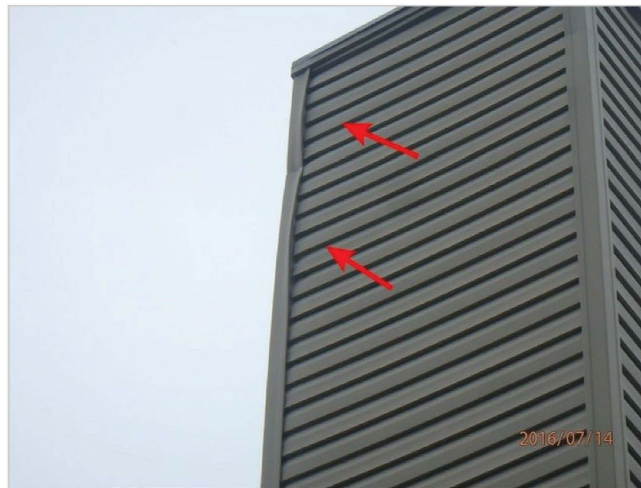
**Photo 6**

NOTE- Although the vinyl on the flue chase is not loose there are areas that appear to be buckled. These areas should be monitored for any needed repairs and repaired as necessary

buckled vinyl

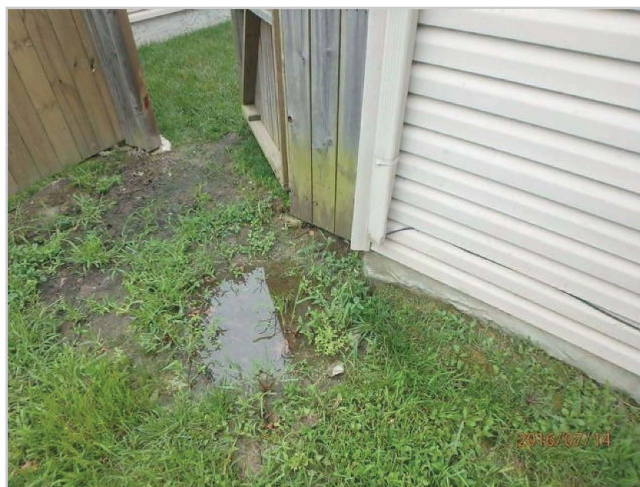
**Photo 8**

**Several downspouts were draining at or too close to the base of the foundation.** To reduce the likelihood of water problems at the base of the home, all roof drainage should be directed at least six feet from the base of the foundation.

several downspouts are draining adjacent to the foundation

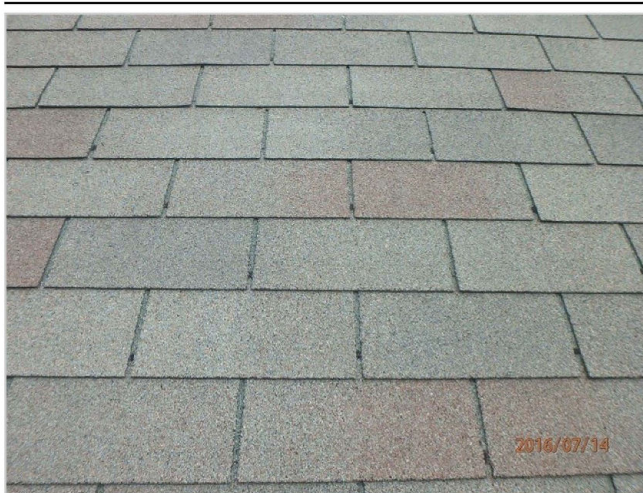
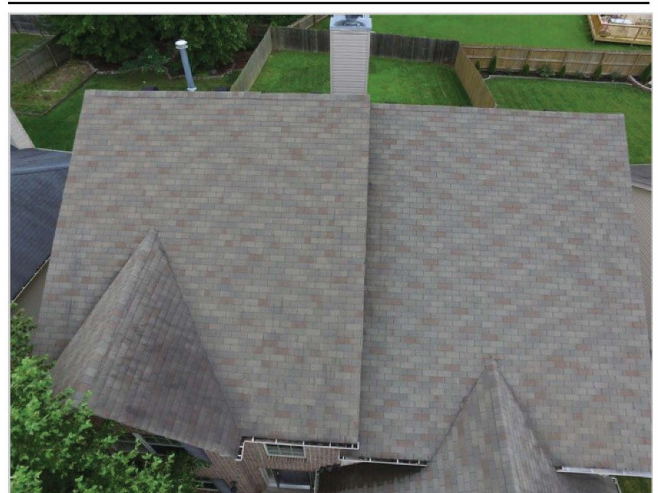
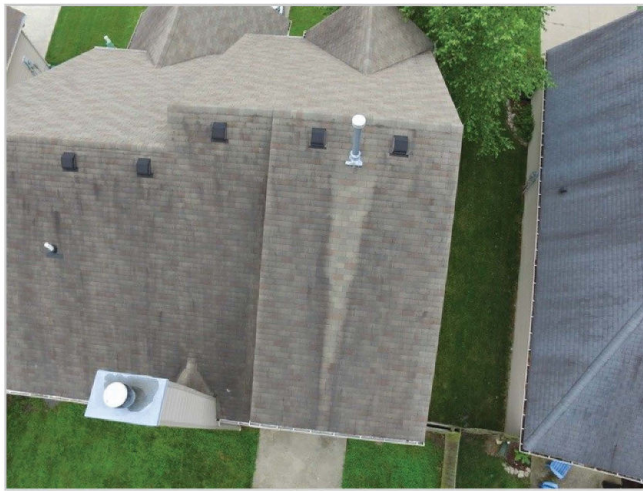
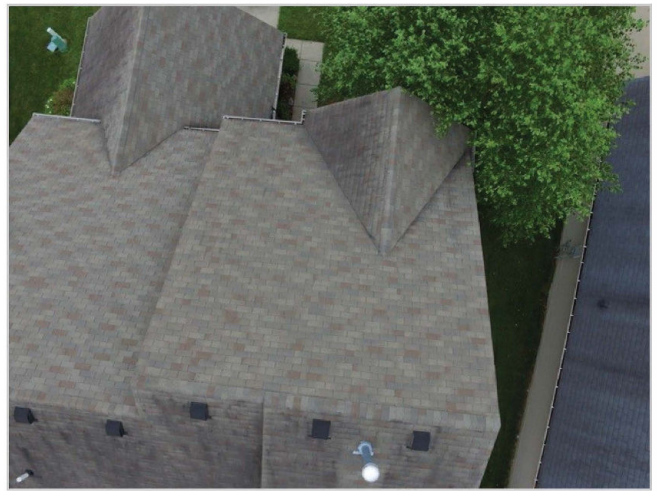
The roof shingles exhibited light curling and moderate surface wear. Several areas were tested for lifted edges, and lifted edges were not observed. Nail pops were observed. Evidence of a hail event was not observed.

These conditions indicate the roof shingles were in the second half of their useful life.

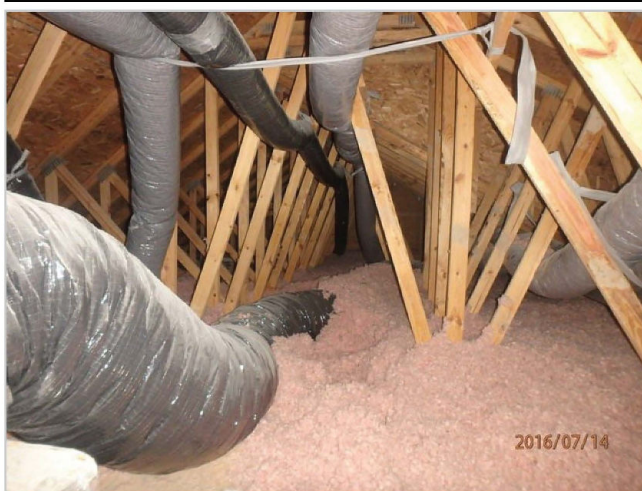
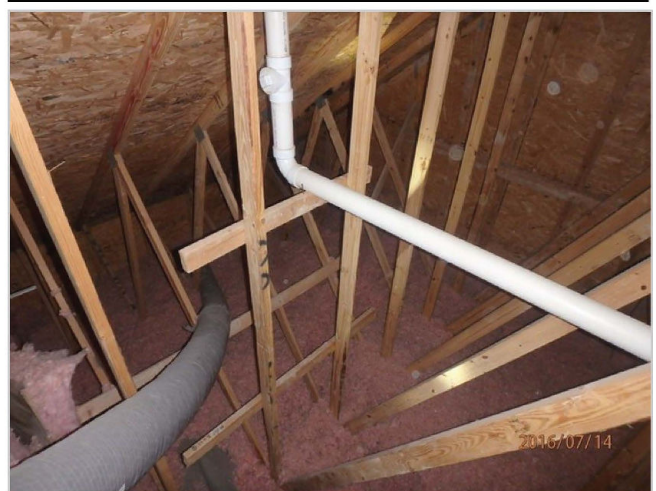
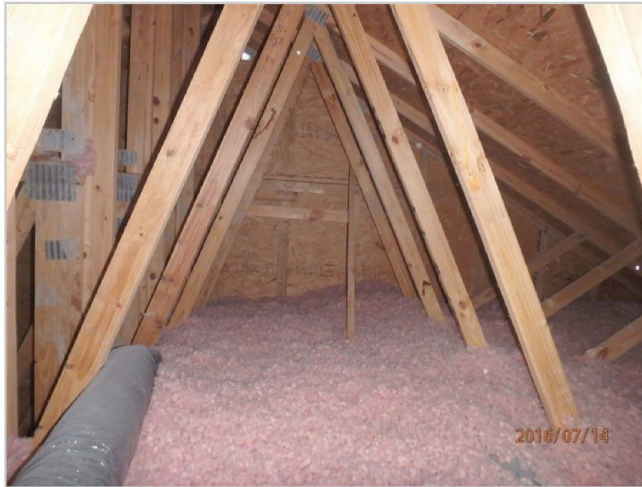
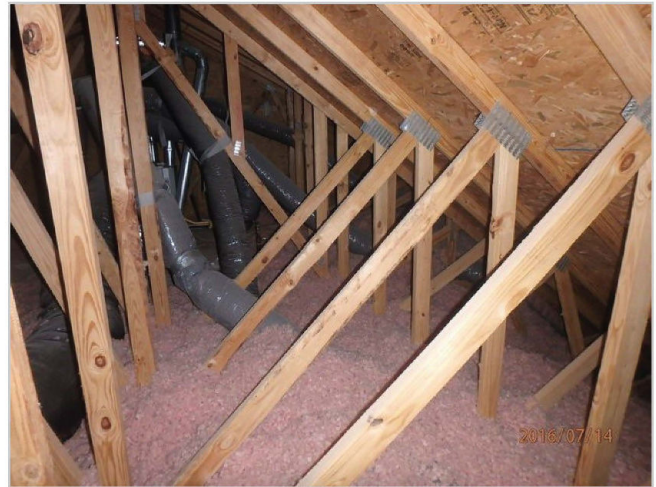
Parts of the attic show signs of previous water intrusion. The areas were dry at the time of the inspection. The buyer should maintain vigilance in monitoring the areas for any recurrence of the previous issue and should rectify any issues immediately upon observing them.

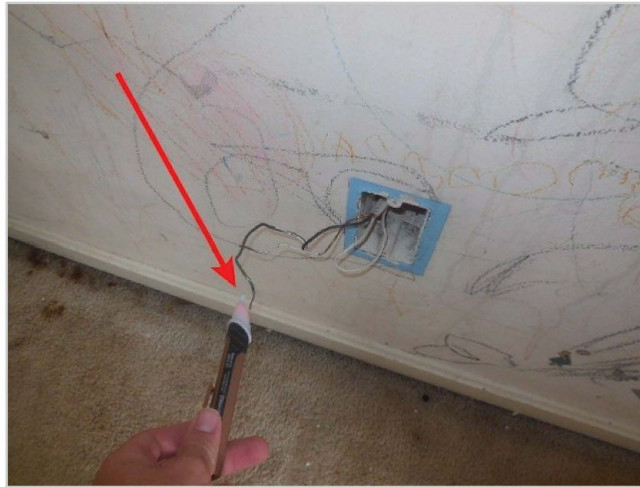
**Photo 18**

**Exposed live wires were observed in the upstairs right bedroom.** The wires should either be disconnected at the source or properly terminated in an approved, covered electrical box. Consult with a qualified electrician for repair and further assessment.

Exposed live wires.

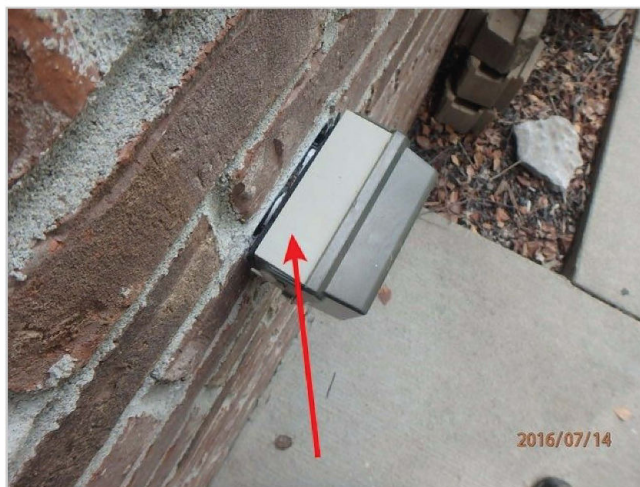
**Photo 19**

**One exterior outlets were not properly covered, potentially allowing rainwater to enter the circuit.** Outlet covers designed for use in wet locations should be installed on all exterior outlets.

outlet is not properly covered

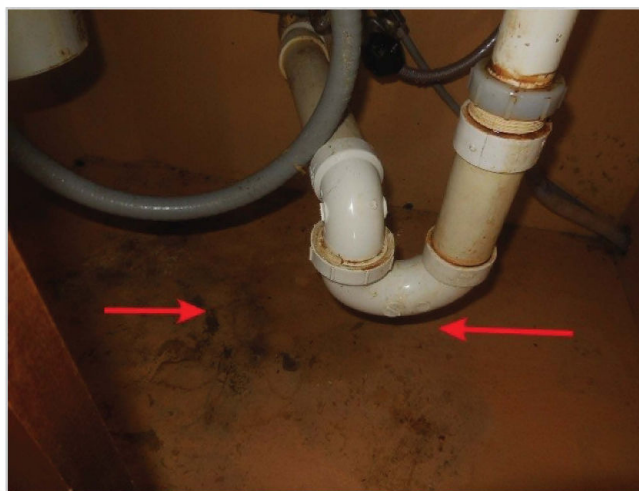
**Photo 20**

**The drain line under the kitchen sink leaks** and should be repaired to prevent further water intrusion. At

the time of repair, all drain lines should be further assessed.

Drain line leaks under the kitchen sink.

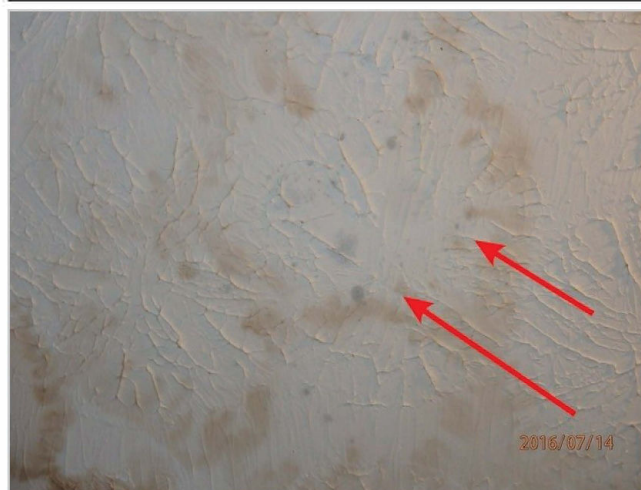
**Photo 23**

**Mold-like growth is visible in the structure (garage).** The EPA has helpful information that may assist the buyer (<http://www.epa.gov/mold/moldresources.html>). HomeTeam recommends having the areas tested to determine presence, type and relative concentration of mold spores, and professionally remediated by a reputable mold remediation company, which may include removing and replacing affected segments. A mold remediation company may uncover additional areas or issues requiring repair or remediation.

mold like growth in the garage

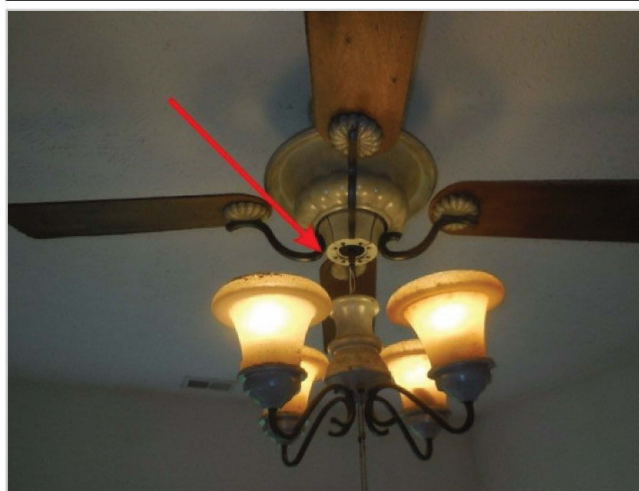
**Photo 24**

**A light fixture in the master bedroom is loose** and should be secured.

Loose light fixture.

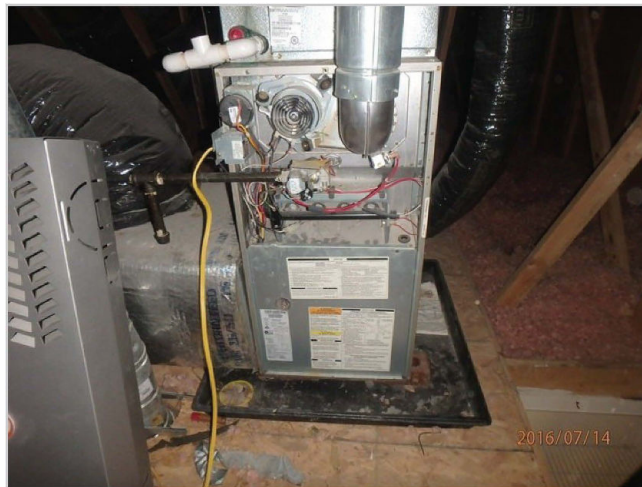
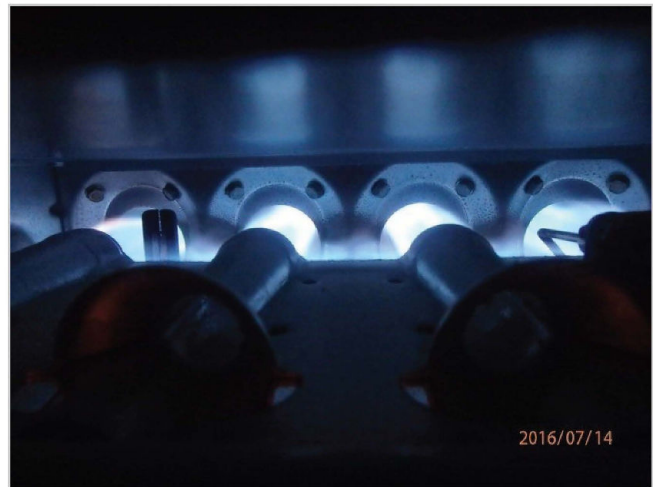
Because of its condition and performance at the time of the inspection, **the furnace requires cleaning and servicing by a professional HVAC technician.** At that time, the technician will test refrigerant levels, service the equipment to improve its performance, and perform other tests beyond the scope of the home inspection to assess and identify any additional areas that may require attention.
